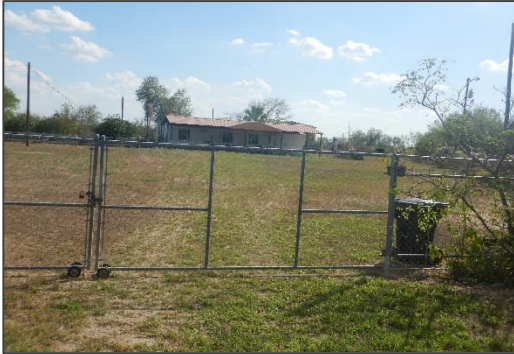
Photograph 1 – View looking south at the former location of Reported Site 1, Quintanilla Tire Shop. The site is no longer active and is a private residence.

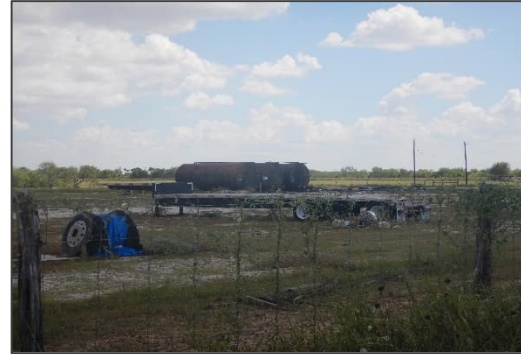
Photograph 4 – View looking southeast at oil tankers located near the entrance of Reported Site 4, Rio Farms Gas Plant. The site was inaccessible due to a lack of right-of-entry permissions.

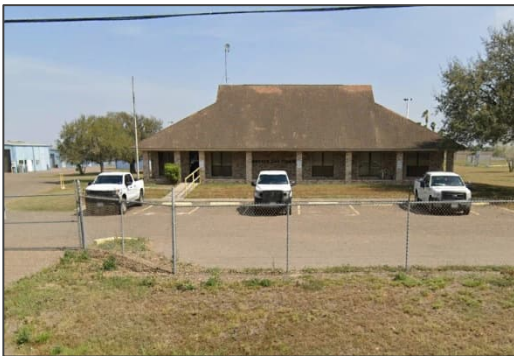
Photograph 2 – View looking east at Reported Site 2, Tennessee Gas Company.

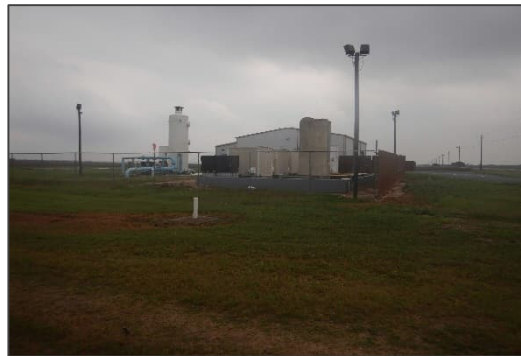
Photograph 5 – View looking east from the existing Raymondville Drain at Reported Site 5, North Alamo Water Supply Corporation Reverses Osmosis Wastewater Treatment Plant.

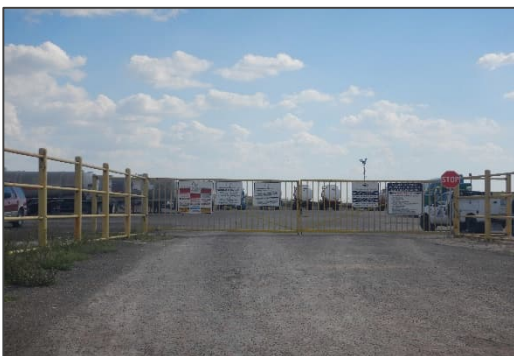
Photograph 3 – View looking south at the entrance to Reported Site 3, Key Energy Service.

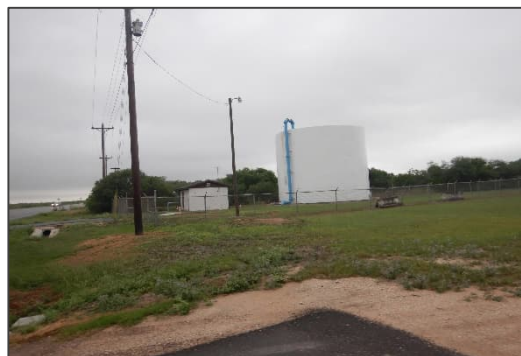
Photograph 6 – View looking west at an above-ground storage tank associated with Reported Site 5.

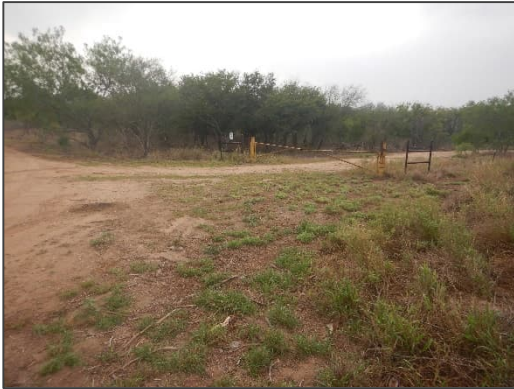
Photograph 7 – View looking northwest at the entrance to Reported Site 7, Lower Rio Grande National Wildlife Refuge.

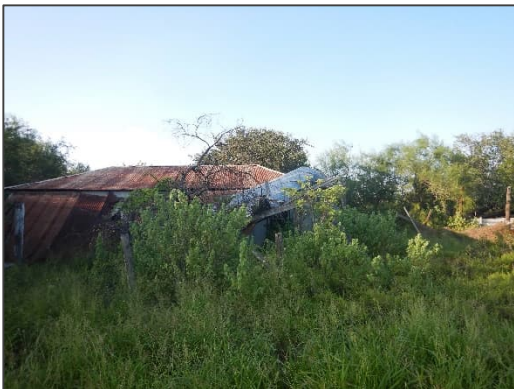
Photograph 8 – View looking north at an abandoned and collapsed structure at the entrance of Reported Site 9, Raymondville Historical Landfill.

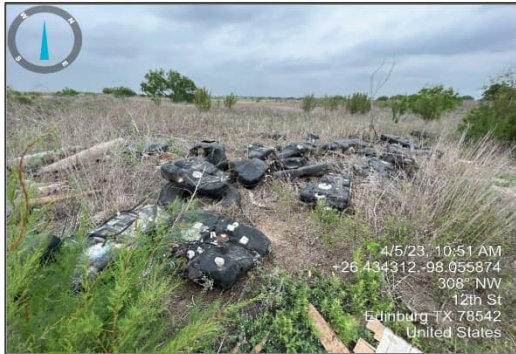
Photograph 9 – View northwest at Unreported Site 1, discarded gas tanks located along 12th Street.

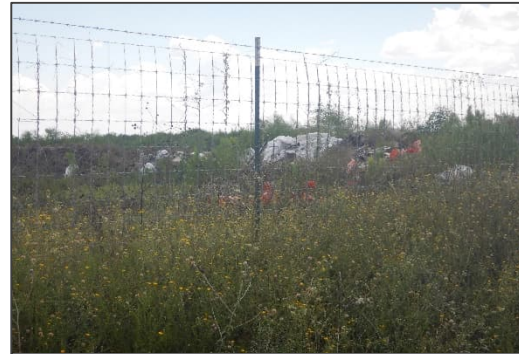
Photograph 12 – View looking southeast at construction debris located at Unreported Site 3.

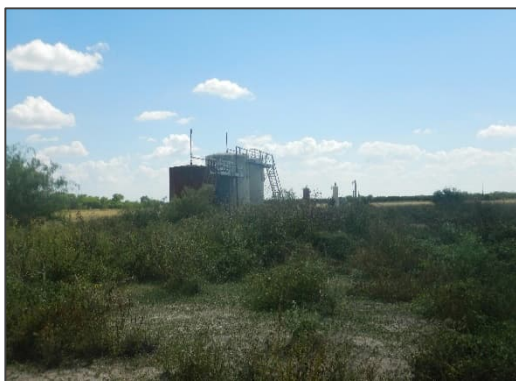
Photograph 10 – View south at tank batteries located at Unreported Site 2. This photograph was taken from a publicly accessible roadway.

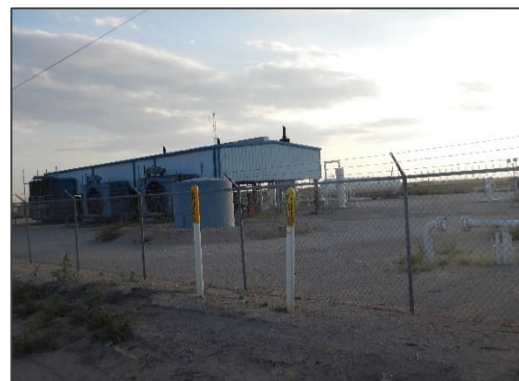
Photograph 13 – View looking southwest at Unreported Site 5, Energy Transfer Raymondville Facility.

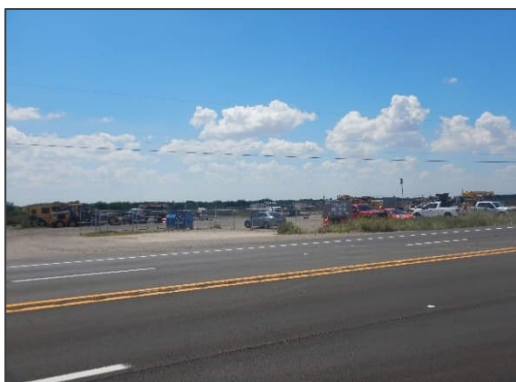
Photograph 11 – View looking north at Unreported Site 3, Construction Staging Area.

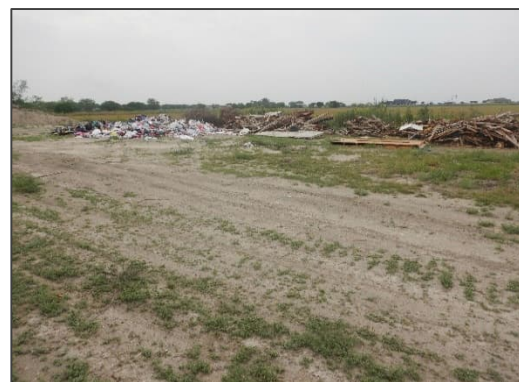
Photograph 14 – View looking south at Unreported Site 6, an illegal dumping area located within the RDP study corridor.

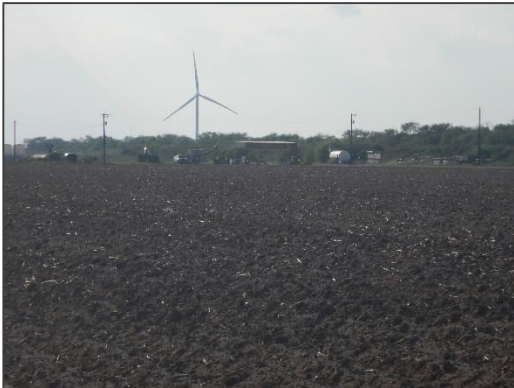
Photograph 15 – View looking northwest at Unreported Site 7, a farming staging area. This photograph was taken from a publicly accessible roadway.
