The following site photographs of the proposed Raymondville Drain Project Alternative 2 right-of-way were recorded during field investigations conducted in March 2021. Photographs generally proceed from the upstream extent of the existing Delta Lake Drain eastward to the confluence of the Delta Lake Drain and the Raymondville Drain.

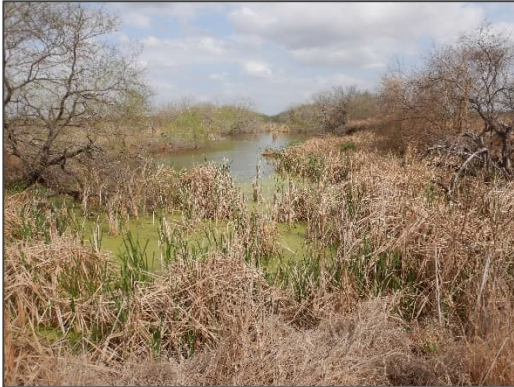
Photograph 1 – View looking east (downstream) at the existing Delta Lake Drain.

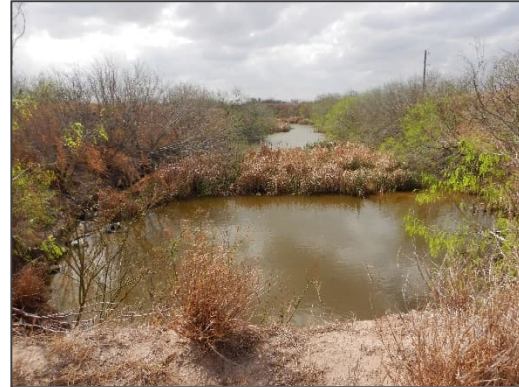
Photograph 4 – View looking west at the existing Delta Lake Drain from FM 3444.

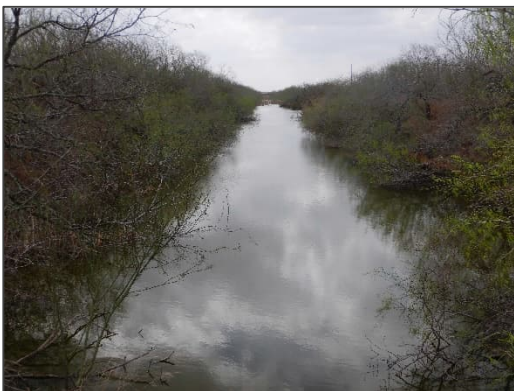
Photograph 2 – View looking west at the existing Delta Lake Drain from Private Culvert Crossing #1.

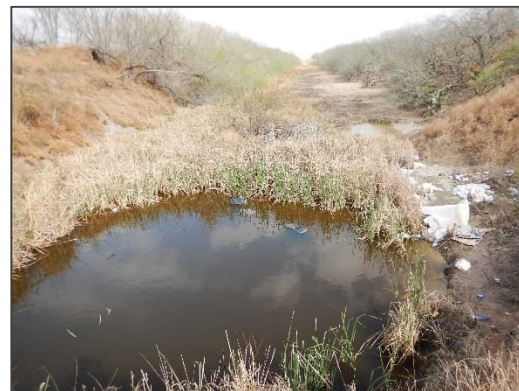
Photograph 5 – View looking east (downstream) at the existing Delta Lake Drain from FM 3444.

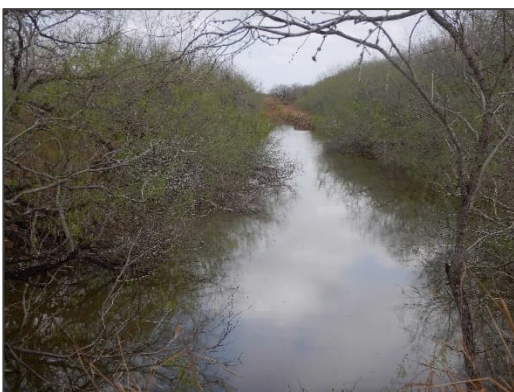
Photograph 3 – View looking east at the existing Delta Lake Drain from Private Culvert Crossing #1.

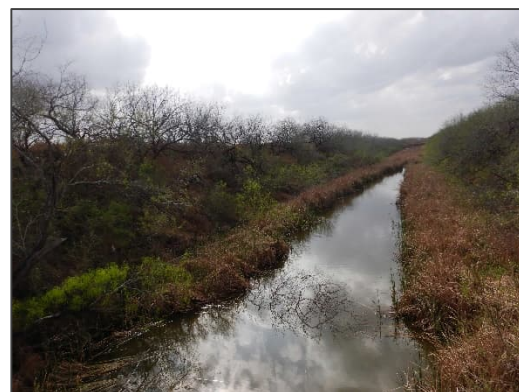
Photograph 6 – View looking at the existing Delta Lake Drain from Private Culvert Crossing #2.

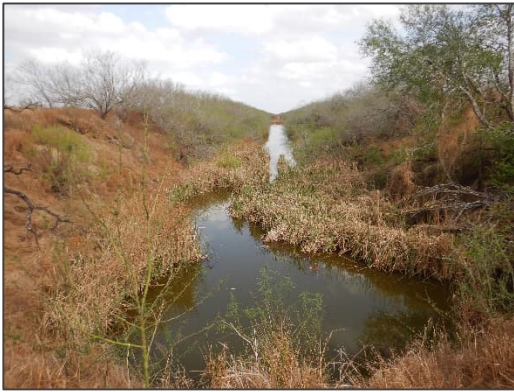
Photograph 7 – View looking east (downstream) at the existing Delta Lake Drain from Private Culvert Crossing #2.

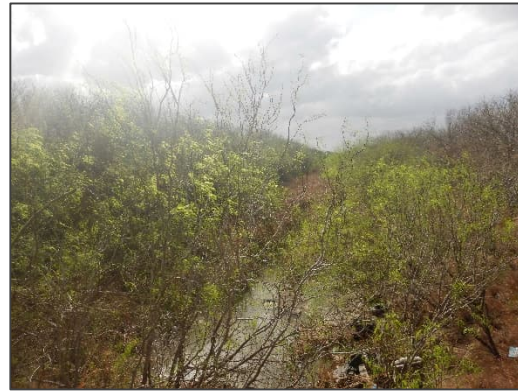
Photograph 10 – View looking west (upstream) at the existing Delta Lake Drain from Private Culvert Crossing #4.

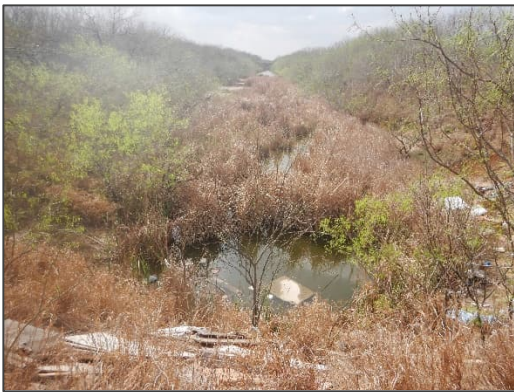
Photograph 8 – View looking west (upstream) at the existing Delta Lake Drain from Private Culvert Crossing #3.

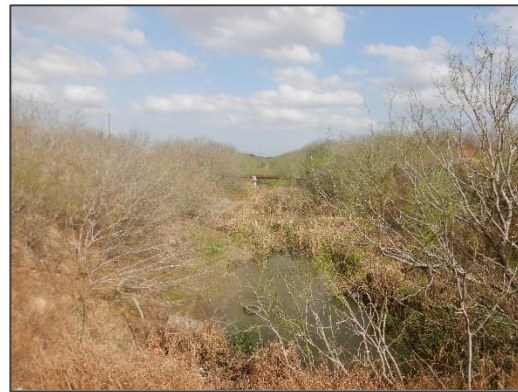
Photograph 11 – View looking east (downstream) at the existing Delta Lake Drain from Private Culvert Crossing #4.

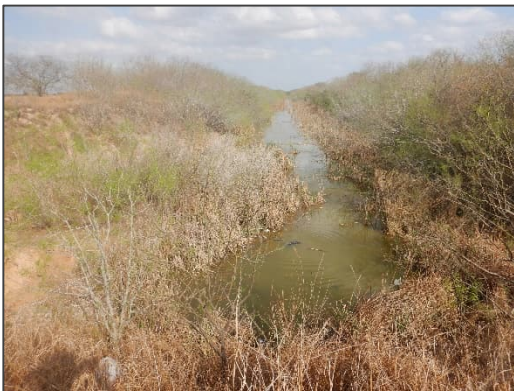
Photograph 9 – View looking east (downstream) at the existing Delta Lake Drain from Private Culvert Crossing #3.

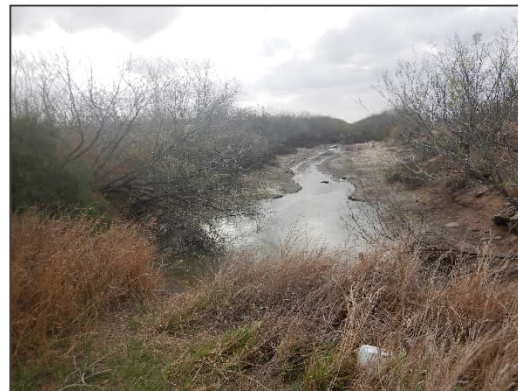
Photograph 12 – View looking west (upstream) at the existing Delta Lake Drain near FM 493.

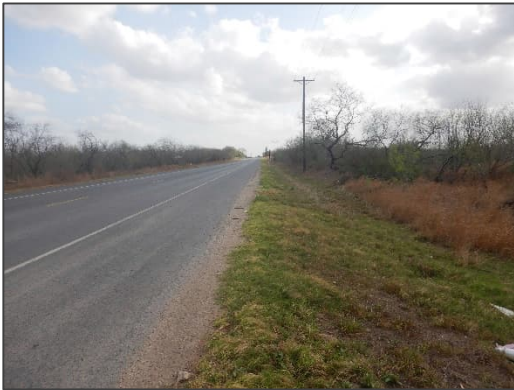
Photograph 13 – View looking south at FM 493. The existing Delta Lake Drain flows west to east under FM 493 via a box culvert.

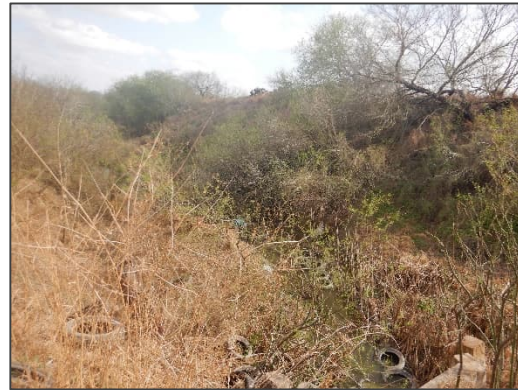
Photograph 16 – View looking southeast (downstream) at the existing Delta Lake Drain from Mile 25 North Road.

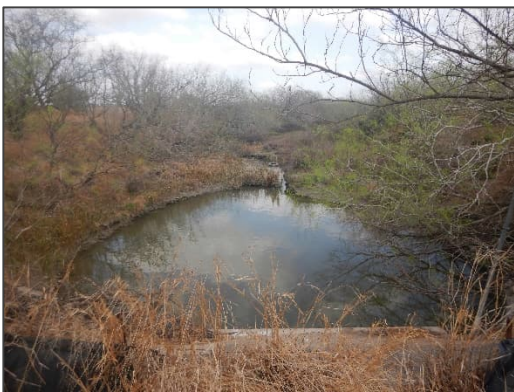
Photograph 14 – View looking east (downstream) at the existing Delta Lake Drain from the FM 493 bridge.

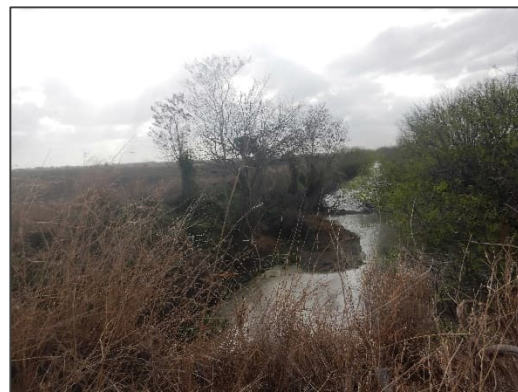
Photograph 17 – View looking west (upstream) at the existing Delta Lake Drain from the Jesus Flores Road bridge.

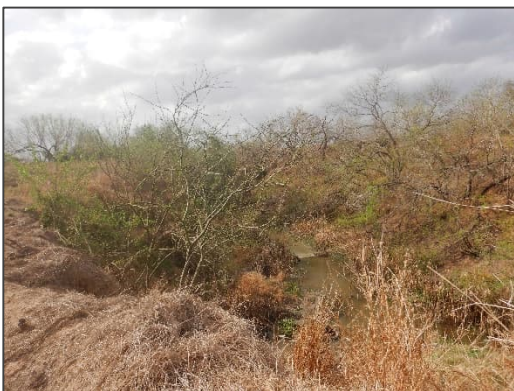
Photograph 15 – View looking northwest (upstream) at the existing Delta Lake Drain from Mile 25 North Road.

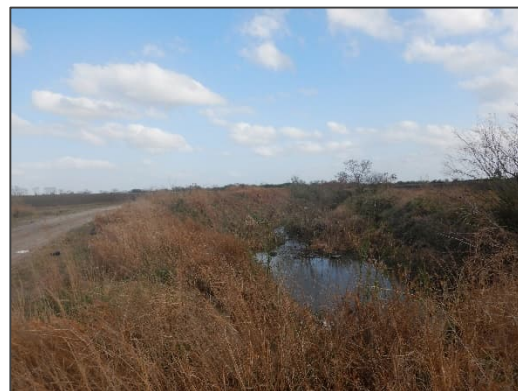
Photograph 18 – View looking southeast (downstream) at the existing Delta Lake Drain from the Jesus Flores Road bridge.

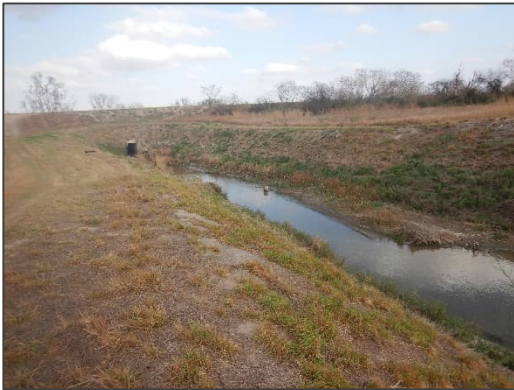
Photograph 19 – View looking east (downstream) at the existing Delta Lake Drain as it flows beneath the Delta Lake Irrigation Channel (higher in elevation than the RDP).

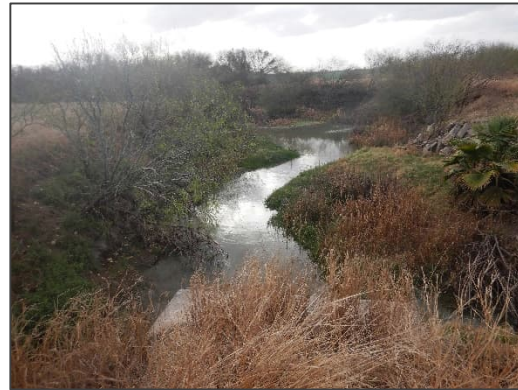
Photograph 22 – View looking west (upstream) at the existing Delta Lake Drain from Mile 5 1/2 West Road.

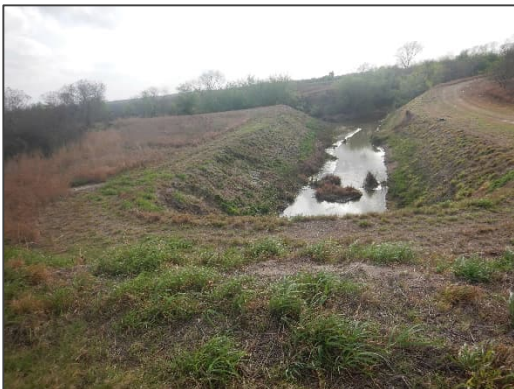
Photograph 20 – View looking west (upstream) at the existing Delta Lake Drain from the Delta Lake Irrigation Channel.

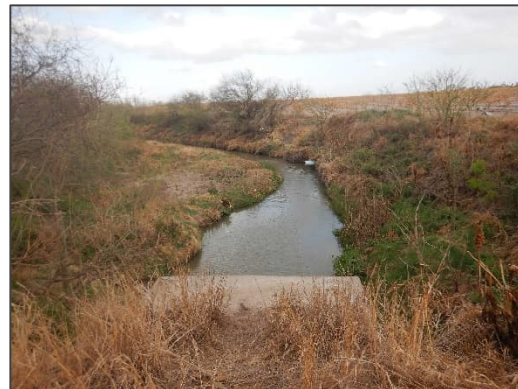
Photograph 23 – View looking east (downstream) at the existing Delta Lake Drain from Mile 5 1/2 West Road.

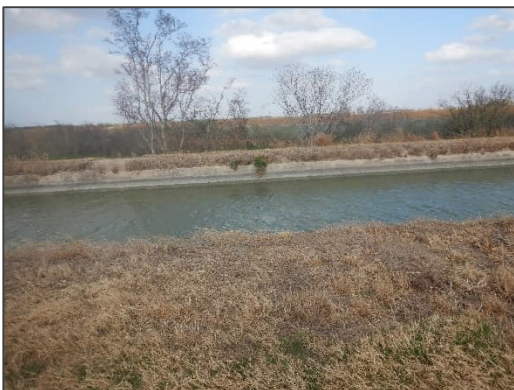
Photograph 21 – View looking northeast at the Delta Lake Irrigation Channel, which flows through a structure over the existing Delta Lake Drain.

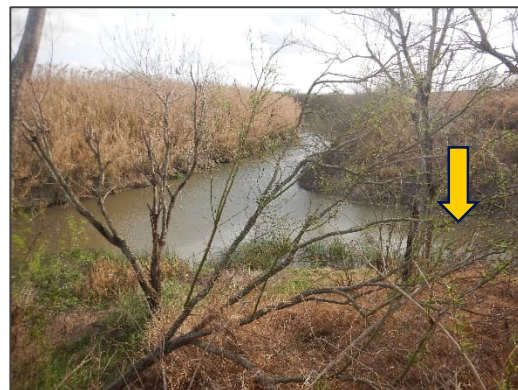
Photograph 24 – View looking south at the confluence of the existing Delta Lake Drain and an irrigation ditch (indicated by the arrow).

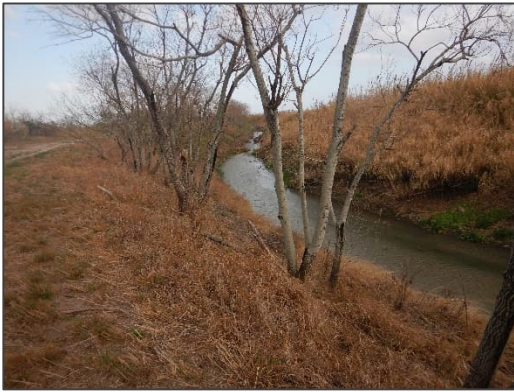
Photograph 25 – View looking east at the existing Delta Lake Drain, east of the location depicted in the previous photograph.

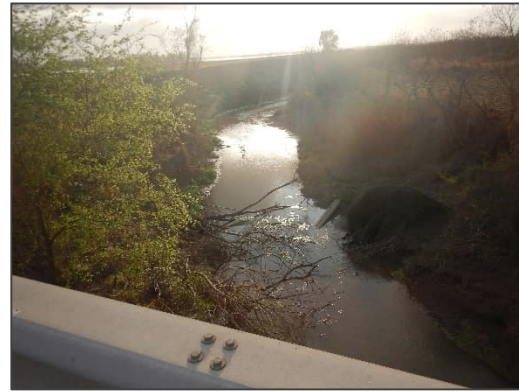
Photograph 28 – View looking west (upstream) at the existing Delta Lake Drain from the FM 88 bridge.

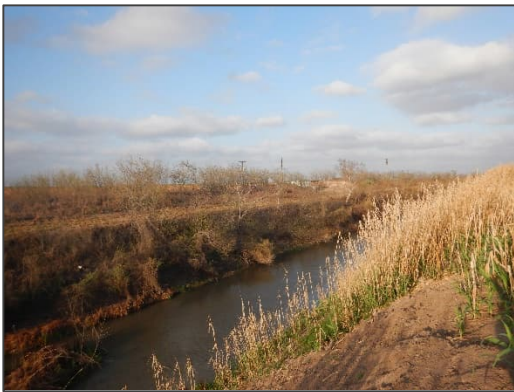
Photograph 26 – View looking northeast (downstream) at the existing Delta Lake Drain where it is adjacent to Delta Lake. Delta Lake is separated from the existing Delta Lake Drain by an access road and maintenance berm.

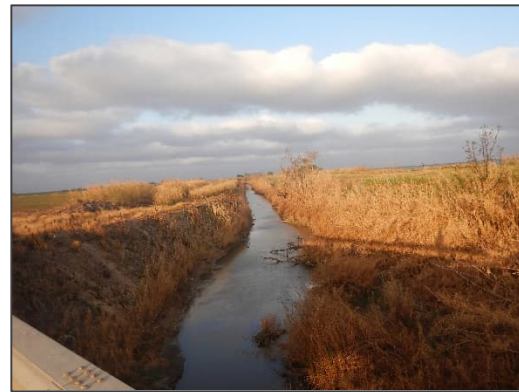
Photograph 29 – View looking east (downstream) at the existing Delta Lake Drain from the FM 88 bridge.

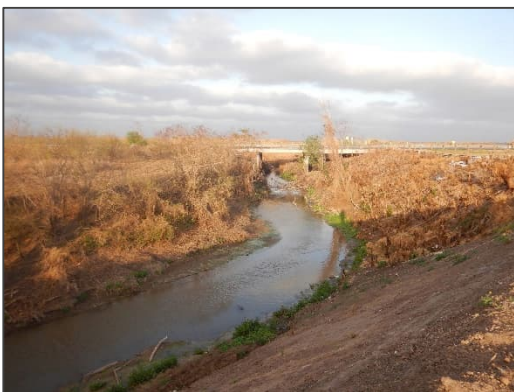
Photograph 27 – View looking east (downstream) at the existing Delta Lake Drain and FM 88.

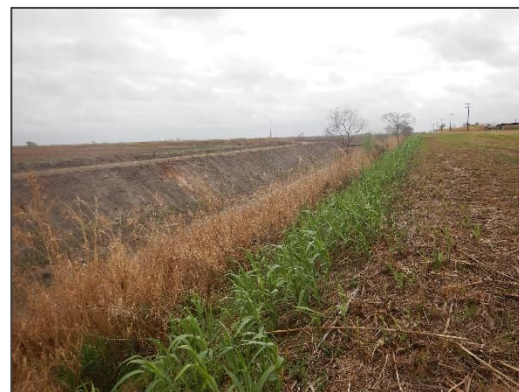
Photograph 30 – View looking further east (downstream) than the previous photograph.

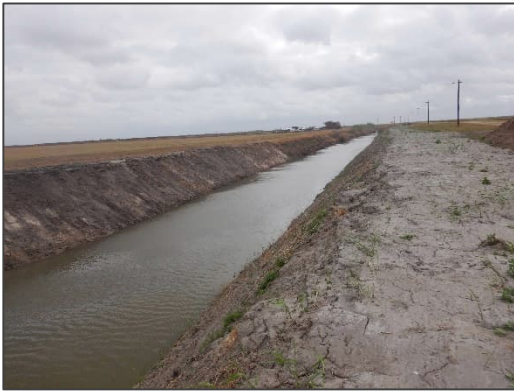
Photograph 31 – View looking northeast (downstream) at the existing Delta Lake Drain where it flows away from Delta Lake.

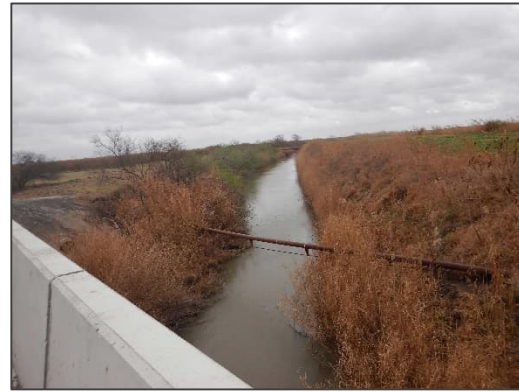
Photograph 34 – View looking northeast (downstream) at the existing Delta Lake Drain from the FM 1015 bridge.

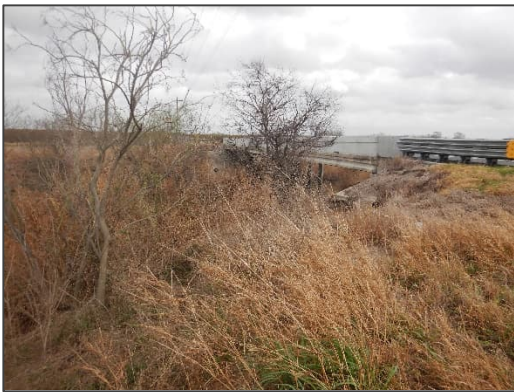
Photograph 32 – View looking northeast at FM 1015 as it crosses over the existing Delta Lake Drain.

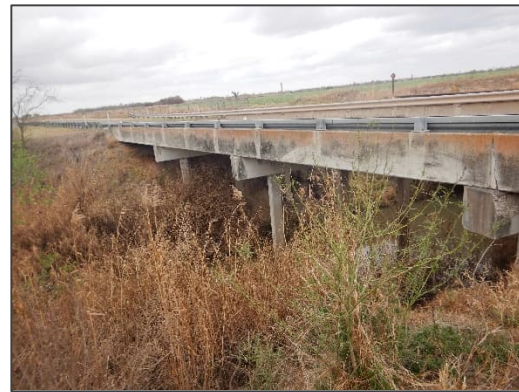
Photograph 35 – View looking northeast at the existing Delta Lake Drain as it flows under the FM 490 bridge.

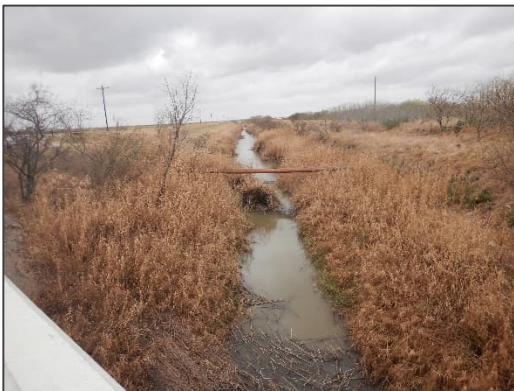
Photograph 33 – View looking southwest (upstream) at the existing Delta Lake Drain from the FM 1015 bridge.

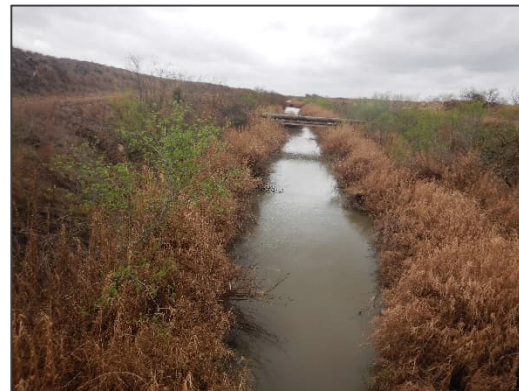
Photograph 36 – View looking southwest (upstream) at the existing Delta Lake Drain from the FM 490 bridge.

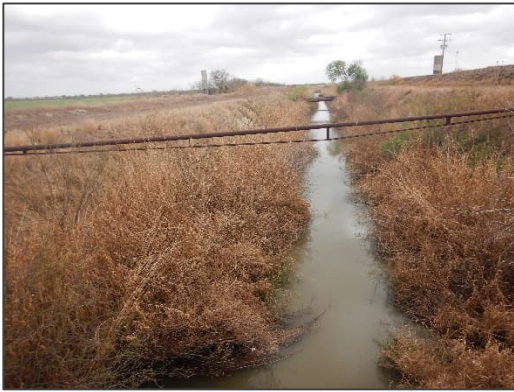
Photograph 37 – View looking northeast (downstream) at the existing Delta Lake Drain from the FM 490 bridge.

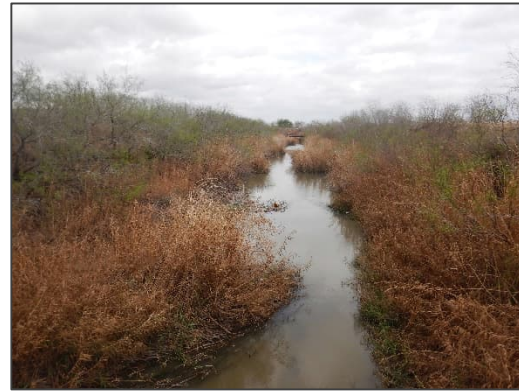
Photograph 40 – View looking north (downstream) at the existing Delta Lake Drain from CR 2900 West.

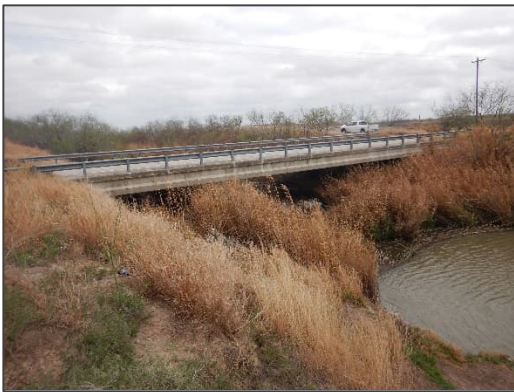
Photograph 38 – View looking northeast at the existing Delta Lake Drain as it flows under County Road (CR) 2900 West.

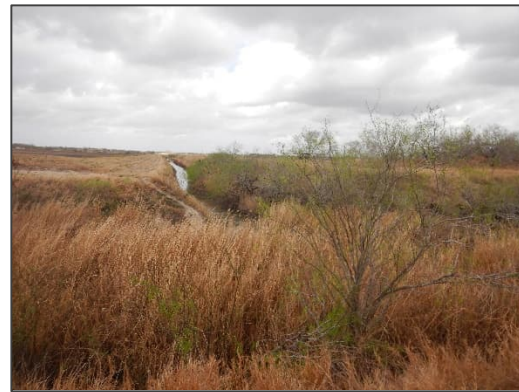
Photograph 41 – View looking west at the existing Delta Lake Drain at the intersection of the Alternative 1 and Alternative 2 rights-of-way.

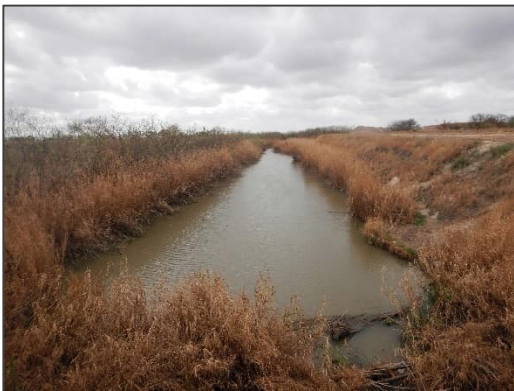
Photograph 39 – View looking south (upstream) at the existing Delta Lake Drain from CR 2900 West.
