The following figures and attachments present data and information used in the Integrated Feasibility Report and Environmental Assessment (IFR-EA) for the Raymondville Drain Project. The results of and conclusions of the IFR-EA are provided in the main report. Additional data and information are presented in Attachments A-M of this appendix.

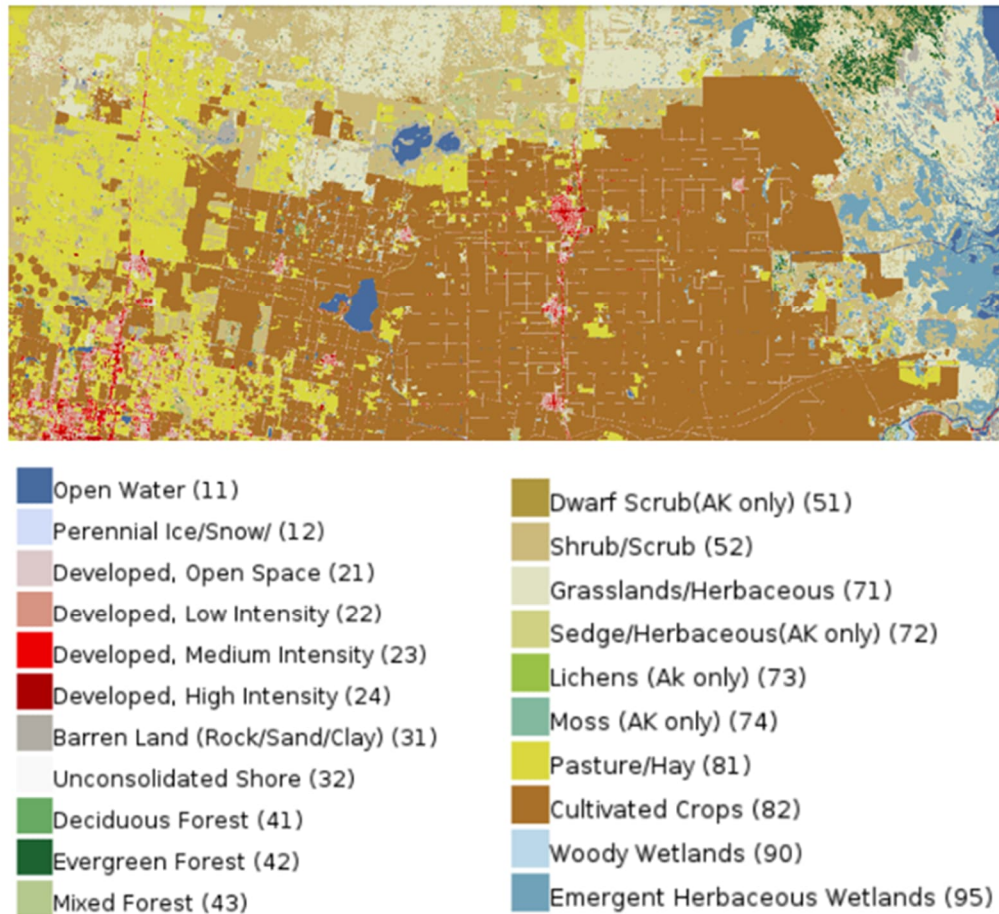
Figure 1: National Land Cover Database Classifications for the Raymondville Drain Project study area.  
Source: US Geological Survey, 2024.

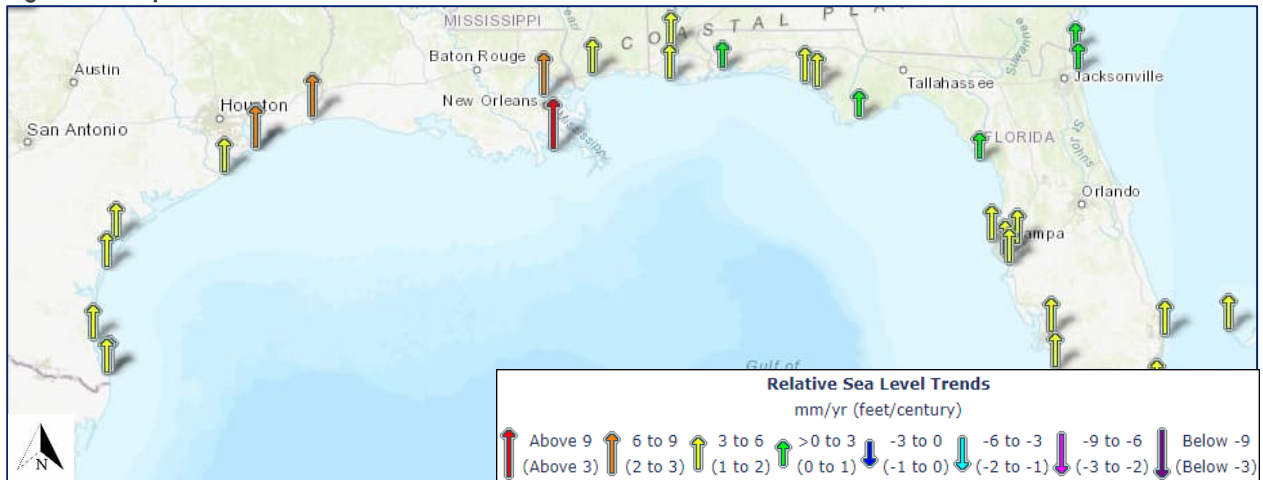
Figure 3: Map of relative sea level trends in the Gulf of Mexico. Source: NOAA, 2023.

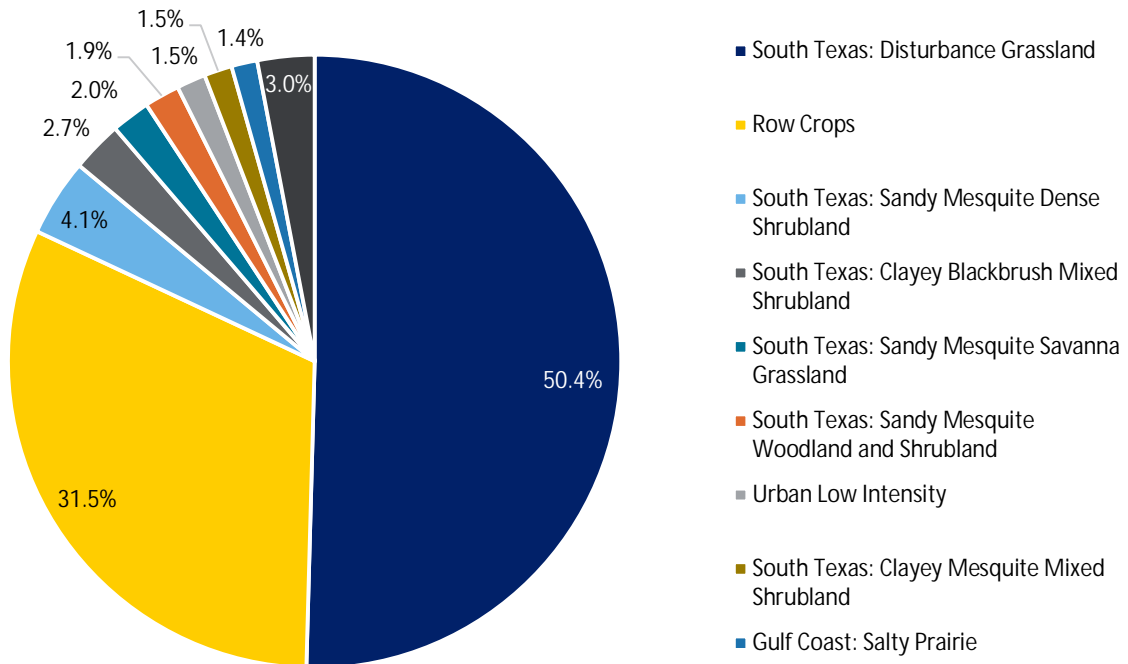
Figure 4: Ecological Mapping Systems of Texas Data for Alternative 1

**Table 12: Ecological Mapping Systems of Texas Classifications within the Alternative 1 Study Corridor**

EMST Classification	Acres	Percentage of Total
South Texas: Sandy Mesquite Savanna Grassland	122.79	2.0%
South Texas: Sandy Mesquite Woodland and Shrubland	111.26	1.9%
Urban Low Intensity	91.47	1.5%
South Texas: Clayey Mesquite Mixed Shrubland	88.77	1.5%
Gulf Coast: Salty Prairie	83.03	1.4%
Other	178.92	3.0%
<b>Total</b>	<b>6,000.62</b>	<b>100%</b>

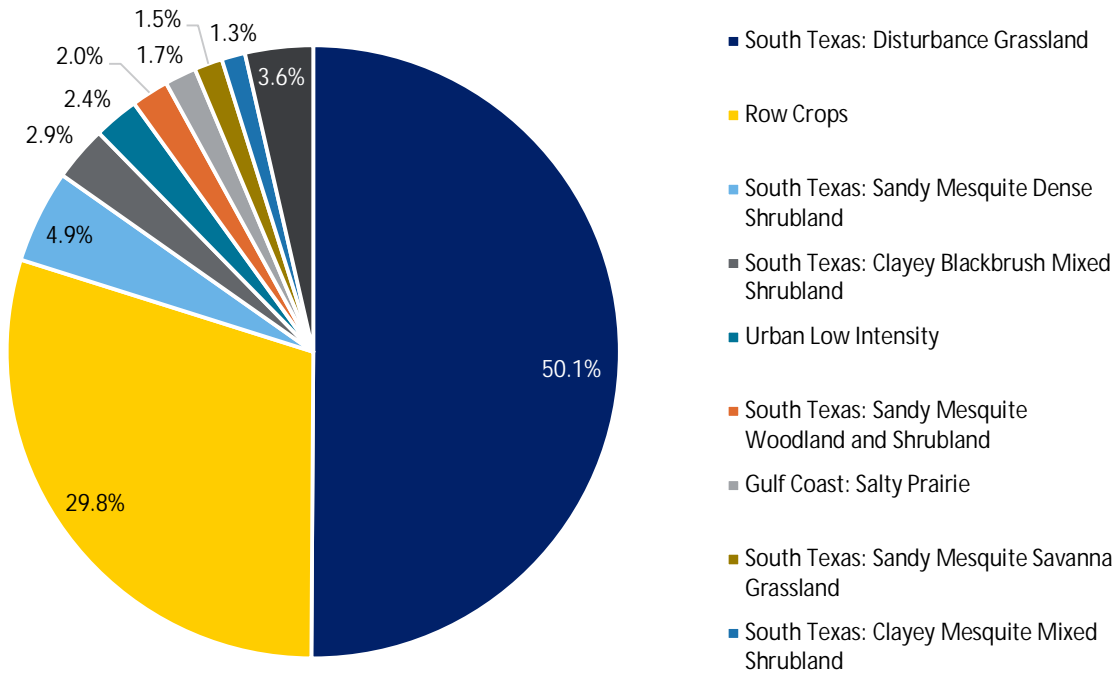
Figure 5: Ecological Mapping Systems of Texas Data for Alternative 2

**Table 13: Ecological Mapping Systems of Texas Classifications within the Alternative 2 Study Corridor**

EMST Classification	Acres	Percentage of Total
South Texas: Disturbance Grassland	2,497.97	50.1%
Row Crops	1,484.98	29.8%
South Texas: Sandy Mesquite Dense Shrubland	244.13	4.9%
South Texas: Clayey Blackbrush Mixed Shrubland	145.06	2.9%
Urban Low Intensity	118.62	2.4%
South Texas: Sandy Mesquite Woodland and Shrubland	97.47	2.0%
Gulf Coast: Salty Prairie	83.03	1.7%
South Texas: Sandy Mesquite Savanna Grassland	73.99	1.5%
South Texas: Clayey Mesquite Mixed Shrubland	62.41	1.3%
Other	178.74	3.6%
<b>Total</b>	<b>4,986.39</b>	<b>100%</b>

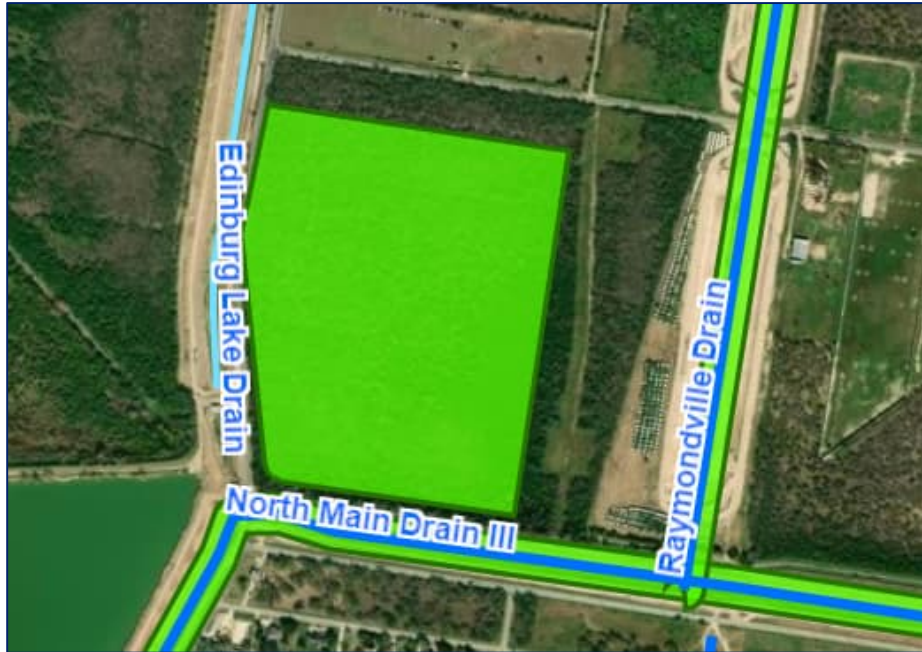
Figure 8: Proposed regional stormwater detention facility. The green polygon represents the 67.8-acre facility.
