Job No. SBI23290

**SEAGRASS SURVEY
LOWER LAGUNA MADRE
DRAFT REPORT**

Freese and Nichols, Inc.
10431 Morado Circle, Suite 300
Austin, Texas 78759

May 2023

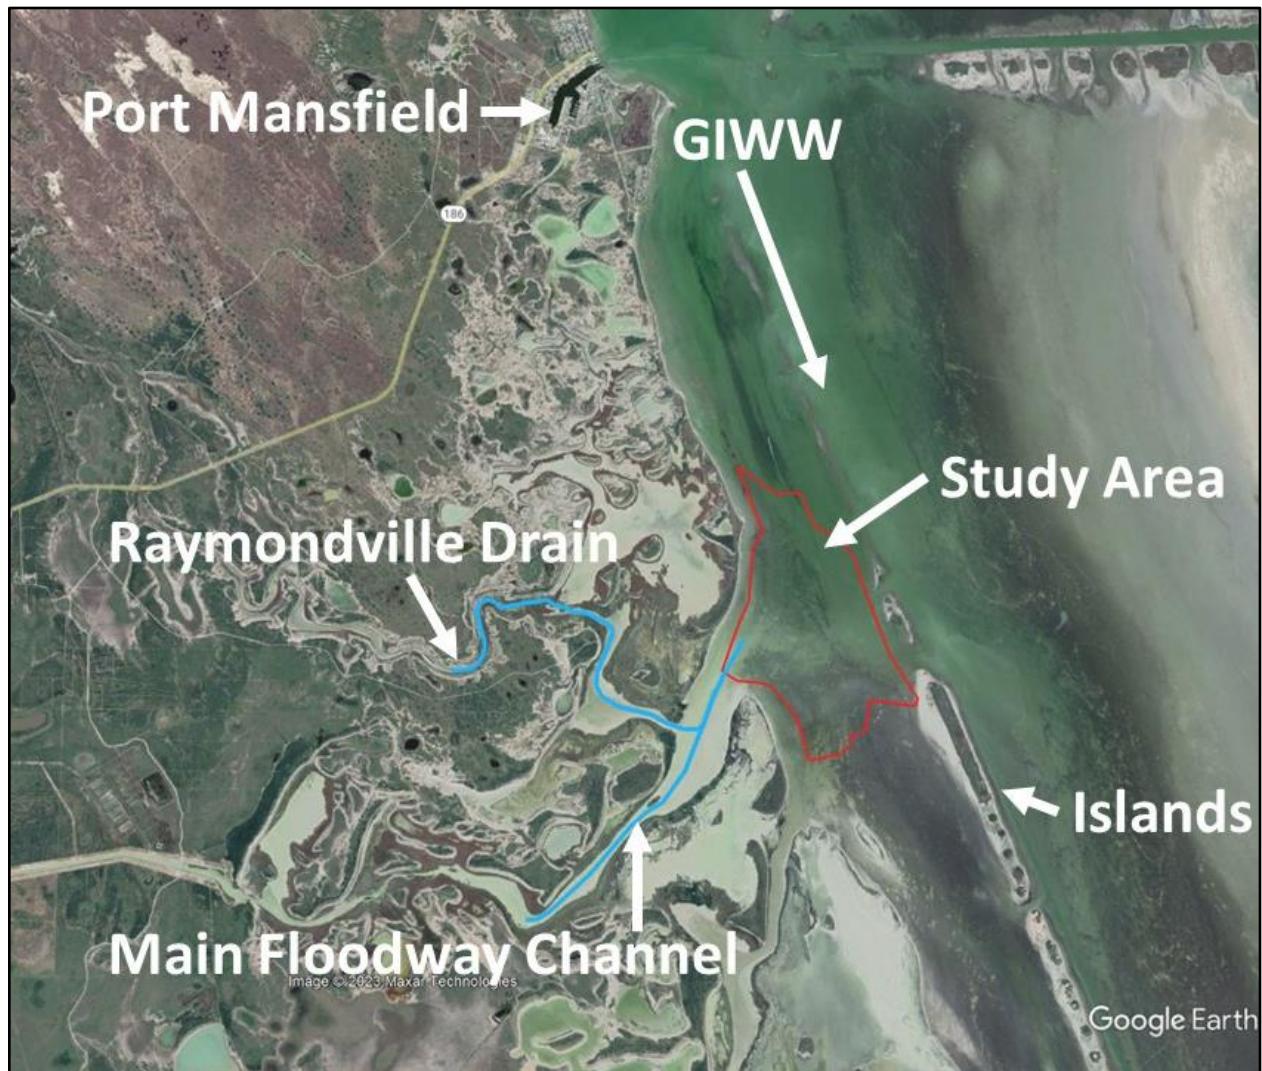
Figure 1. Lower Laguna Madre Seagrass Study Area

Google Earth Image from December 15, 2018

Sampling was conducted over a 1,200-acre area extending from the west shore of the Lower Laguna Madre east to the west side of islands created with dredged material placed along the west side of the Gulf Intracoastal Waterway (Figure 1). The study area extended from about 3.7 to 6.2 miles south of Port Mansfield. Sampling stretched into the channel formed by the confluence of the Main Floodway Channel and the Raymondville Drain. Water depths in the study area ranged from 1.2 to 5.6 feet with shallower water at the south end and deeper water towards the north end.

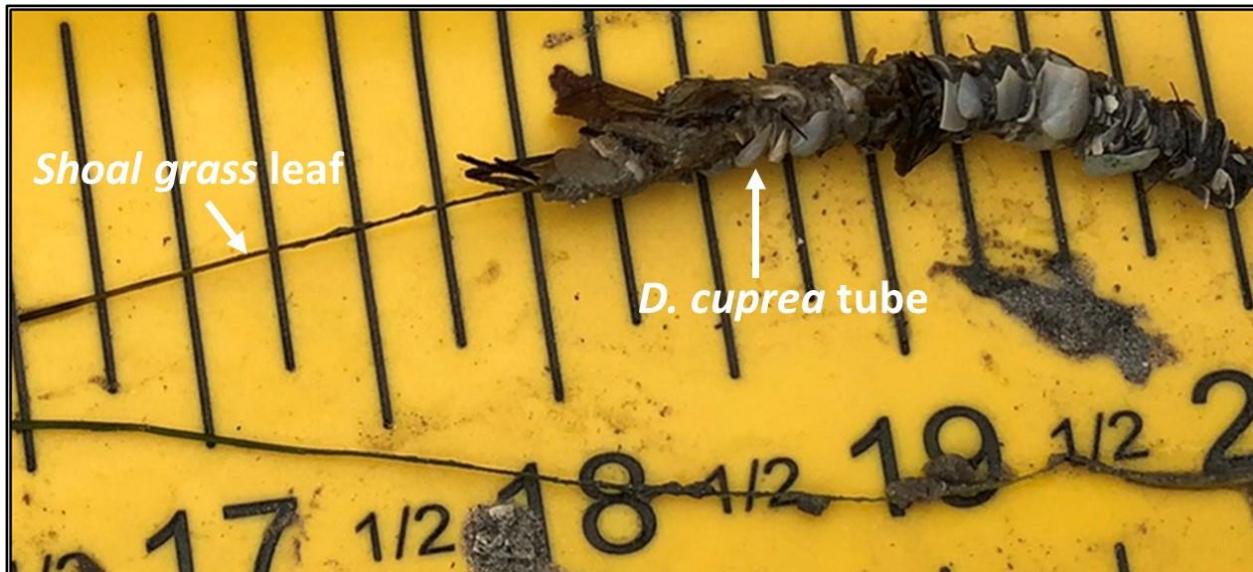
Figure 6. *D. cuprea* with Live Shoal Grass Leaf Attached to Exposed End of Case
(Ruler units are inches.)

Polychaetes, particularly the decorator worm, *Diopatra cuprea*, were common and observed in many samples. *D. cuprea* were observed with a green blade of Shoal grass attached to the exposed end of the polychaete's case in seven samples (Figure 6). Other invertebrates observed in samples included a ghost shrimp (Family Callianassidae), a grass shrimp (*Palaemonetes*), an unidentified shrimp, and the bivalves, stout tagelus (*Tagelus plebeius*), minor jackknife clam (*Ensis minor*), and Florida Cross-barred Venus (*Chione elevata*). Gastropods were not observed in any samples.

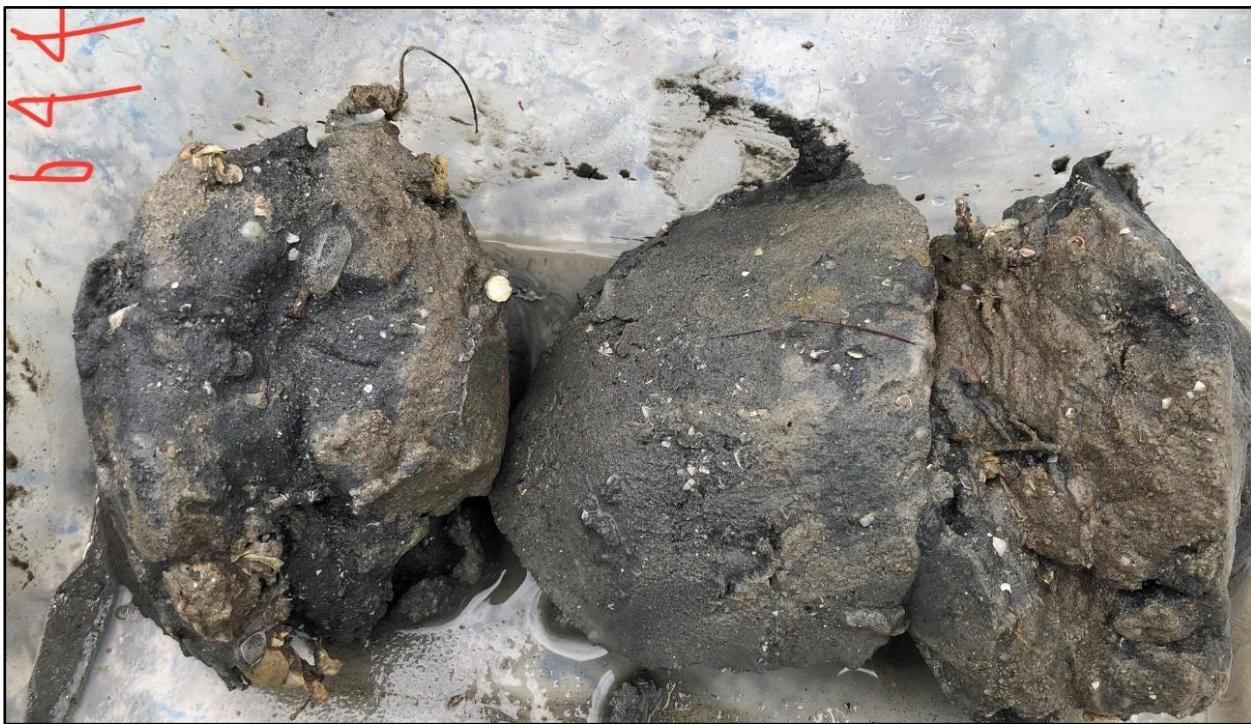
Figure 7. Three Sediment Plugs Collected at Sample Point 44

At each sample point, if the first sediment plug did not have visible seagrass blades or rhizomes, a second sediment plug was collected. If the second sediment plug did not have visible blades or rhizomes, a third sediment plug was collected (Figure 7).

(Seagrass was absent from these plugs. One blade of Shoal grass was attached to a polychaete case.)

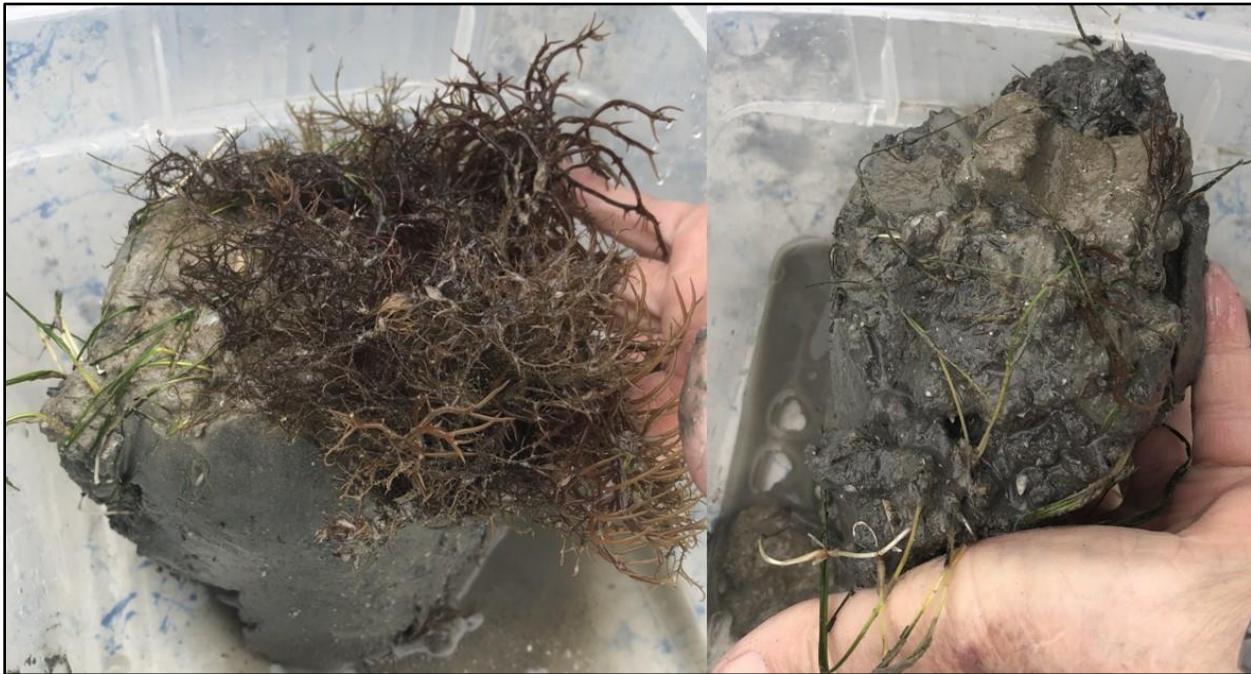
Figure 8. Sediment Plug at Sample Point 21

At each sample point, two biologists visually estimated the percent seagrass cover on each sediment plug independently of each other. Percent seagrass cover was estimated using this method at 81 of the 84 points sampled. Seagrass was present at Sample Points 1 and 2 but there are not estimates of percent seagrass cover at those two points. Percent seagrass cover was also not estimated at Sample Point 66. After estimating percent seagrass cover, the two biologists compared their results and reached consensus on the final value recorded for seagrass cover. The greatest difference in estimated seagrass cover between the biologists for any sample was 15 percent. If the sediment plug was covered with macroalgae, the percent seagrass cover was estimated after removal of the macroalgae (Figure 8).

(Plug with macroalgae in photo on the left. Plug without macroalgae on the right.)

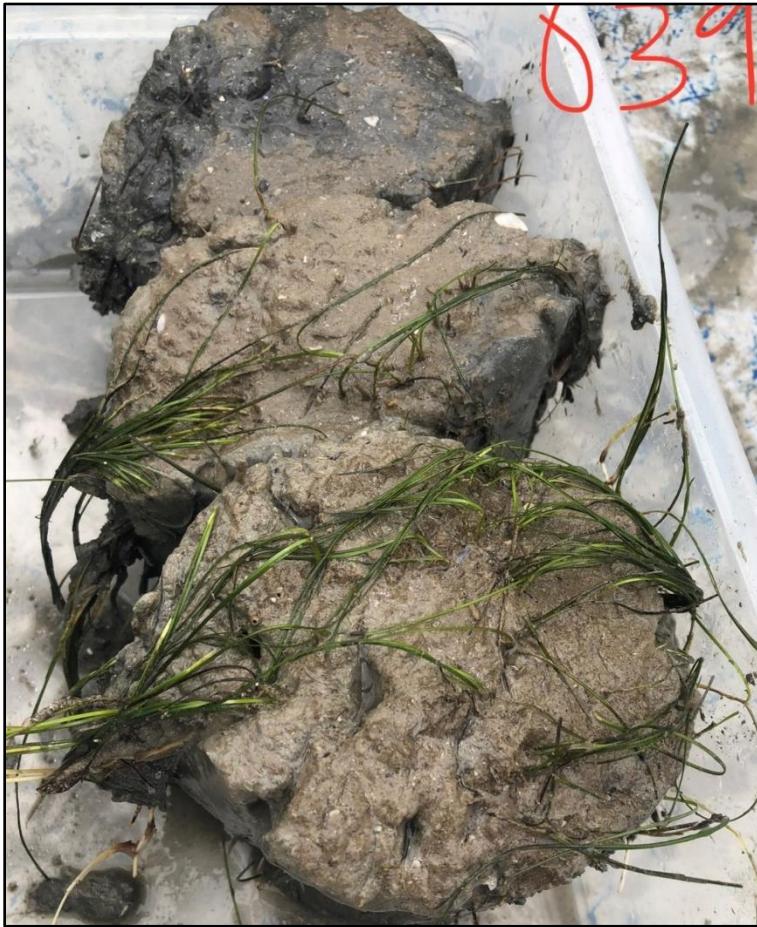
Figure 9. Sediment Plugs at Sample Point 39

The percent cover at each sample point was calculated based on the percent seagrass cover on each plug and the average of the seagrass cover on all the plugs collected at each point. For example, at Sample Point 39, three sediment plugs were collected, and each plug had a different amount of seagrass cover (Figure 9). The plug at the top of the photo did not have any seagrass, the plug in the middle of the photo was estimated to have 10 percent seagrass cover, and the plug at the bottom of the figure was estimated to have 20 percent seagrass cover. The seagrass cover value for Sample Point 39 was 10 percent, the average of the values for the three plugs.

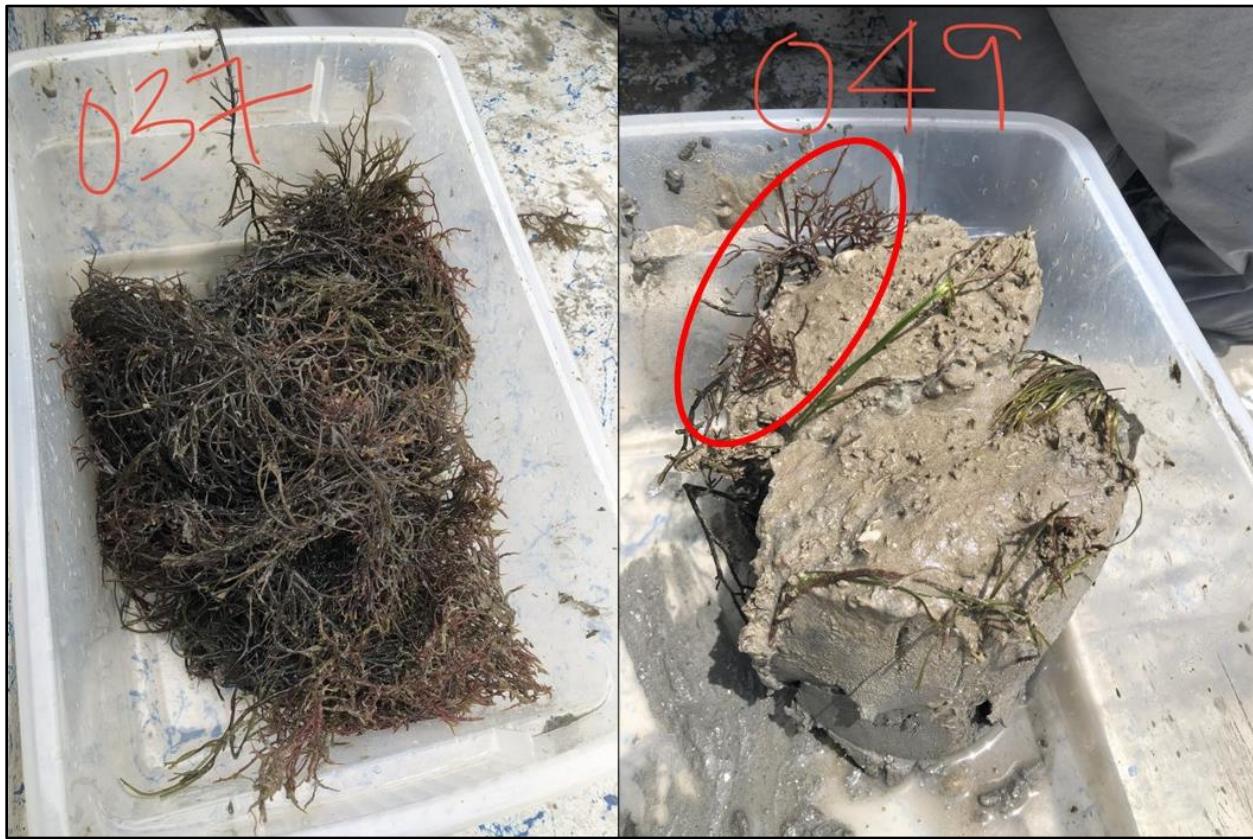
Figure 15. Examples of *Gracilaria*/*Gracilaropsis*
Sample Point 37 (left photo) and Sample Point 49 (right photo)

Macroalgae were observed at 43 sample points. Kopecky and Dunton (2006) studied drift macroalgae in the Lower Laguna Madre and found drift macroalgae abundance was highly variable and these algae tended to accumulate in seagrass beds rather than bare areas. The red algae, *Gracilaria/Gracilaropsis*, was observed most often and was found at 33 sample points (Figure 15). AlgaeBase was checked to determine if the macroalgae was *Gracilaria* or *Gracilaropsis* (Guiry and Guiry, 2023). According to AlgaeBase, these two genera are distinguished by differences in specialized reproductive features. FNI biologists did not attempt to observe reproductive features on these algae and consequently this algae is referred to as *Gracilaria/Gracilaropsis* for this report.

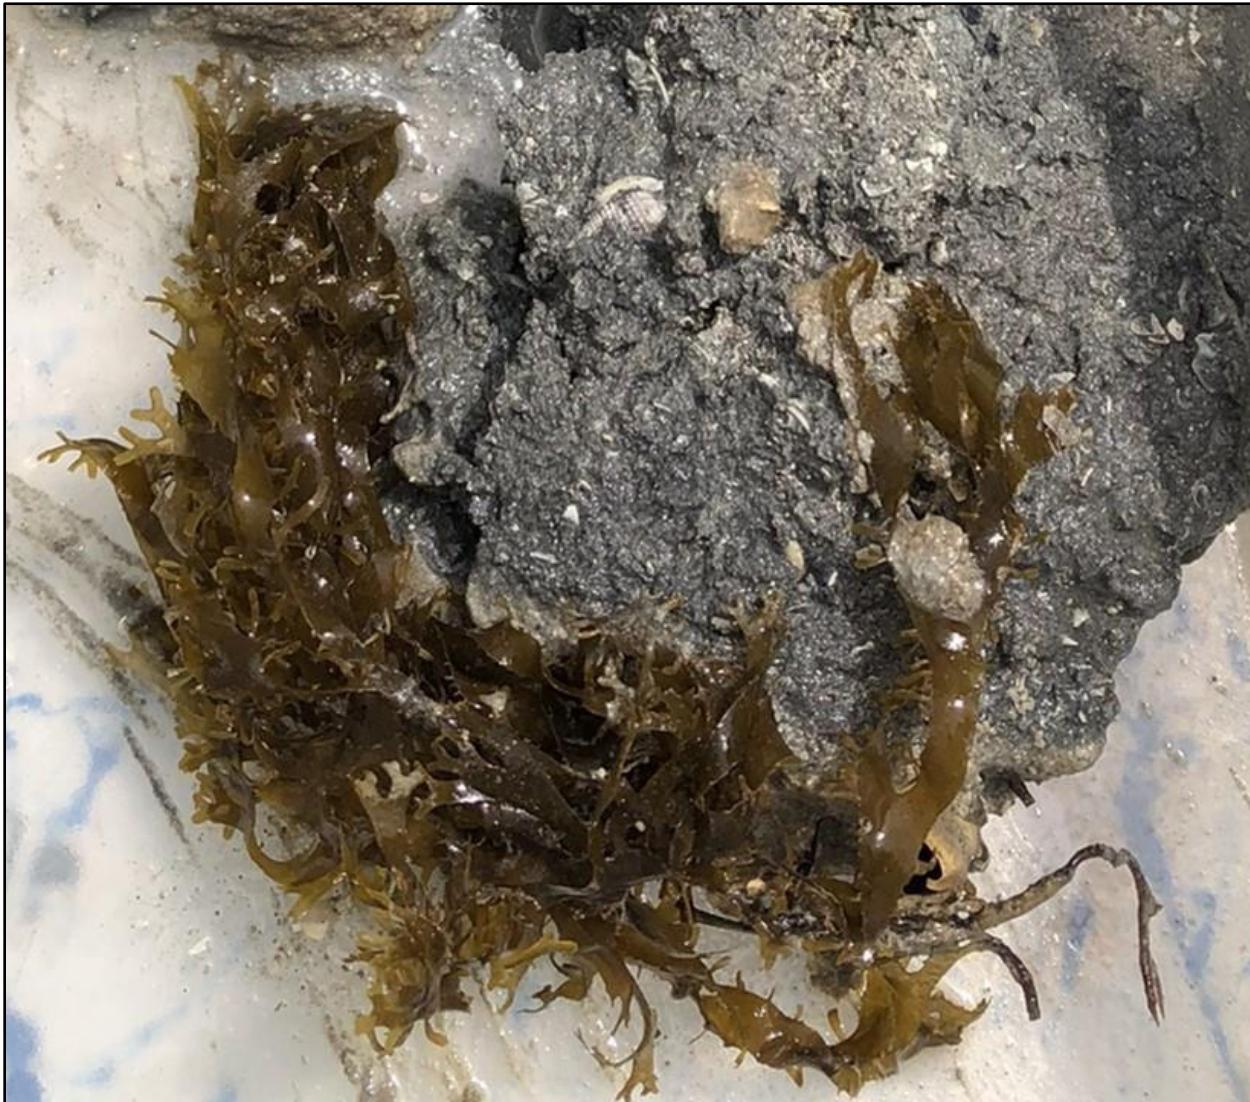
Figure 16. Forked Sea Tumbleweed, *D. menstrualis*, at Sample Point 34

Forked sea tumbleweed, *Dictyota menstrualis*, was observed at six sample points (Figure 16).

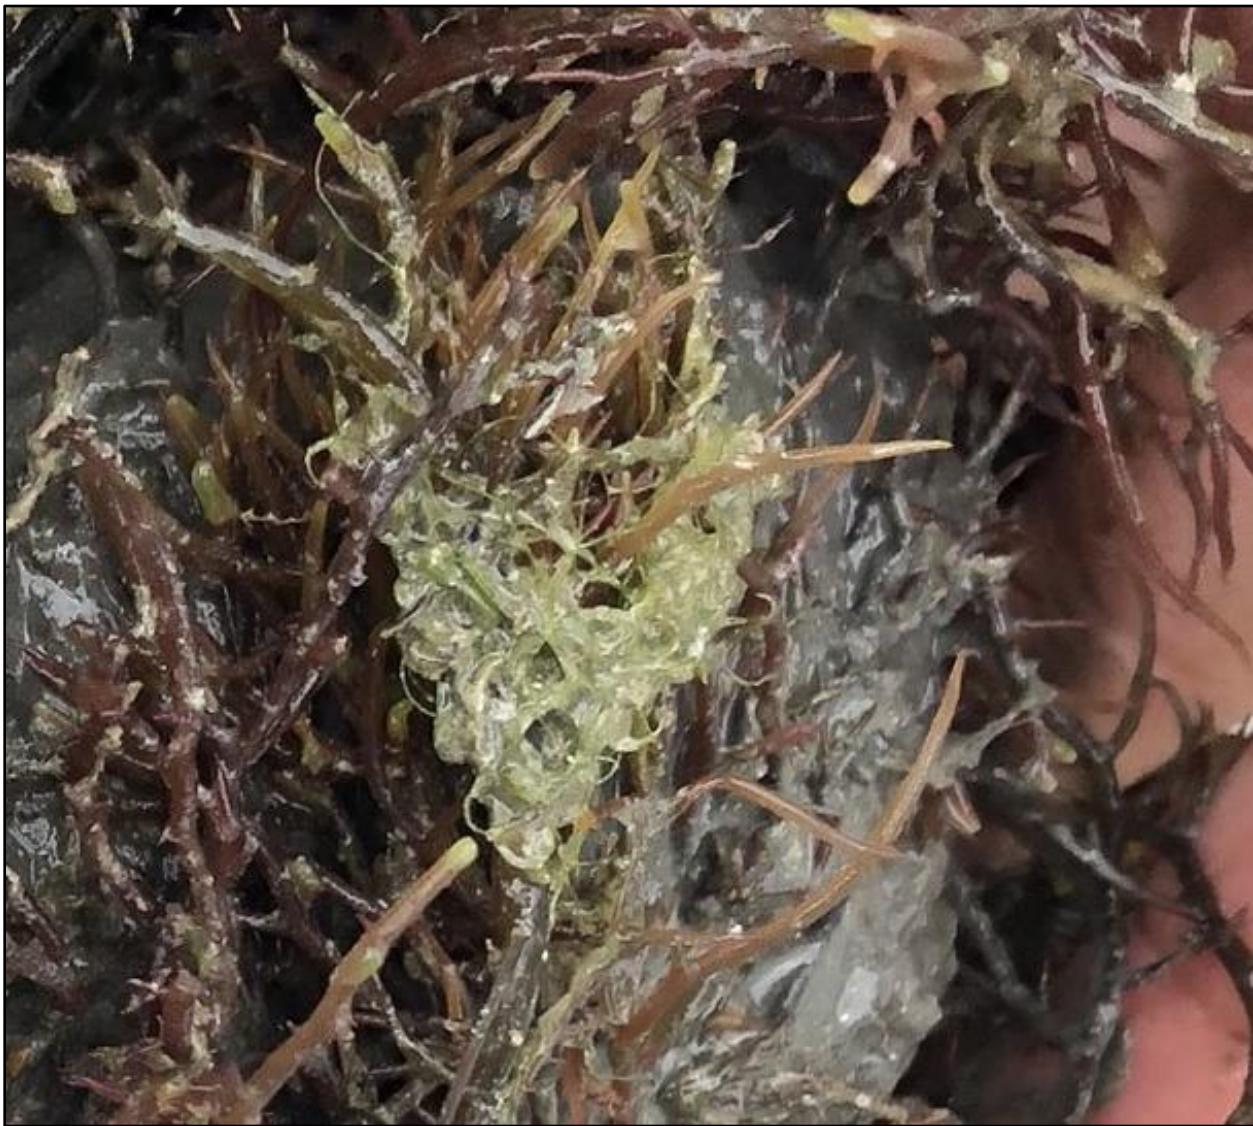
Figure 17. *Cladophora* Trapped on *Gracilaria/Gracilaropsis* at Sample Point 37

The filamentous green algae, *Cladophora*, was observed drifting in the direction of the wind in the south end of the study area about 4 to 6 inches below the water's surface. These drifting aggregations of *Cladophora* were roughly spherical and ranged in diameter up to 4 inches. Where observed, there was about one aggregation of *Cladophora* per square foot of water surface area. Some of these aggregations were captured, primarily on filaments of *Gracilaria/Gracilariopsis*, but did not appear to be substantially covering any seagrass (Figure 17).

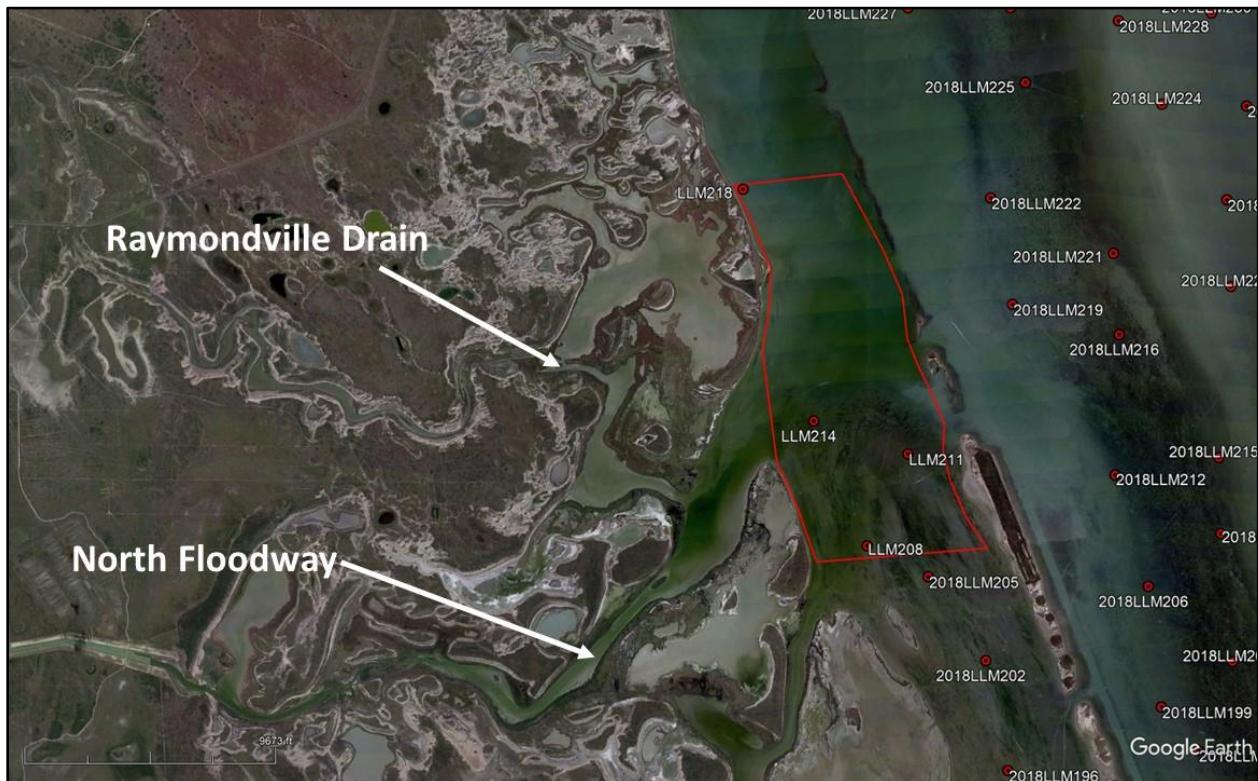
Hidalgo Drainage District 1 proposes modifying drainage patterns to shift some water to the Raymondville Drain from the North Floodway during flooding events. The modification will not change the amount of water contributed by both drains to the back bay complex of the Lower Laguna Madre or to the Lower Laguna Madre. The Drainage District is required to survey seagrass in the Lower Laguna Madre in the vicinity of the drains, and the District's engineers, S&B Infrastructure, hired Freese and Nichols, Inc. to survey seagrass in the area (Figure 1).

Figure 1. Draft Seagrass Study Area (red polygon). Red points represent seagrass monitoring stations sampled by the University of Texas Marine Science Institute's Texas Statewide Seagrass Monitoring Program. Google Earth Pro image is dated February 6, 2021.

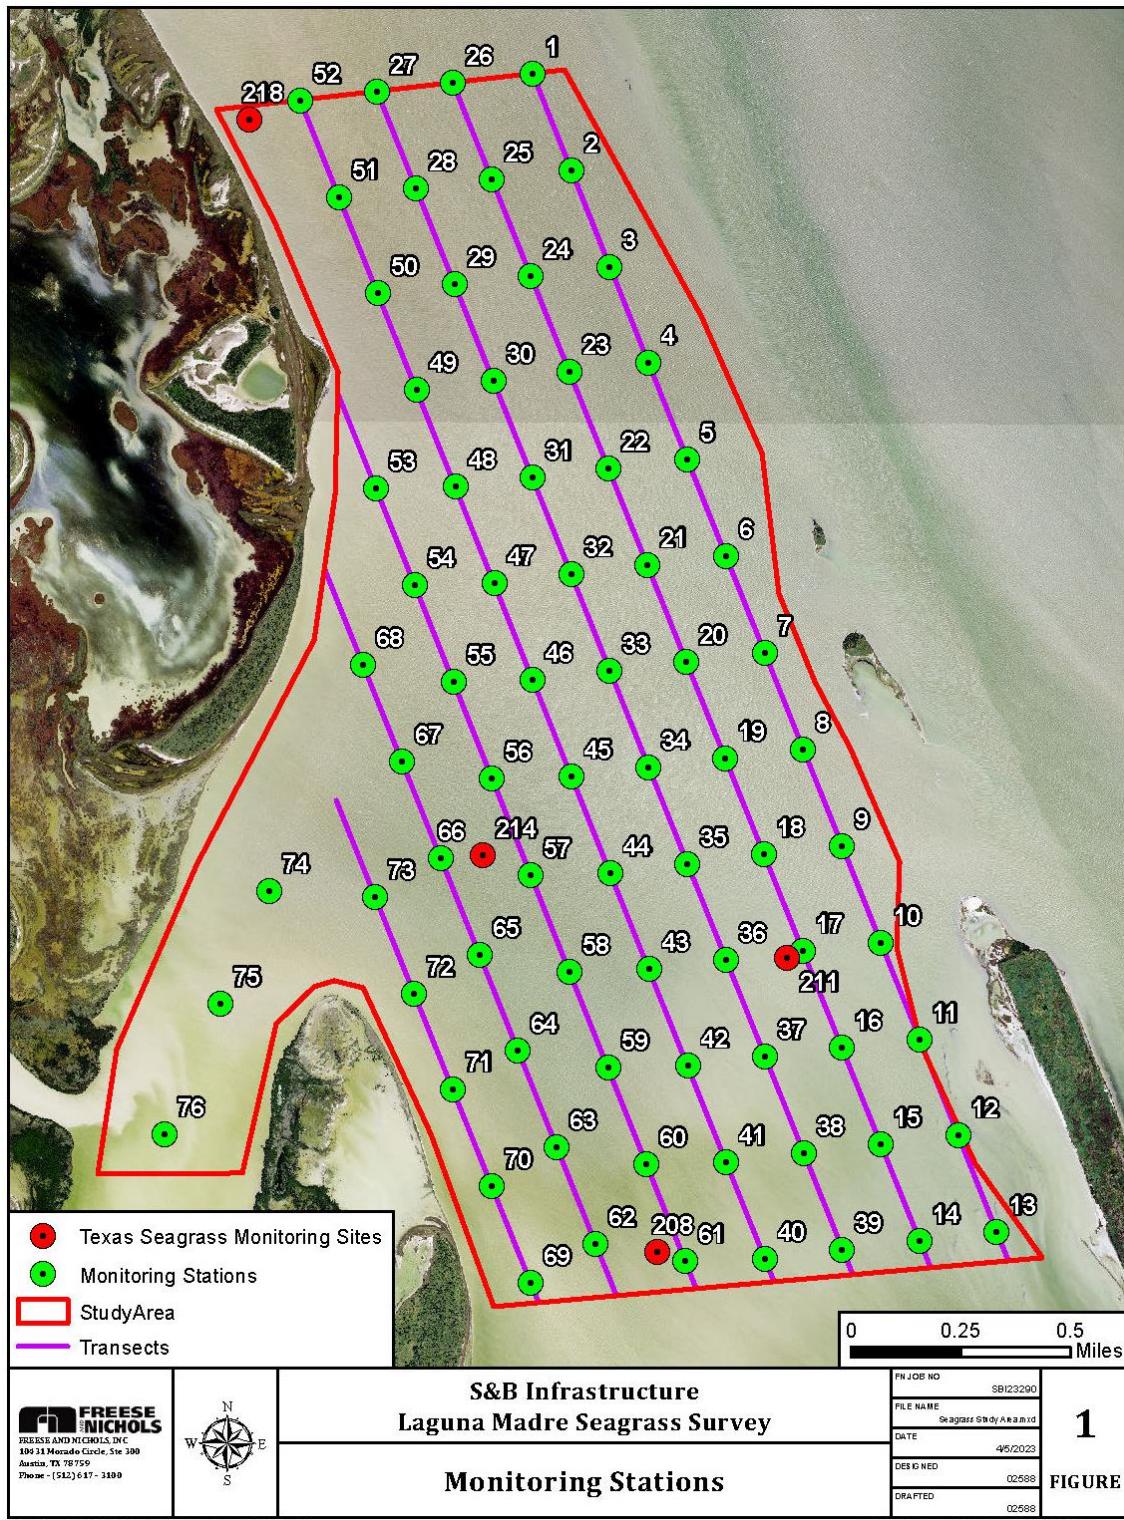
Figure 2. Proposed Sampling Locations. Red points are locations sampled by the Texas Statewide Seagrass Monitoring program on an approximate annual basis. The green points will be sampled by Freese and Nichols, Inc. in this study. Google Earth Pro image is dated February 6, 2021.
