## **Delineation Report**

Raymondville Drain Project  
Hidalgo and Willacy Counties, Texas

December 11, 2024

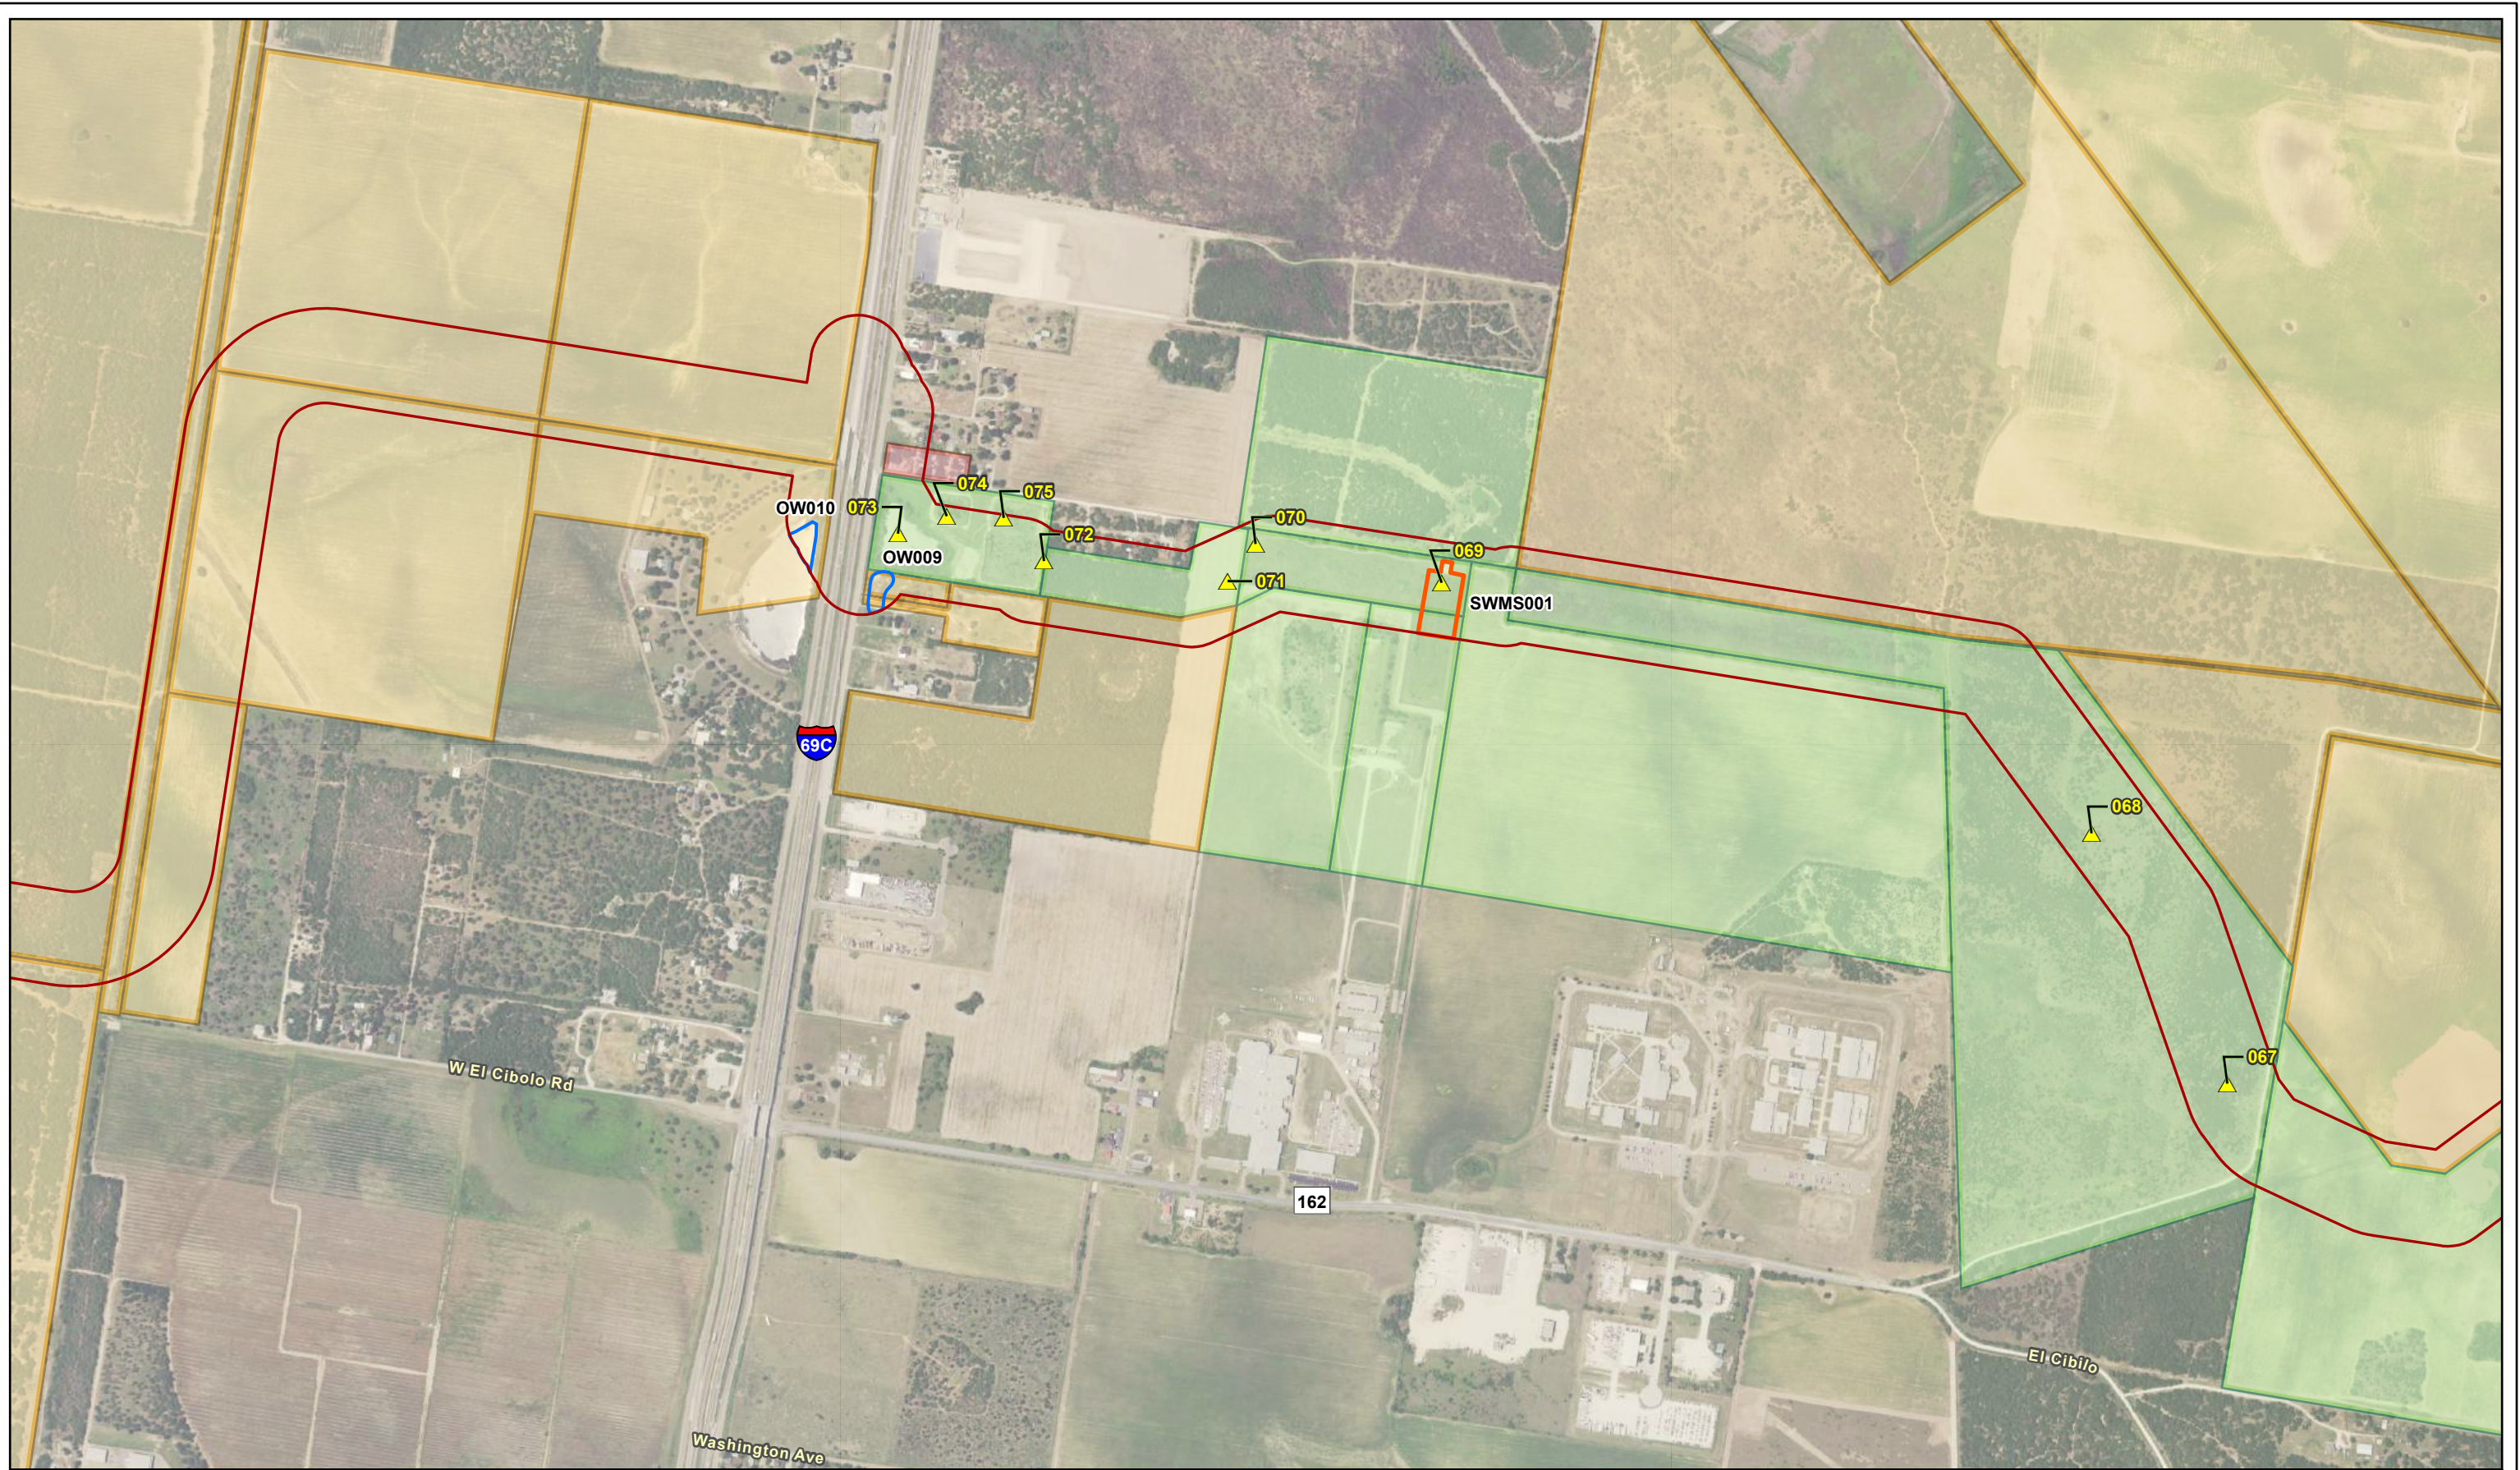
**Figure 7-2.**  
**Delineated Water Features**

OW009 is an assumed open water feature due to the lack of ROE to the parcel of land where OW009 is located. The boundary of OW009 is based on NWI polygon data coded PUSJx. The assumed boundary of OW009 also correlates with open water depicted on USGS topographic maps. A review of lidar data, aerial photography, and visual line of sight from a nearby public roadway support the assumed presence and boundary of OW009. This feature appears to be the result of an excavation for the apparent purpose of watering cattle and is best described as an upland stock tank. Additionally, a continuous surface connection between OW009 and a relatively permanent water is not apparent. Therefore, OW009 should be considered isolated and a potentially non-jurisdictional feature. The assumed boundary of OW009 is depicted on **Figure 7-2 in Appendix A**. See Photograph 163 in **Appendix B**.

OW010 is an assumed open water feature due to the lack of ROE to the parcel of land where OW010 is located. The boundary of OW010 is based on a unique signature and inundation visible on recent aerial photography. No aquatic features correlating with the assumed boundary of OW010 are depicted by NWI or on USGS topographic maps. A review of lidar data, aerial photography, and visual line of sight from a nearby public roadway support the assumed presence and boundary of OW010. This feature appears to be the result of an excavation constructed for the purpose of obtaining fill material and/or to water cattle. Additionally, a continuous surface connection between OW010 and a relatively permanent water is not apparent. Therefore, OW010 should be considered isolated and a potentially non-jurisdictional feature. The assumed boundary of OW010 is depicted on **Figure 7-2 in Appendix A**. See Photograph 164 in **Appendix B**.

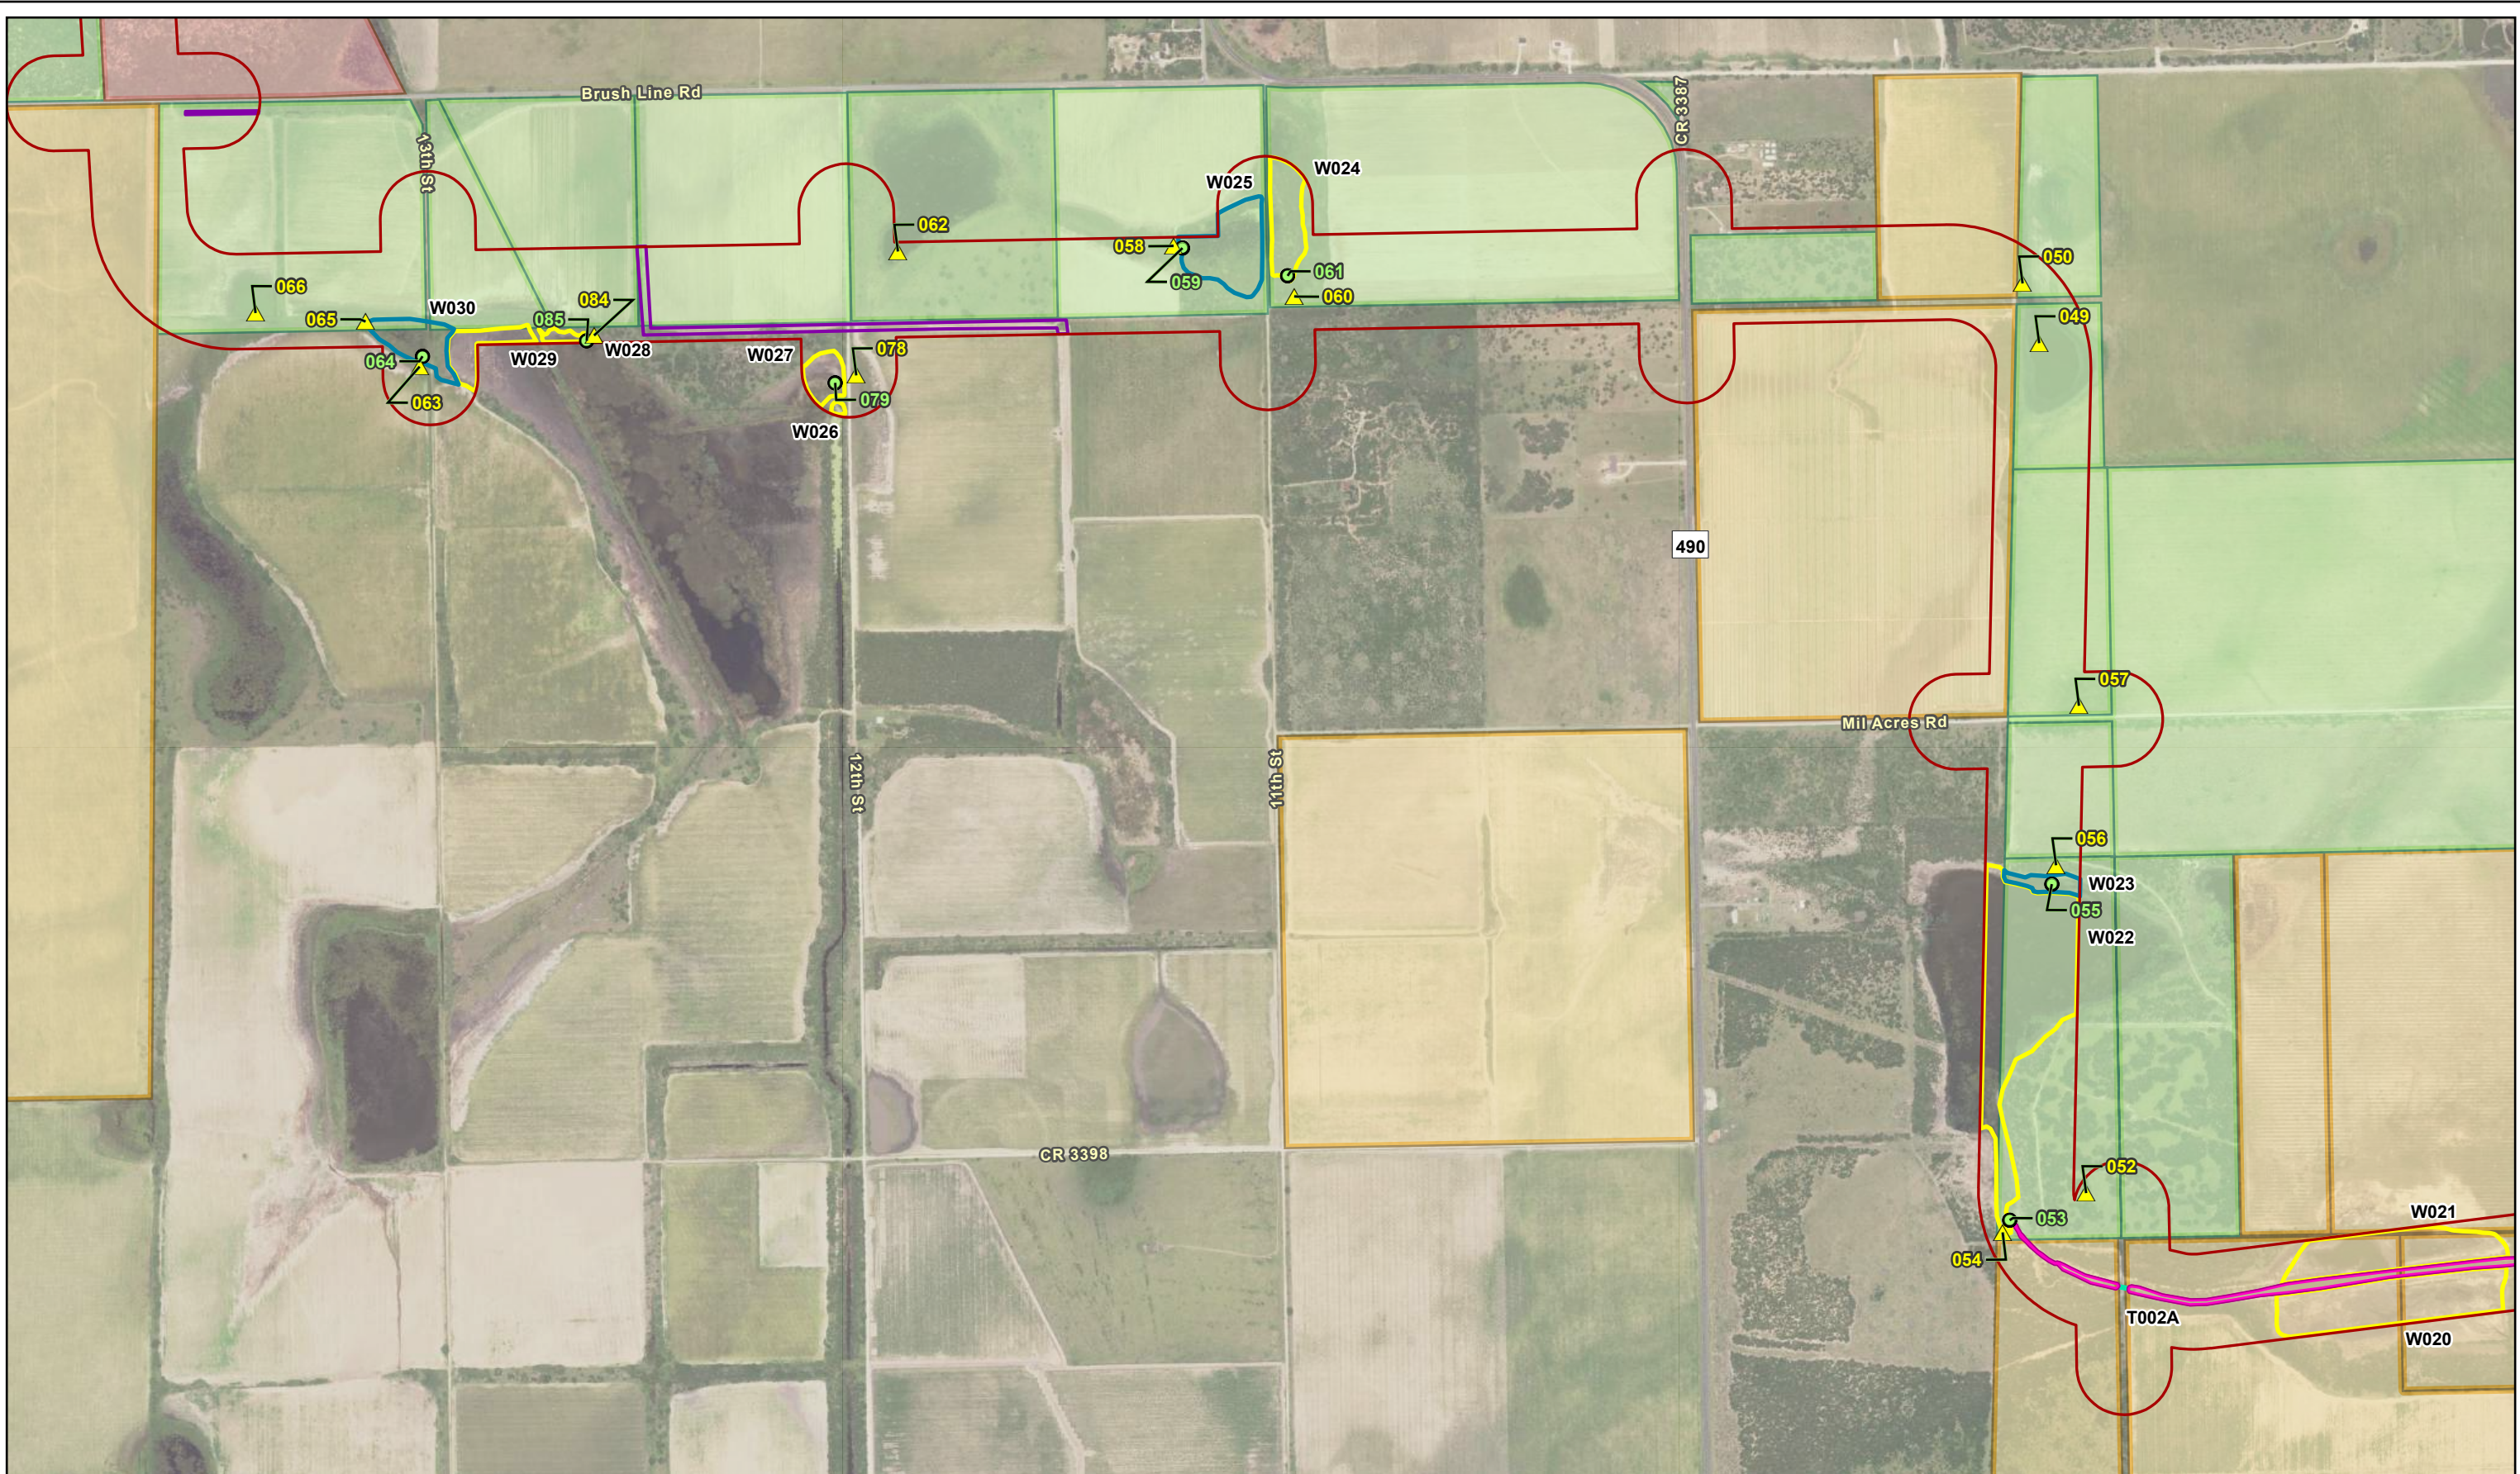
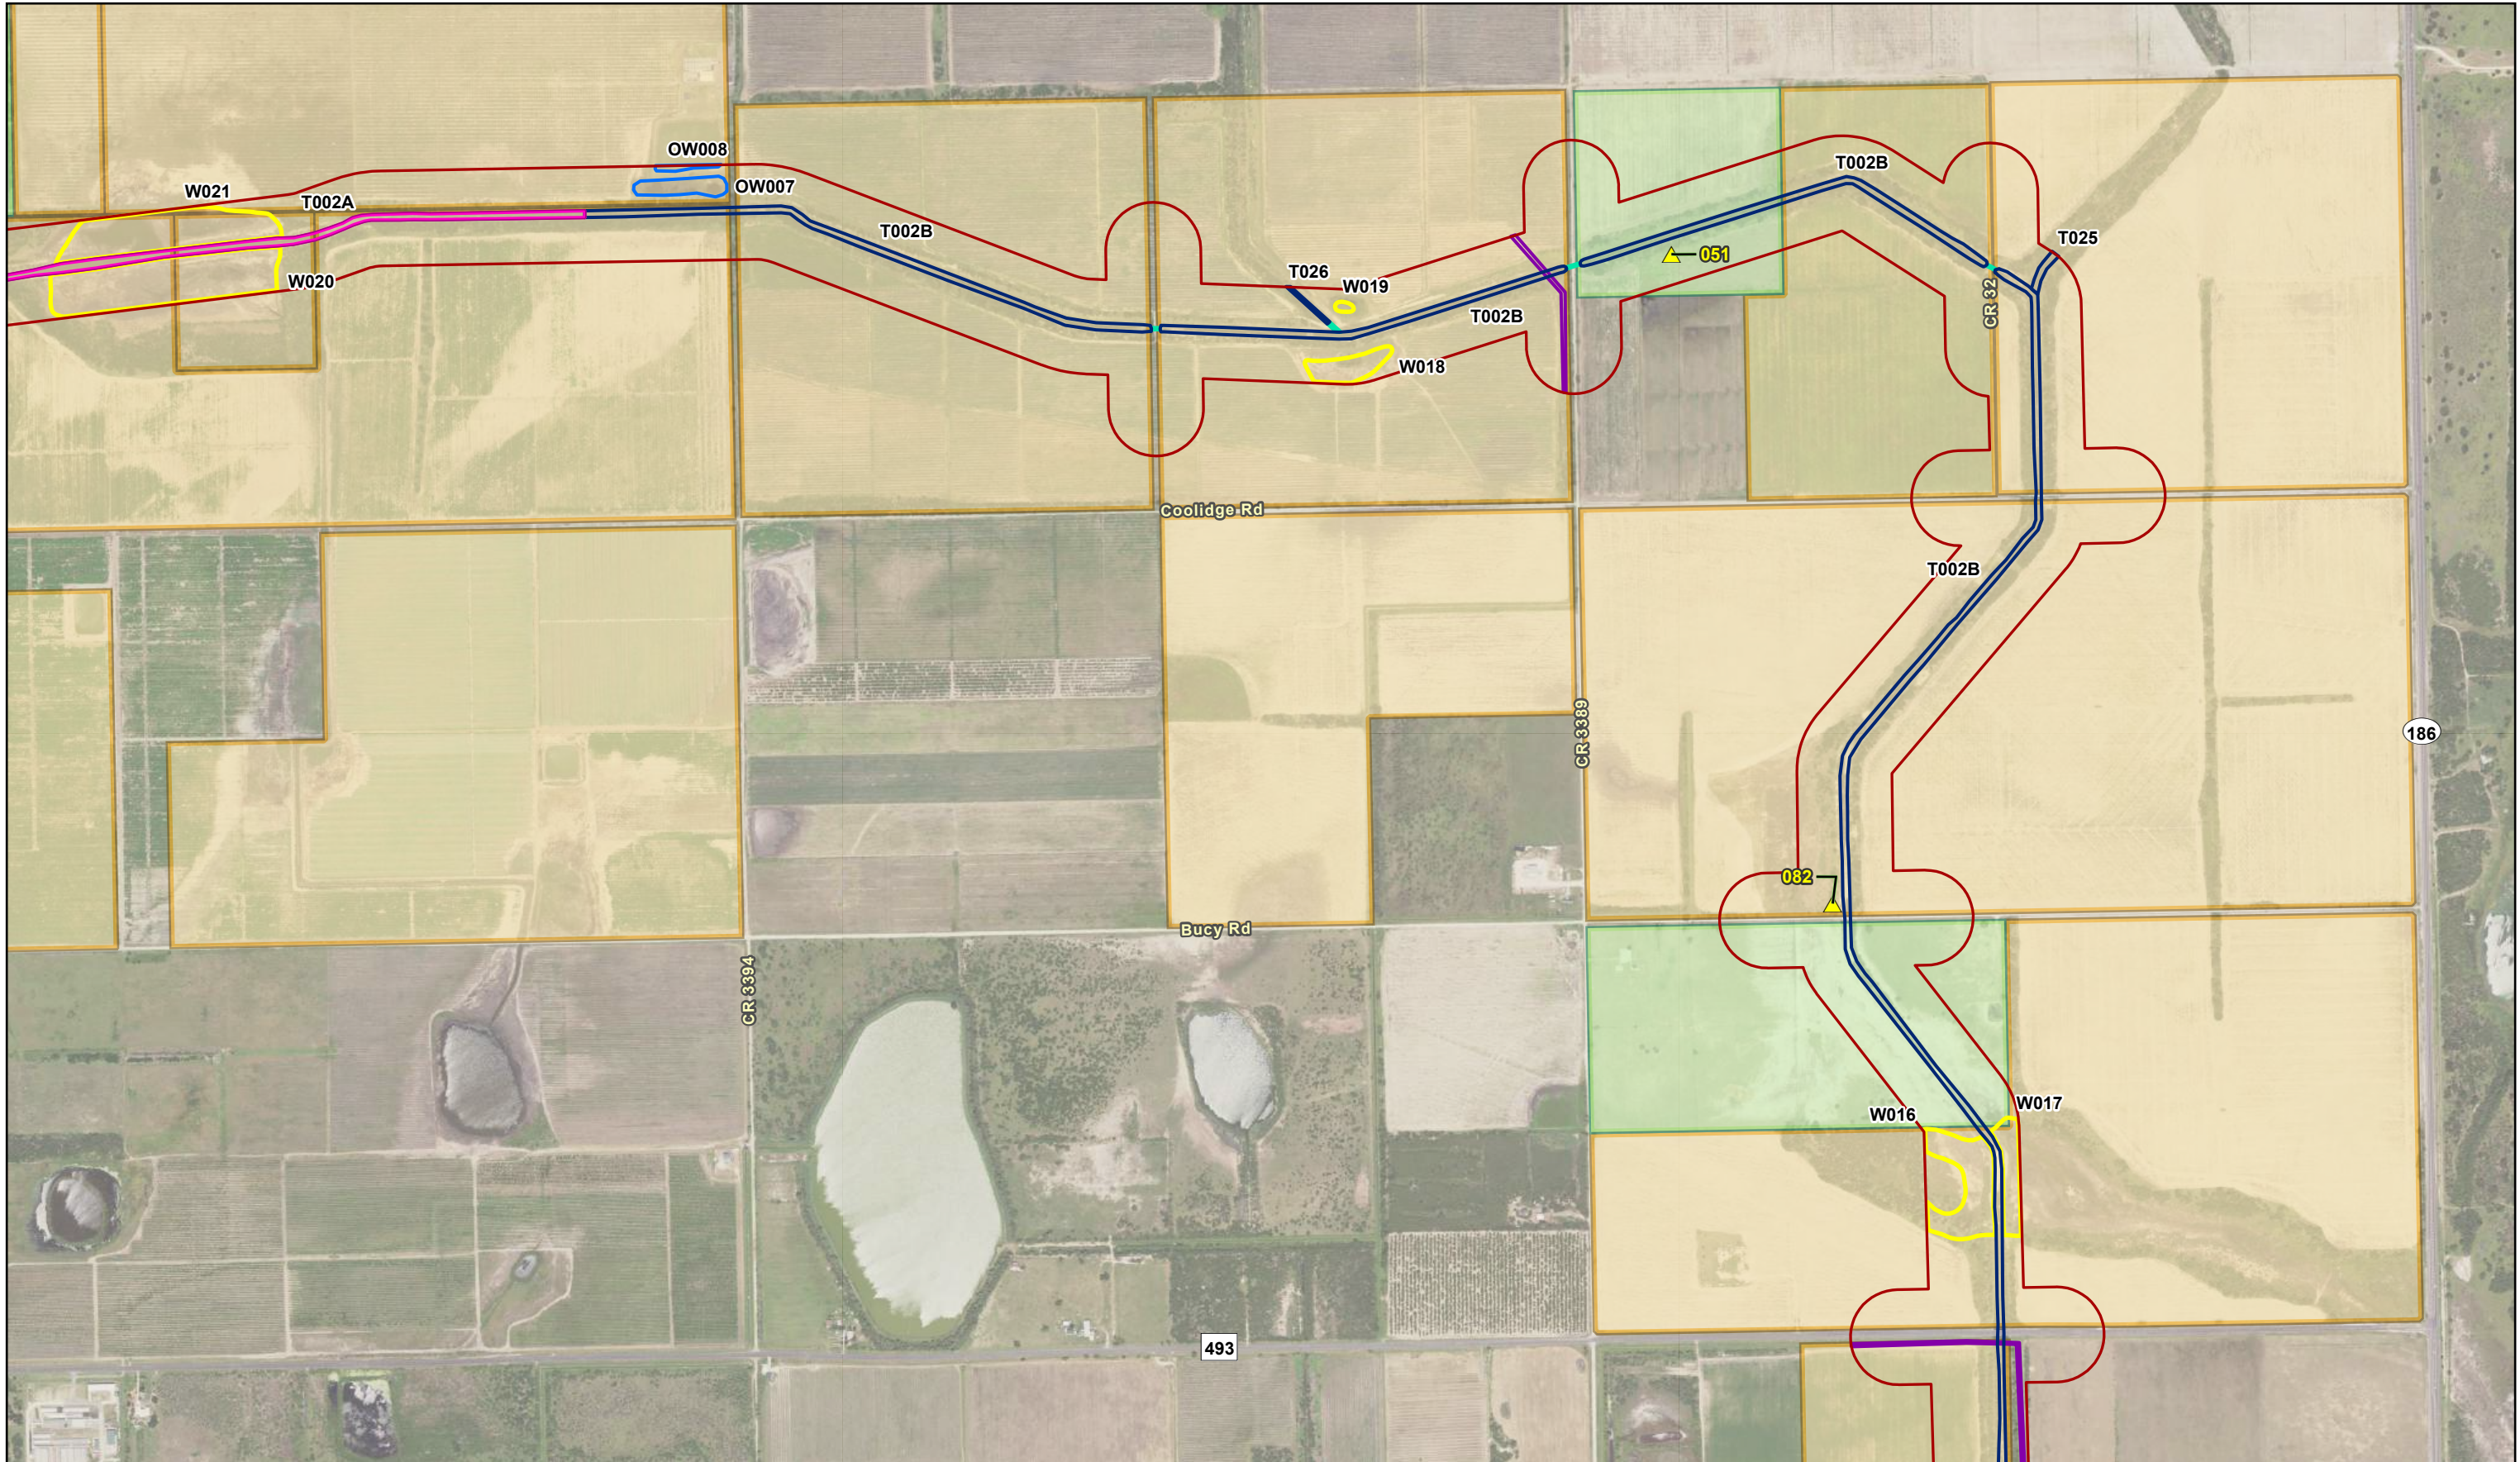
**Figure 7-4.**  
**Delineated Water Features**

T002A is a delineated upland drainage ditch located within and serving as the approximate centerline for the western portion of the project area. The delineated OHWM of T002A correlates with NWI polygon data coded R5UBFx and a flowline on USGS topographic maps. T002A is located northwest of Hargill, Texas and conveys flow north until the transition of the channel to T002B. No flow or pools were observed within the channel of this tributary during field investigations. T002B is not depicted on USGS topographic maps dated 1963 but is visible on aerial imagery dated 1985. Therefore, this tributary appears to have been excavated sometime between 1963 and 1985. T002A is an upland drainage ditch that carries only ephemeral flows in direct response to precipitation and should be considered a non-relatively permanent water. Therefore, T002A should be considered a potentially non-jurisdictional feature. The delineated OHWM of T002A is depicted on **Figures 7-4** and **7-5** in **Appendix A**. See Photographs 98-102 in **Appendix B**.

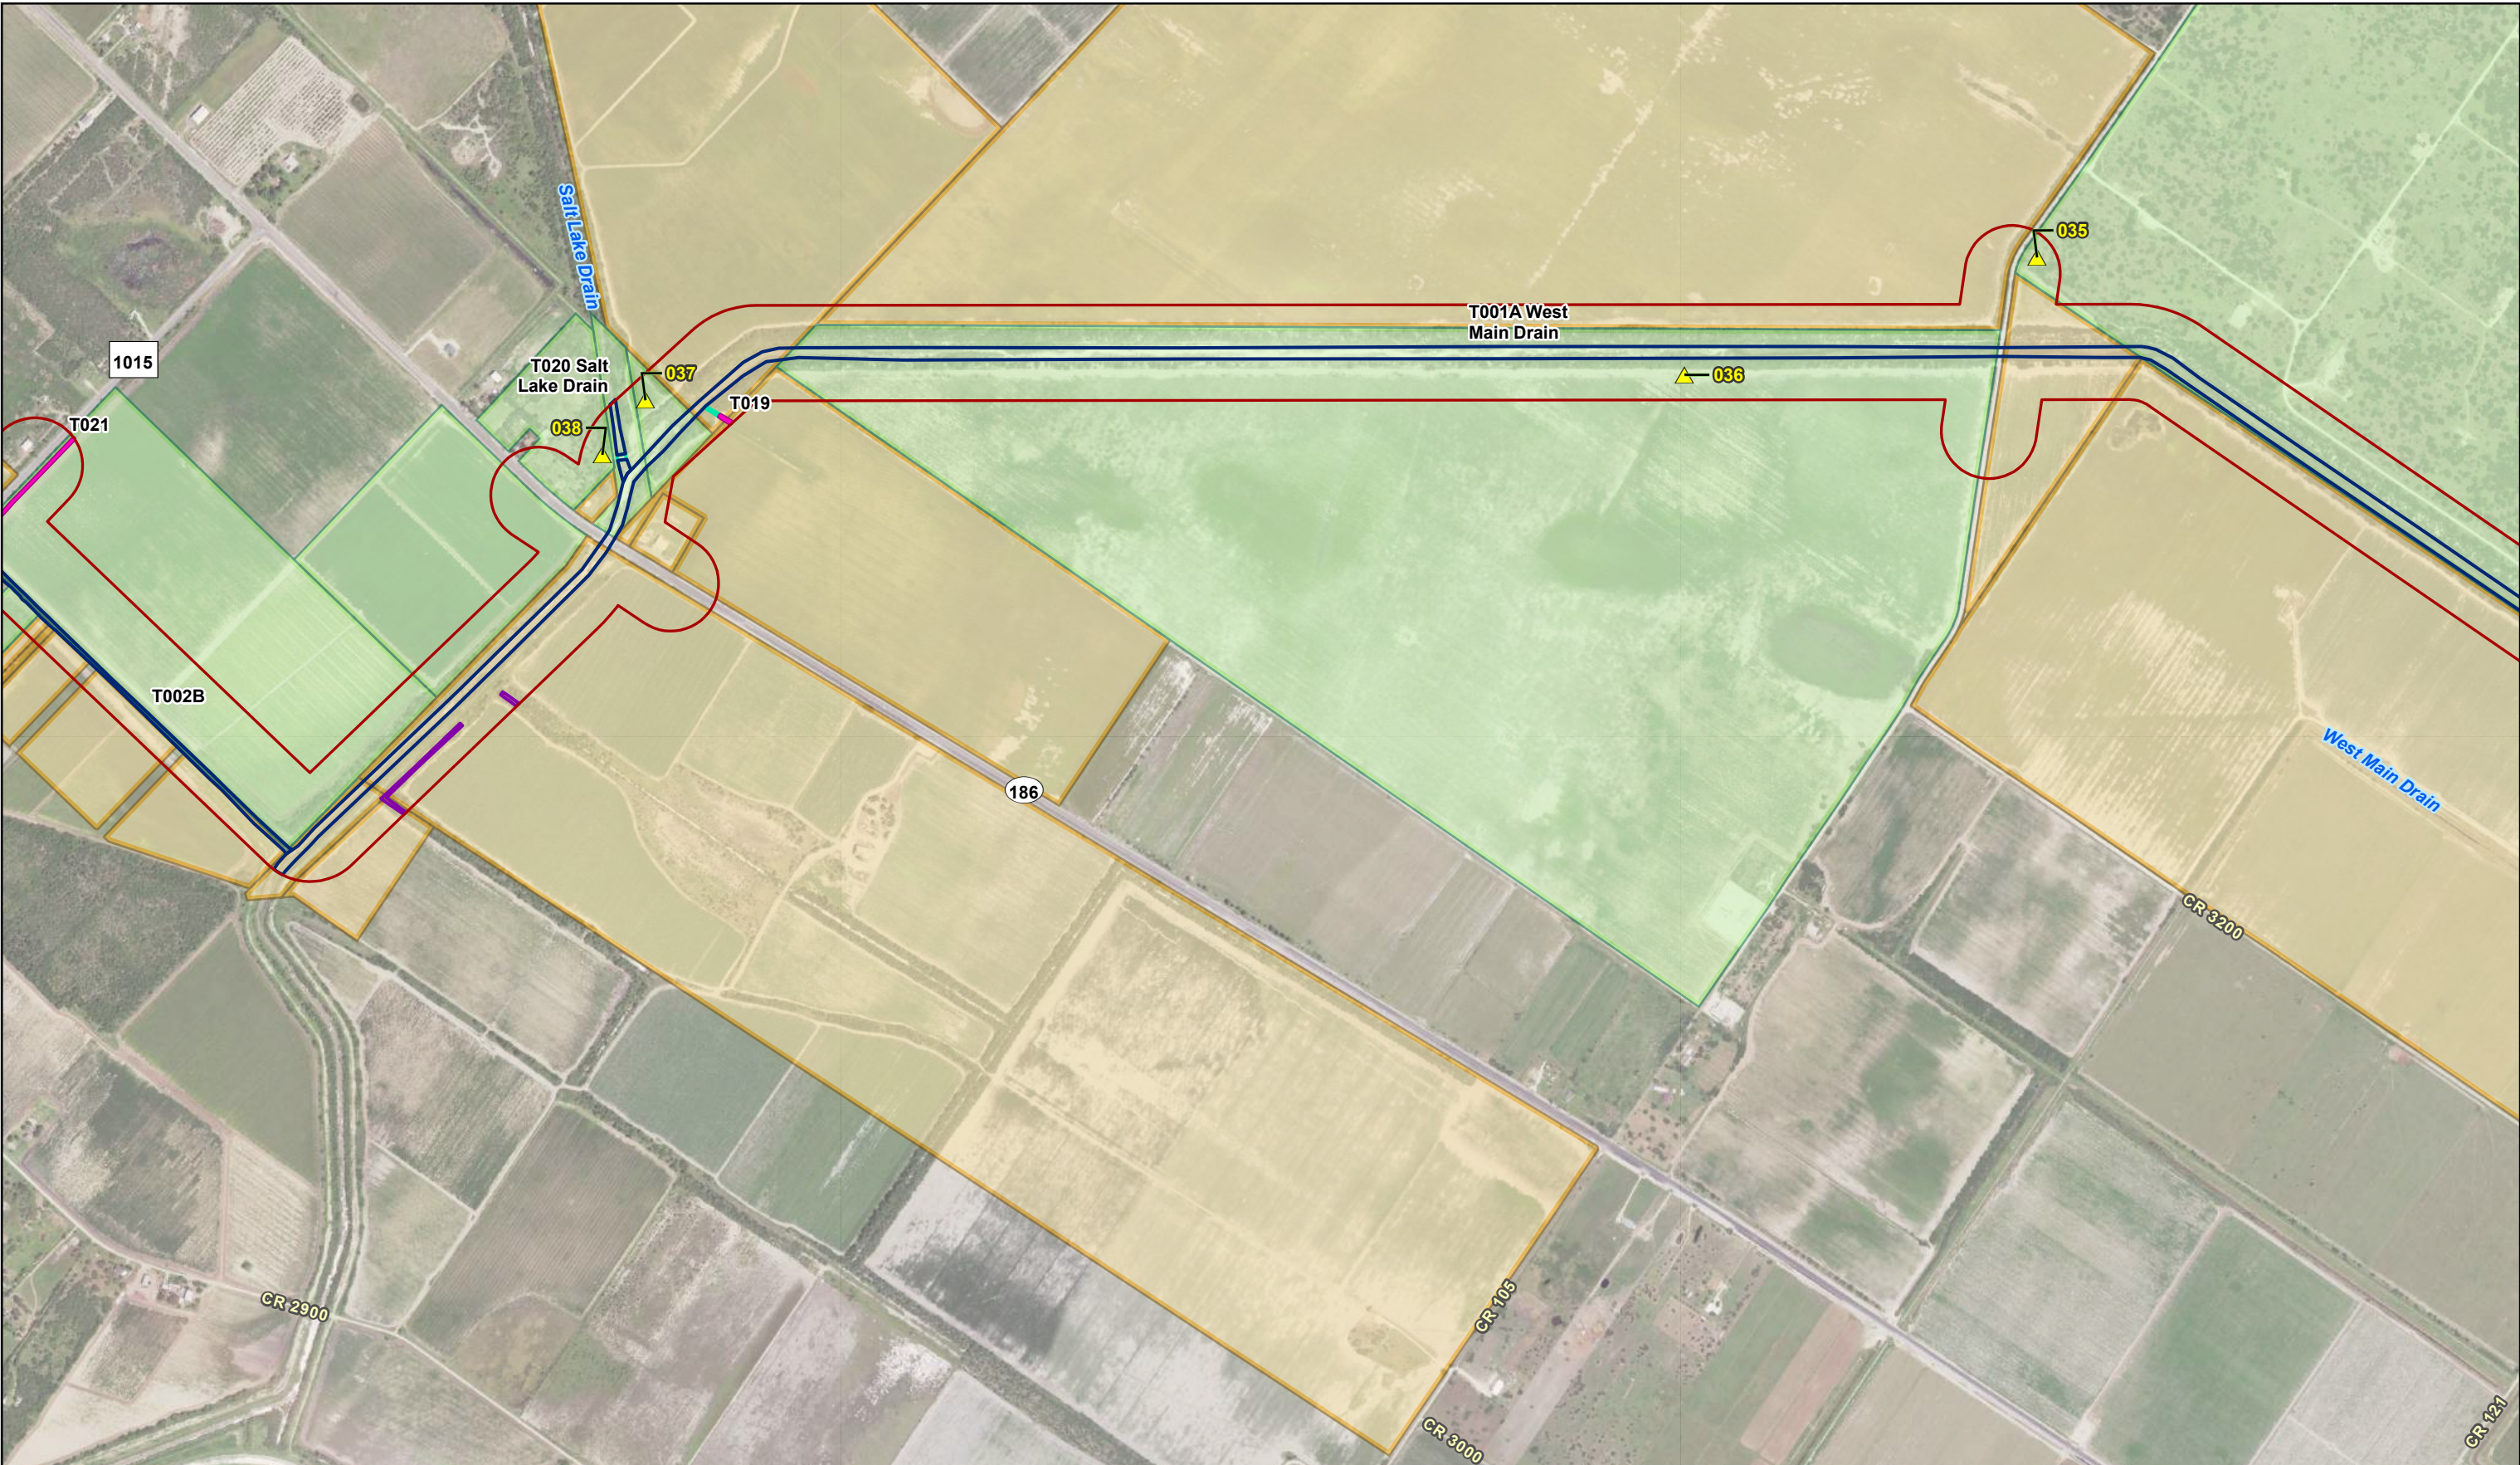
**Figure 7-8.  
Delineated Water Features**

T019 is an assumed upland drainage ditch due to the lack of ROE to the parcel where T019 is located. The OHWM of T019 is based on a strong linear lidar DEM signature correlating with NWI polygon data coded R5UBFx. The assumed OHWM of T019 correlates with a flowline on USGS topographic maps. A review of lidar data, aerial photography, and NHD data support the assumed presence and OHWM of T019. This tributary conveys flow west to its confluence with T001A (West Main Drain). Due to the assumed ephemeral flow characteristics of this tributary, T019 should be considered a non-relatively permanent water. Therefore, T019 should be considered a potentially non-jurisdictional feature. The assumed OHWM of T007 is depicted on **Figure 7-8** in **Appendix A**.

T020 is a delineated perennial drainage ditch. The delineated OHWM of T020 correlates with NWI polygon data coded R2UBHx and a flowline on USGS topographic maps labeled "Salt Lake Drain". NHD indicates that this tributary conveys flows toward La Sal Vieja. Noticeable flow and a water depth of approximately 12-24 inches were observed within this tributary during field investigations. Due to the perennial flow characteristics of this tributary, T020 should be considered a relatively permanent water. Therefore, T020 should be considered a potentially jurisdictional feature. The delineated OHWM of T020 is depicted on **Figure 7-8** in **Appendix A**. See Photographs 131-132 in **Appendix B**.

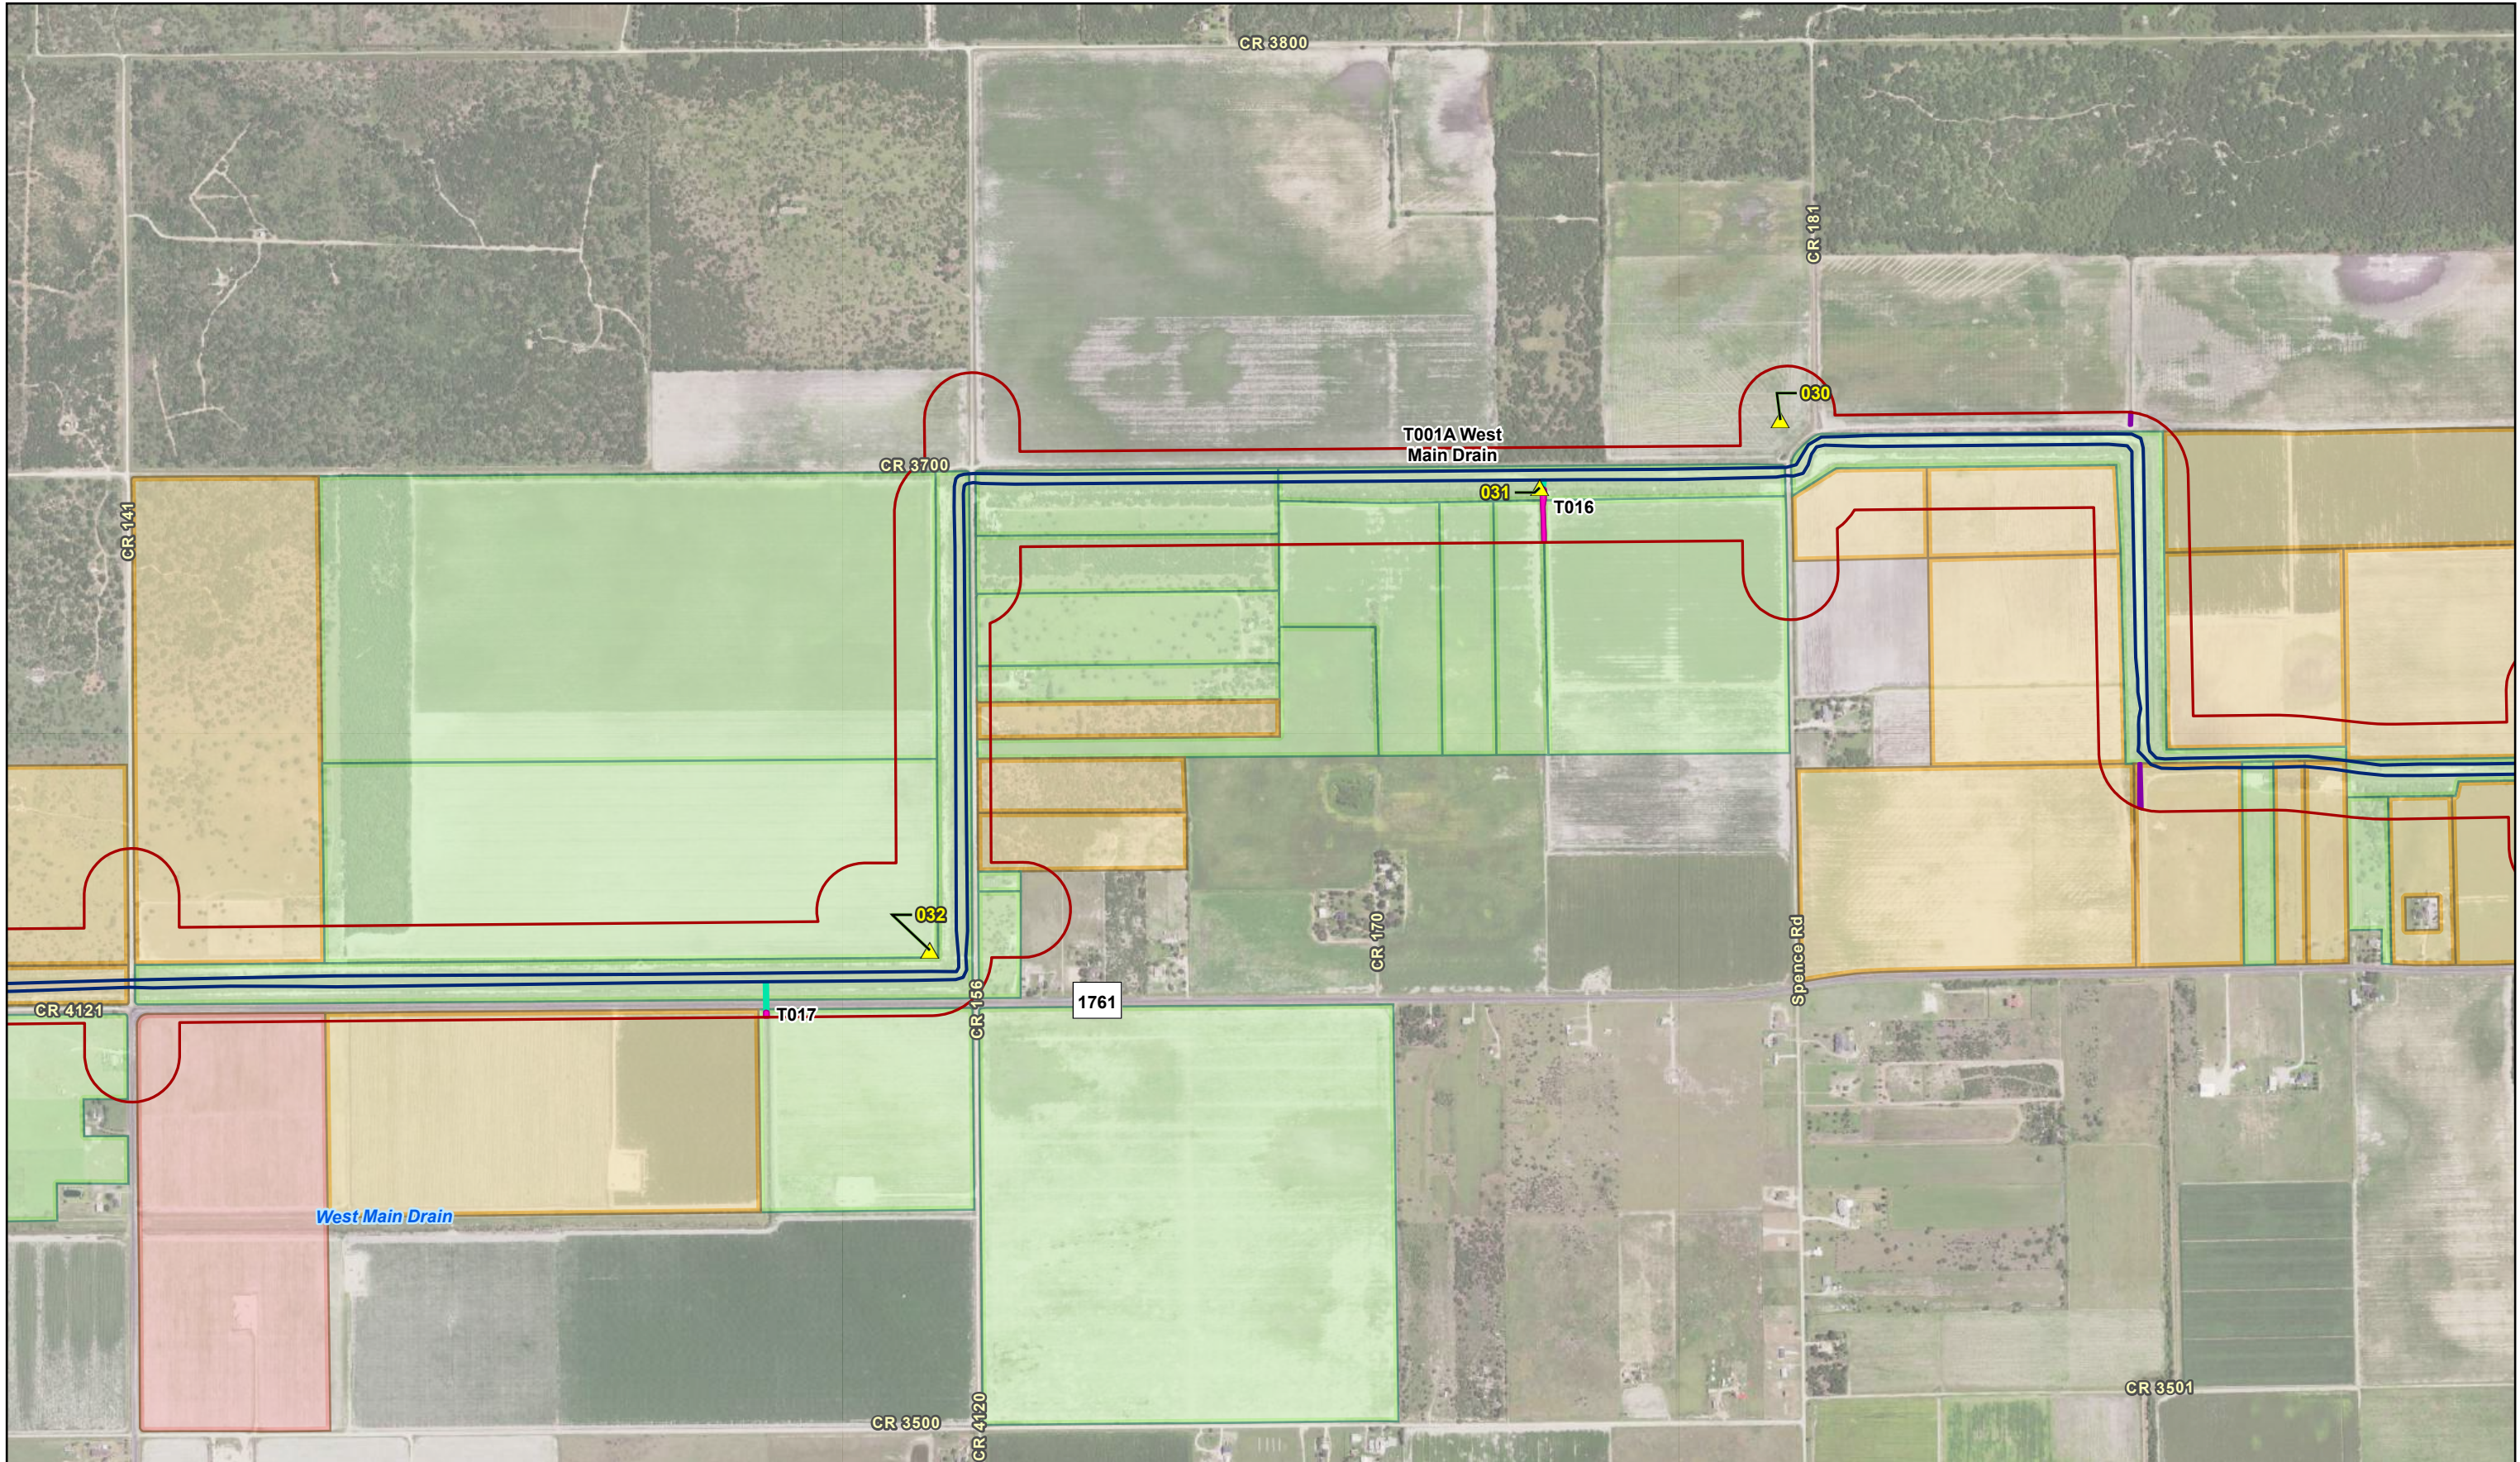
**Figure 7-10.**  
**Delineated Water Features**

T016 is a delineated upland drainage ditch. The delineated OHWM of T016 is not depicted by NWI or USGS topographic maps. This tributary conveys flow north to its confluence with T001A (West Main Drain). No flow or pools were observed within the channel of this tributary during field investigations. T016 is an upland drainage ditch that carries only ephemeral flows in direct response to precipitation and should be considered a non-relatively permanent water. Therefore, T016 should be considered a potentially non-jurisdictional feature. The delineated OHWM of T016 is depicted on **Figure 7-10** in **Appendix A**. See Photographs 124-125 in **Appendix B**.

T017 is a delineated upland drainage ditch. The delineated OHWM of T017 correlates with NWI polygon data coded R5UBFx. No flowline correlating with T017 is depicted on USGS topographic maps. This tributary conveys flow north to its confluence with T001A (West Main Drain). No flow or pools were observed within the channel of this tributary during field investigations. T017 is an upland drainage ditch that carries only ephemeral flows in direct response to precipitation and should be considered a non-relatively permanent water. Therefore, T017 should be considered a potentially non-jurisdictional feature. The delineated OHWM of T016 is depicted on **Figure 7-10** in **Appendix A**. See Photographs 126-127 in **Appendix B**.
