## **Delineation Report**

Raymondville Drain Project  
Hidalgo and Willacy Counties, Texas

December 11, 2024

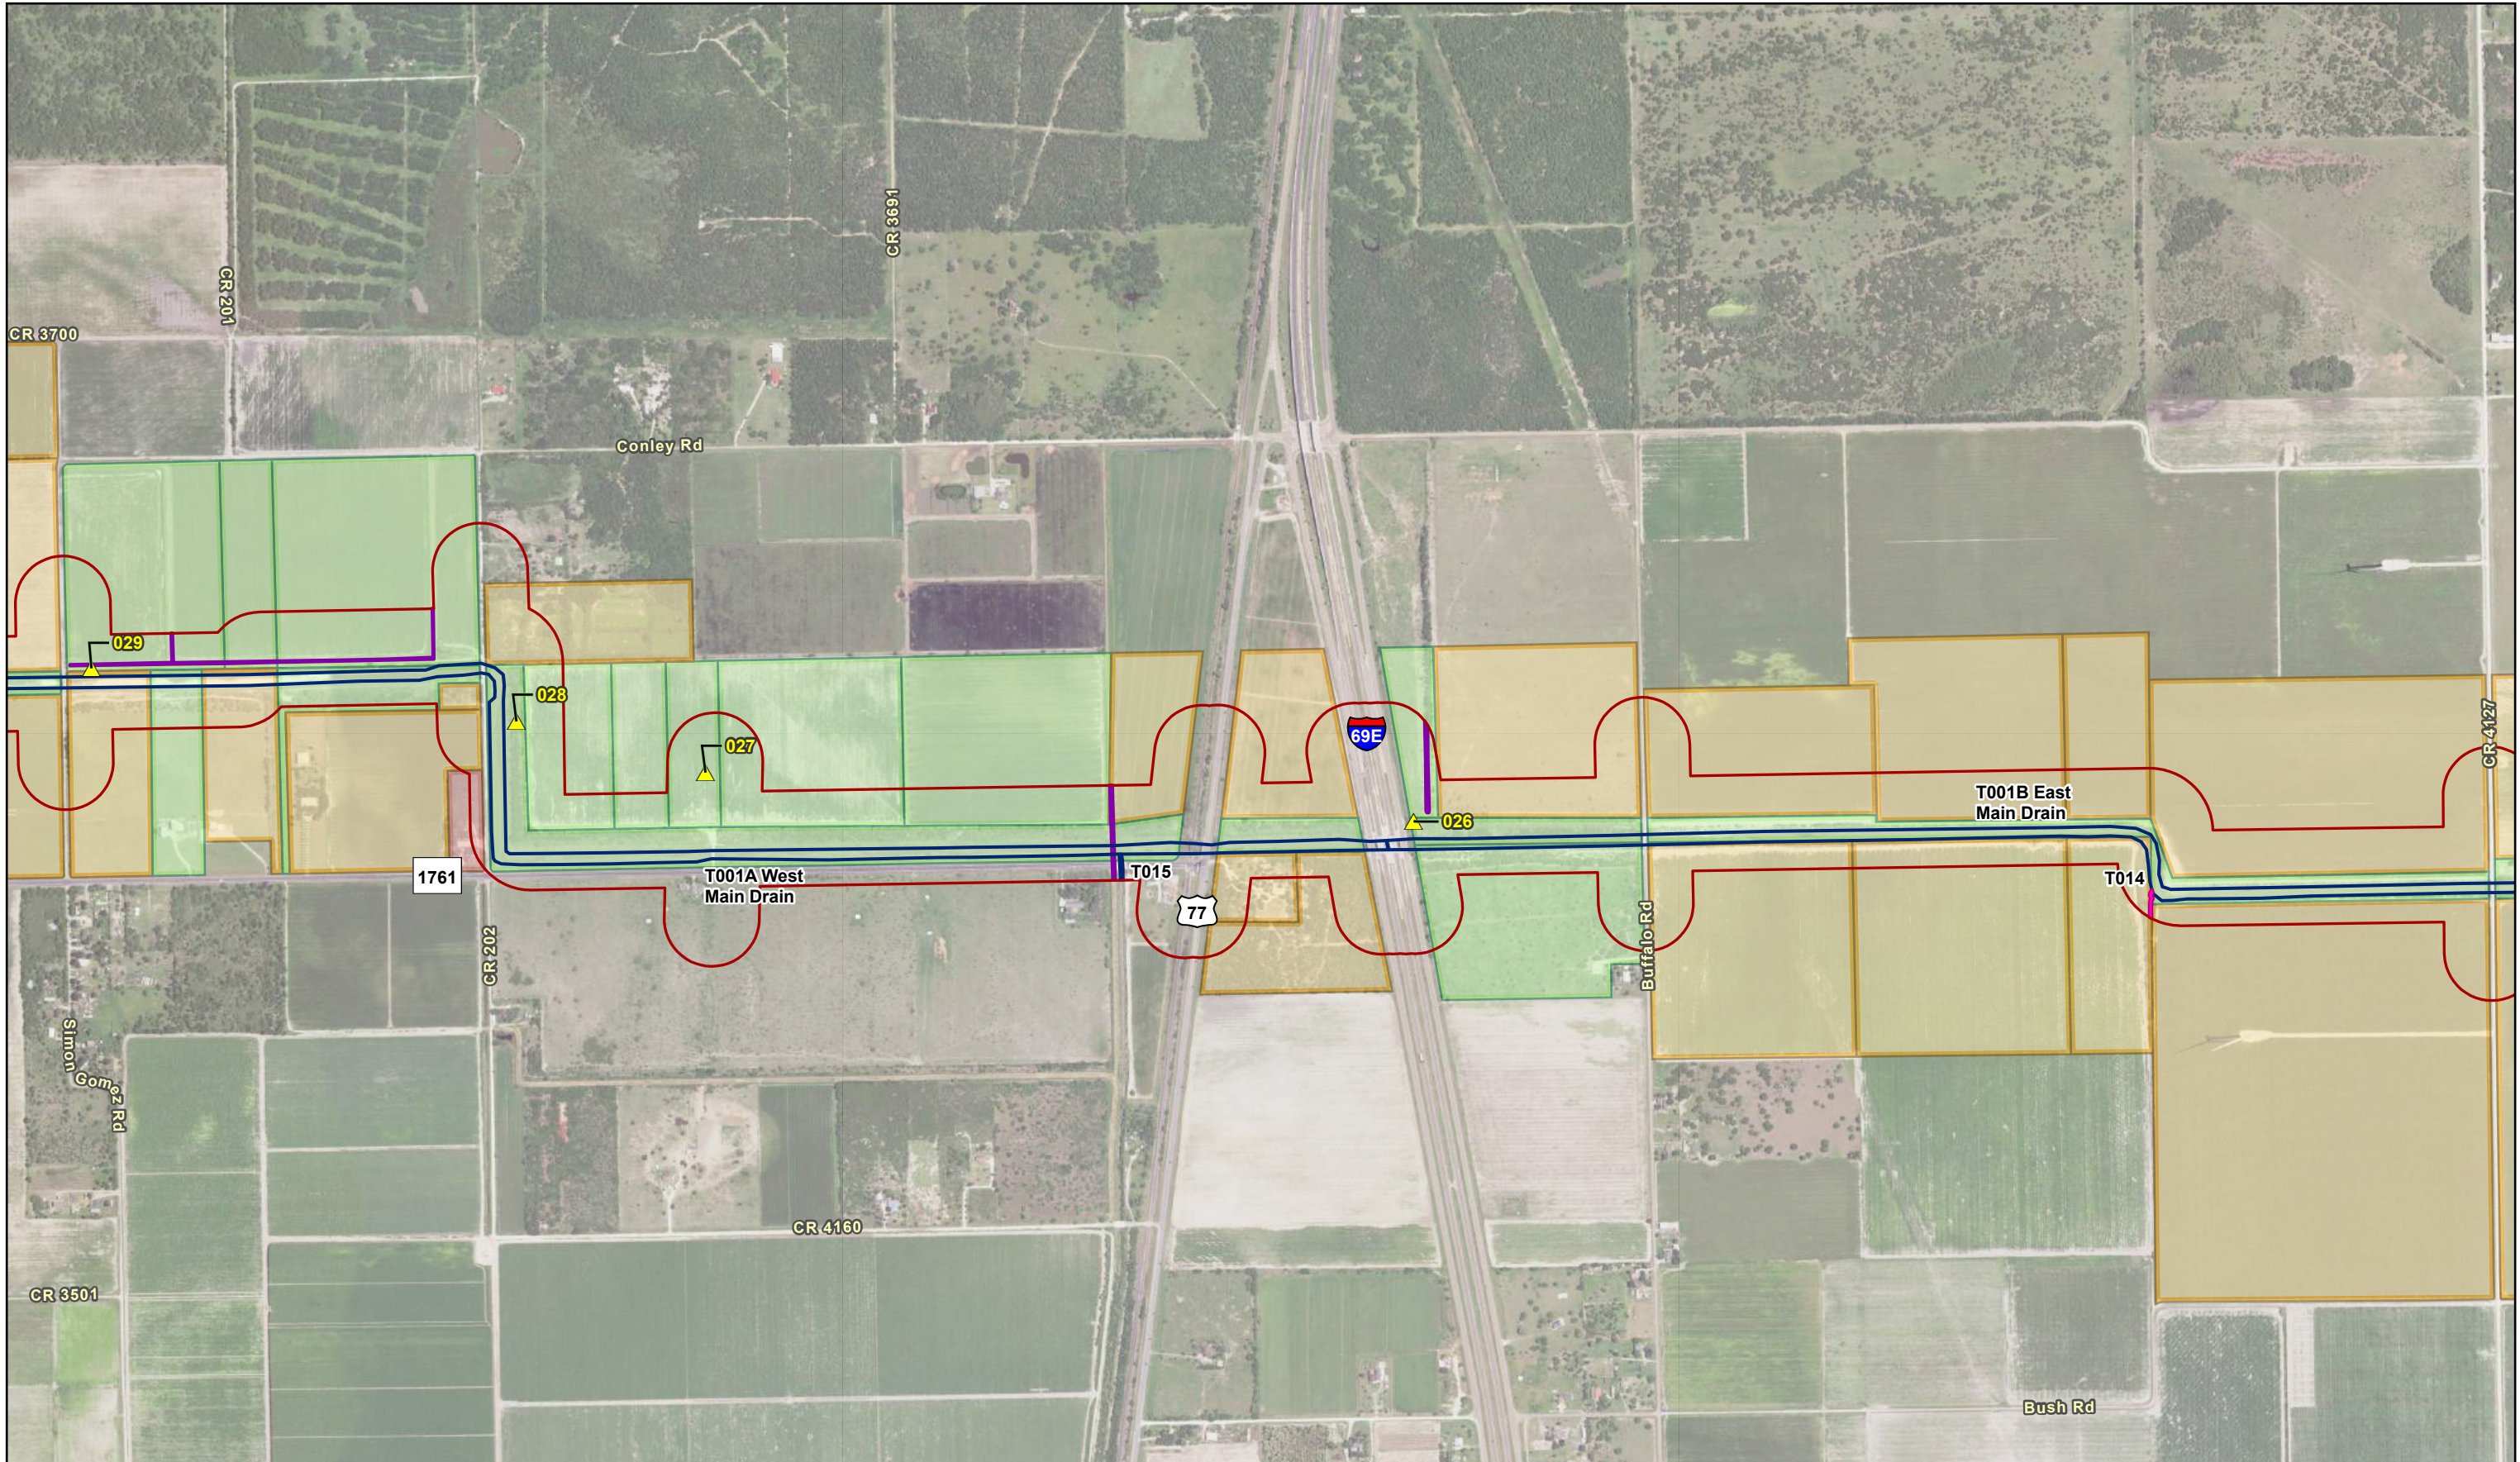
**Figure 7-11.**  
**Delineated Water Features**

T014 is a delineated upland drainage ditch. The delineated OHWM of T014 is not depicted by NWI or USGS topographic maps. This tributary conveys flow north to its confluence with T001B (East Main Drain). No flow or pools were observed within the channel of this tributary during field investigations. T014 is an upland drainage ditch that carries only ephemeral flows in direct response to precipitation and should be considered a non-relatively permanent water. Therefore, T014 should be considered a potentially non-jurisdictional feature. The delineated OHWM of T014 is depicted on **Figure 7-11** in **Appendix A**. See Photographs 120-121 in **Appendix B**.

T015 is a delineated perennial drainage ditch. The delineated OHWM of T015 correlates with NWI polygon data coded R2UBHx and a flowline on USGS topographic maps. This tributary conveys flow north to its confluence with T001A (West Main Drain). Noticeable flow and a water depth of approximately 24 inches were observed within this tributary during field investigations. Due to the perennial flow characteristics of this tributary, T015 should be considered a relatively permanent water with an eventual downgradient continuous surface connection to Laguna Madre through T001A and T001B. Therefore, T015 should be considered a potentially jurisdictional feature. The delineated OHWM of T015 is depicted on **Figure 7-11** in **Appendix A**. See Photographs 122-123 in **Appendix B**.

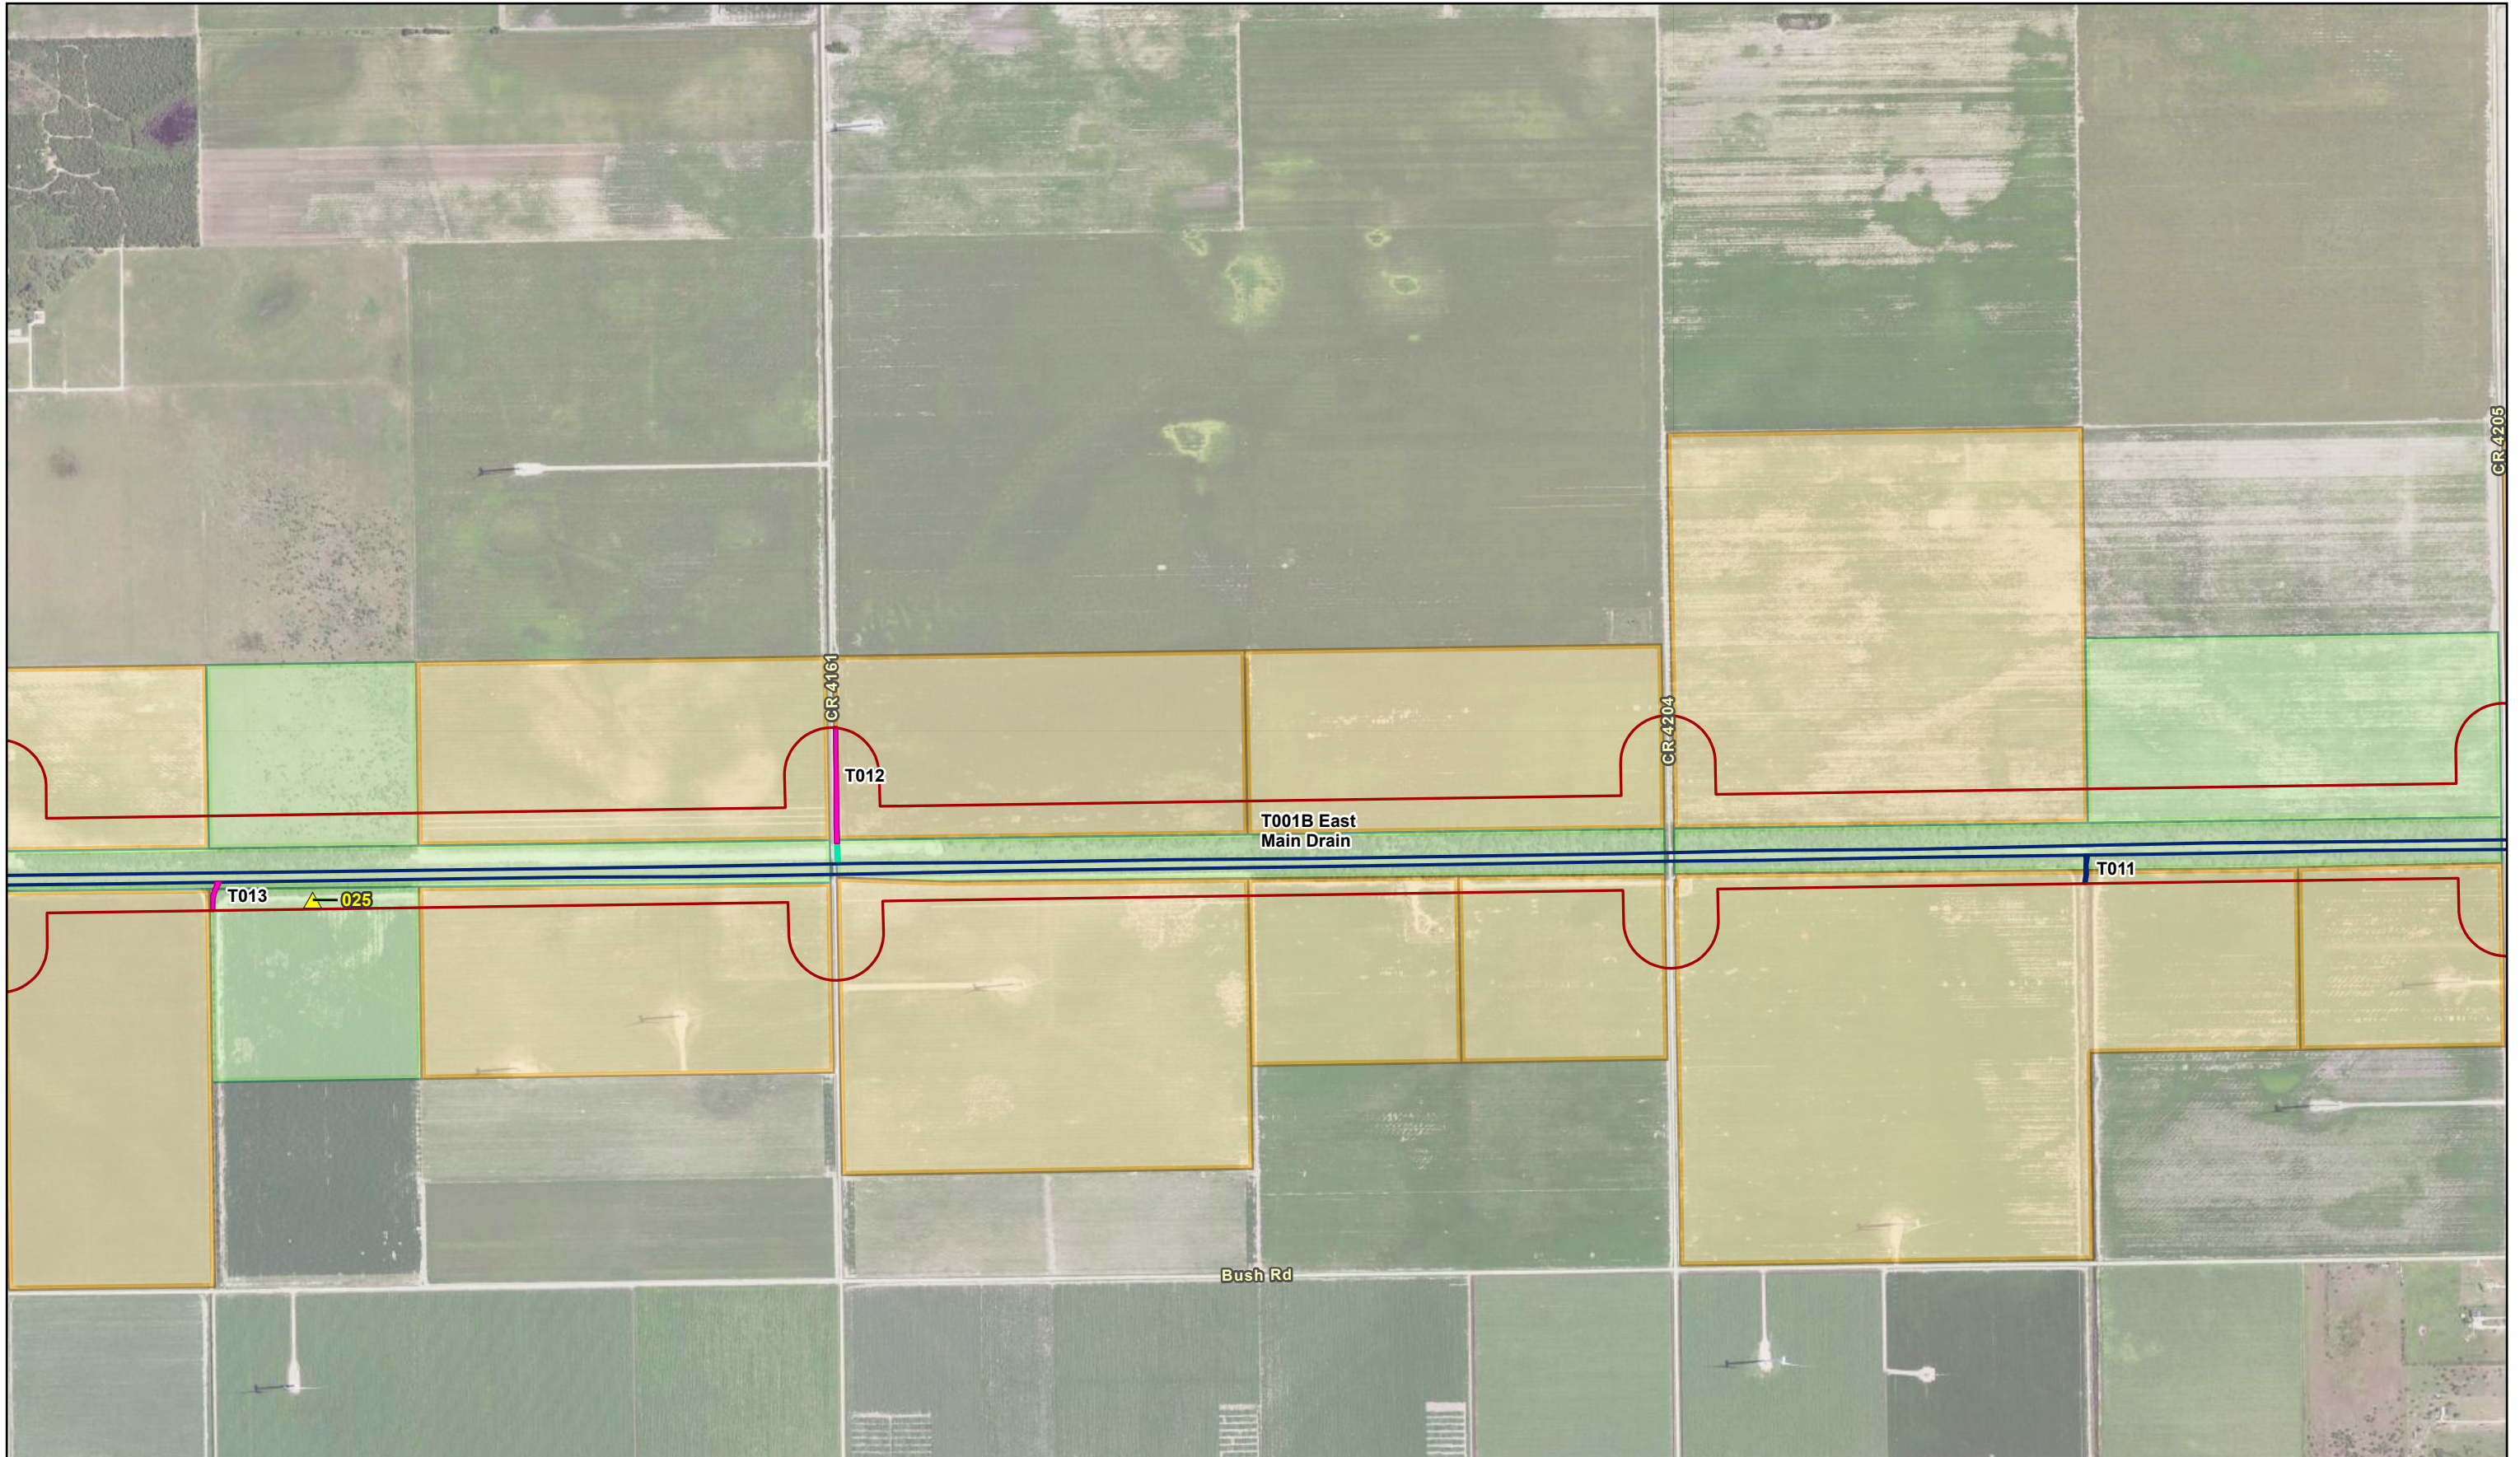
**Figure 7-12.**  
**Delineated Water Features**

T011 is a delineated perennial drainage ditch. The delineated OHWM of T011 correlates with NWI polygon data coded PEM1Cx and a flowline on USGS topographic maps. This tributary conveys flow north to its confluence with T001B (East Main Drain). Noticeable flow and a water depth of approximately 24 inches were observed within this tributary during field investigations. Due to the perennial flow characteristics of this tributary, T011 should be considered a relatively permanent water with an eventual downgradient continuous surface connection to Laguna Madre through T001B. Therefore, T011 should be considered a potentially jurisdictional feature. The delineated OHWM of T011 is depicted on **Figure 7-12 in Appendix A.** See Photographs 114-115 in **Appendix B.**

confluence with T001B (East Main Drain). No flow or pools were observed within the channel of this tributary during field investigations. T012 is an upland drainage ditch that carries only ephemeral flows in direct response to precipitation and should be considered a non-relatively permanent water. Therefore, T012 should be considered a potentially non-jurisdictional feature. The delineated OHWM of T012 is depicted on **Figure 7-12** in **Appendix A**. See Photographs 116-117 in **Appendix B**.

T013 is a delineated upland drainage ditch. The delineated OHWM of T013 correlates with NWI polygon data coded PEM1Cx and a flowline on USGS topographic maps. This tributary conveys flow north to its confluence with T001B (East Main Drain). No flow or pools were observed within the channel of this tributary during field investigations. T013 is an upland drainage ditch that carries only ephemeral flows in direct response to precipitation and should be considered a non-relatively permanent water. Therefore, T013 should be considered a potentially non-jurisdictional feature. The delineated OHWM of T013 is depicted on **Figure 7-12** in **Appendix A**. See Photographs 118-119 in **Appendix B**.

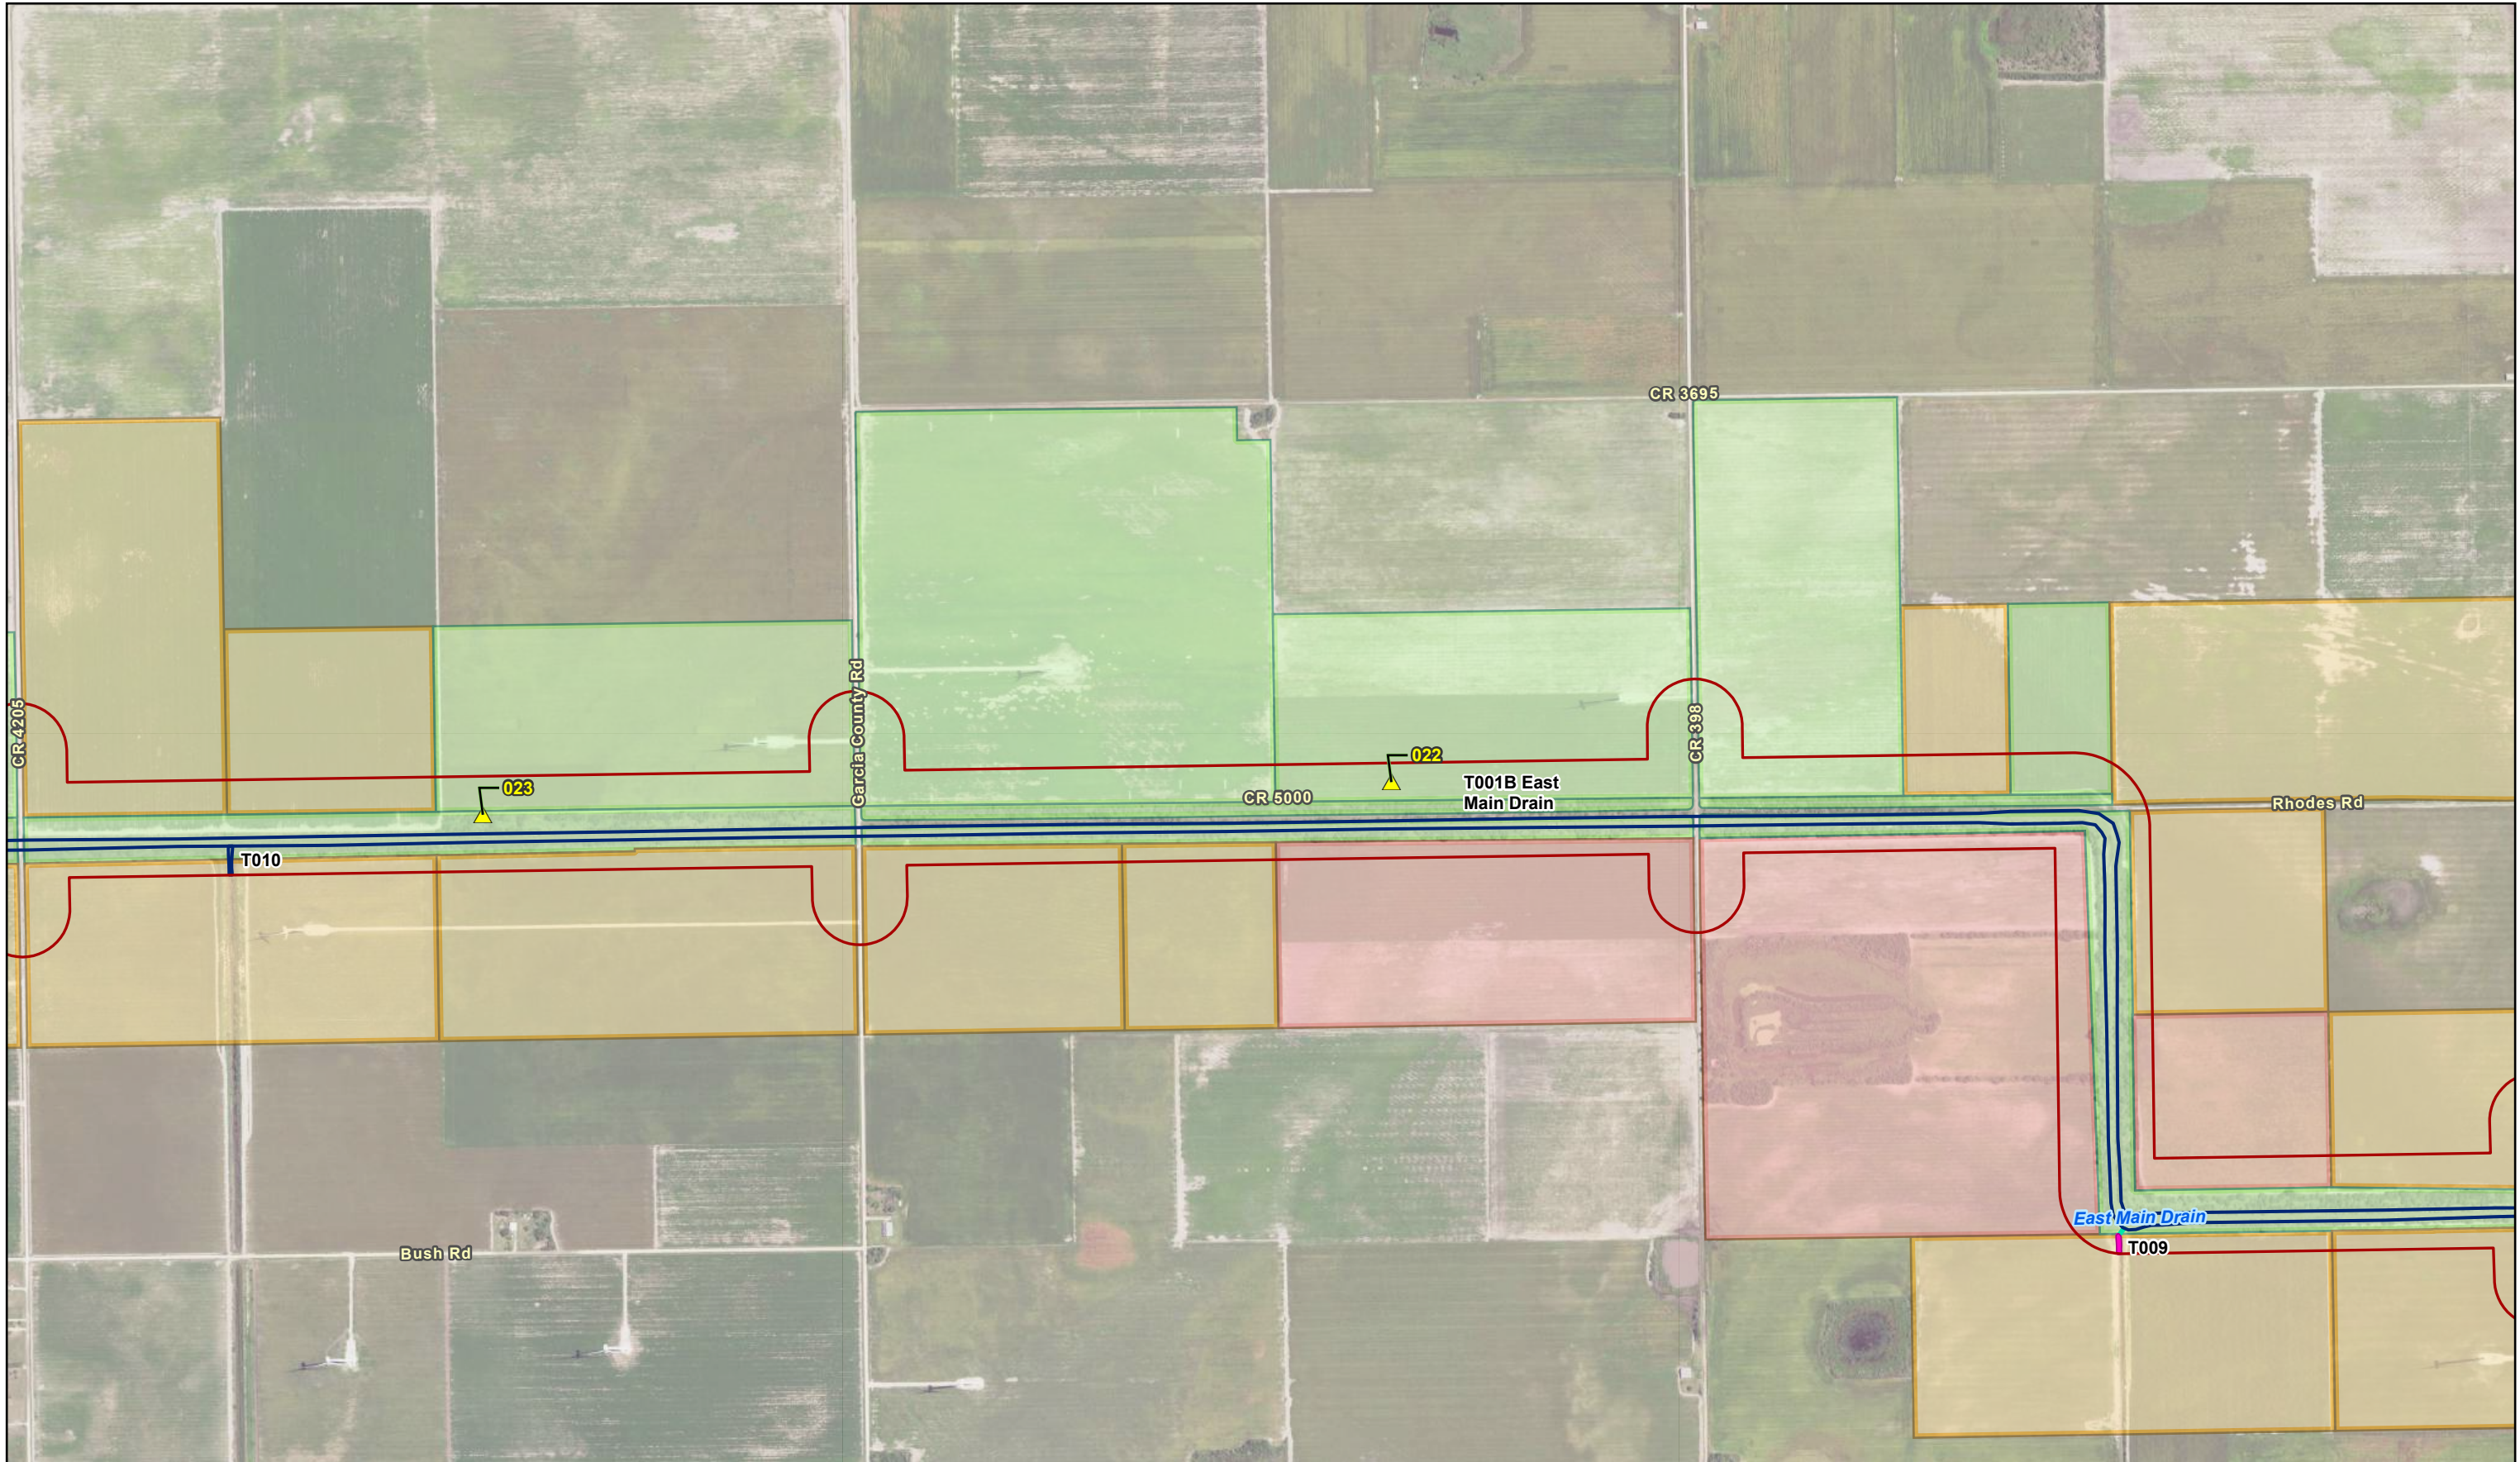
**Figure 7-13.**  
**Delineated Water Features**

T009 is a delineated upland drainage ditch. The delineated OHWM of T009 correlates with NWI polygon data coded R5UBFx and a flowline on USGS topographic maps. This tributary conveys flow north to its confluence with T001B (East Main Drain). No flow or pools were observed within the channel of this tributary during field investigations. T009 is an upland drainage ditch that carries only ephemeral flows in direct response to precipitation and should be considered a non-relatively permanent water. Therefore, T009 should be considered a potentially non-jurisdictional feature. The delineated OHWM of T009 is depicted on **Figure 7-13 in Appendix A.** See Photographs 107-110 in **Appendix B.**

T010 is a delineated perennial drainage ditch. The delineated OHWM of T010 correlates with NWI polygon data coded PEM1Cx and a flowline on USGS topographic maps. This tributary conveys flow north to its confluence with T001B (East Main Drain). Noticeable flow a water depth of approximately 18 inches, and gars (family Lepisosteidae) were observed within this tributary during field investigations. Due to the perennial flow characteristics of this tributary, T010 should be considered a relatively permanent water with an eventual downgradient continuous surface connection to Laguna Madre through T001B. Therefore, T010 should be considered a potentially jurisdictional feature. The delineated OHWM of T010 is depicted on **Figure 7-13 in Appendix A.** See Photographs 111-113 in **Appendix B.**

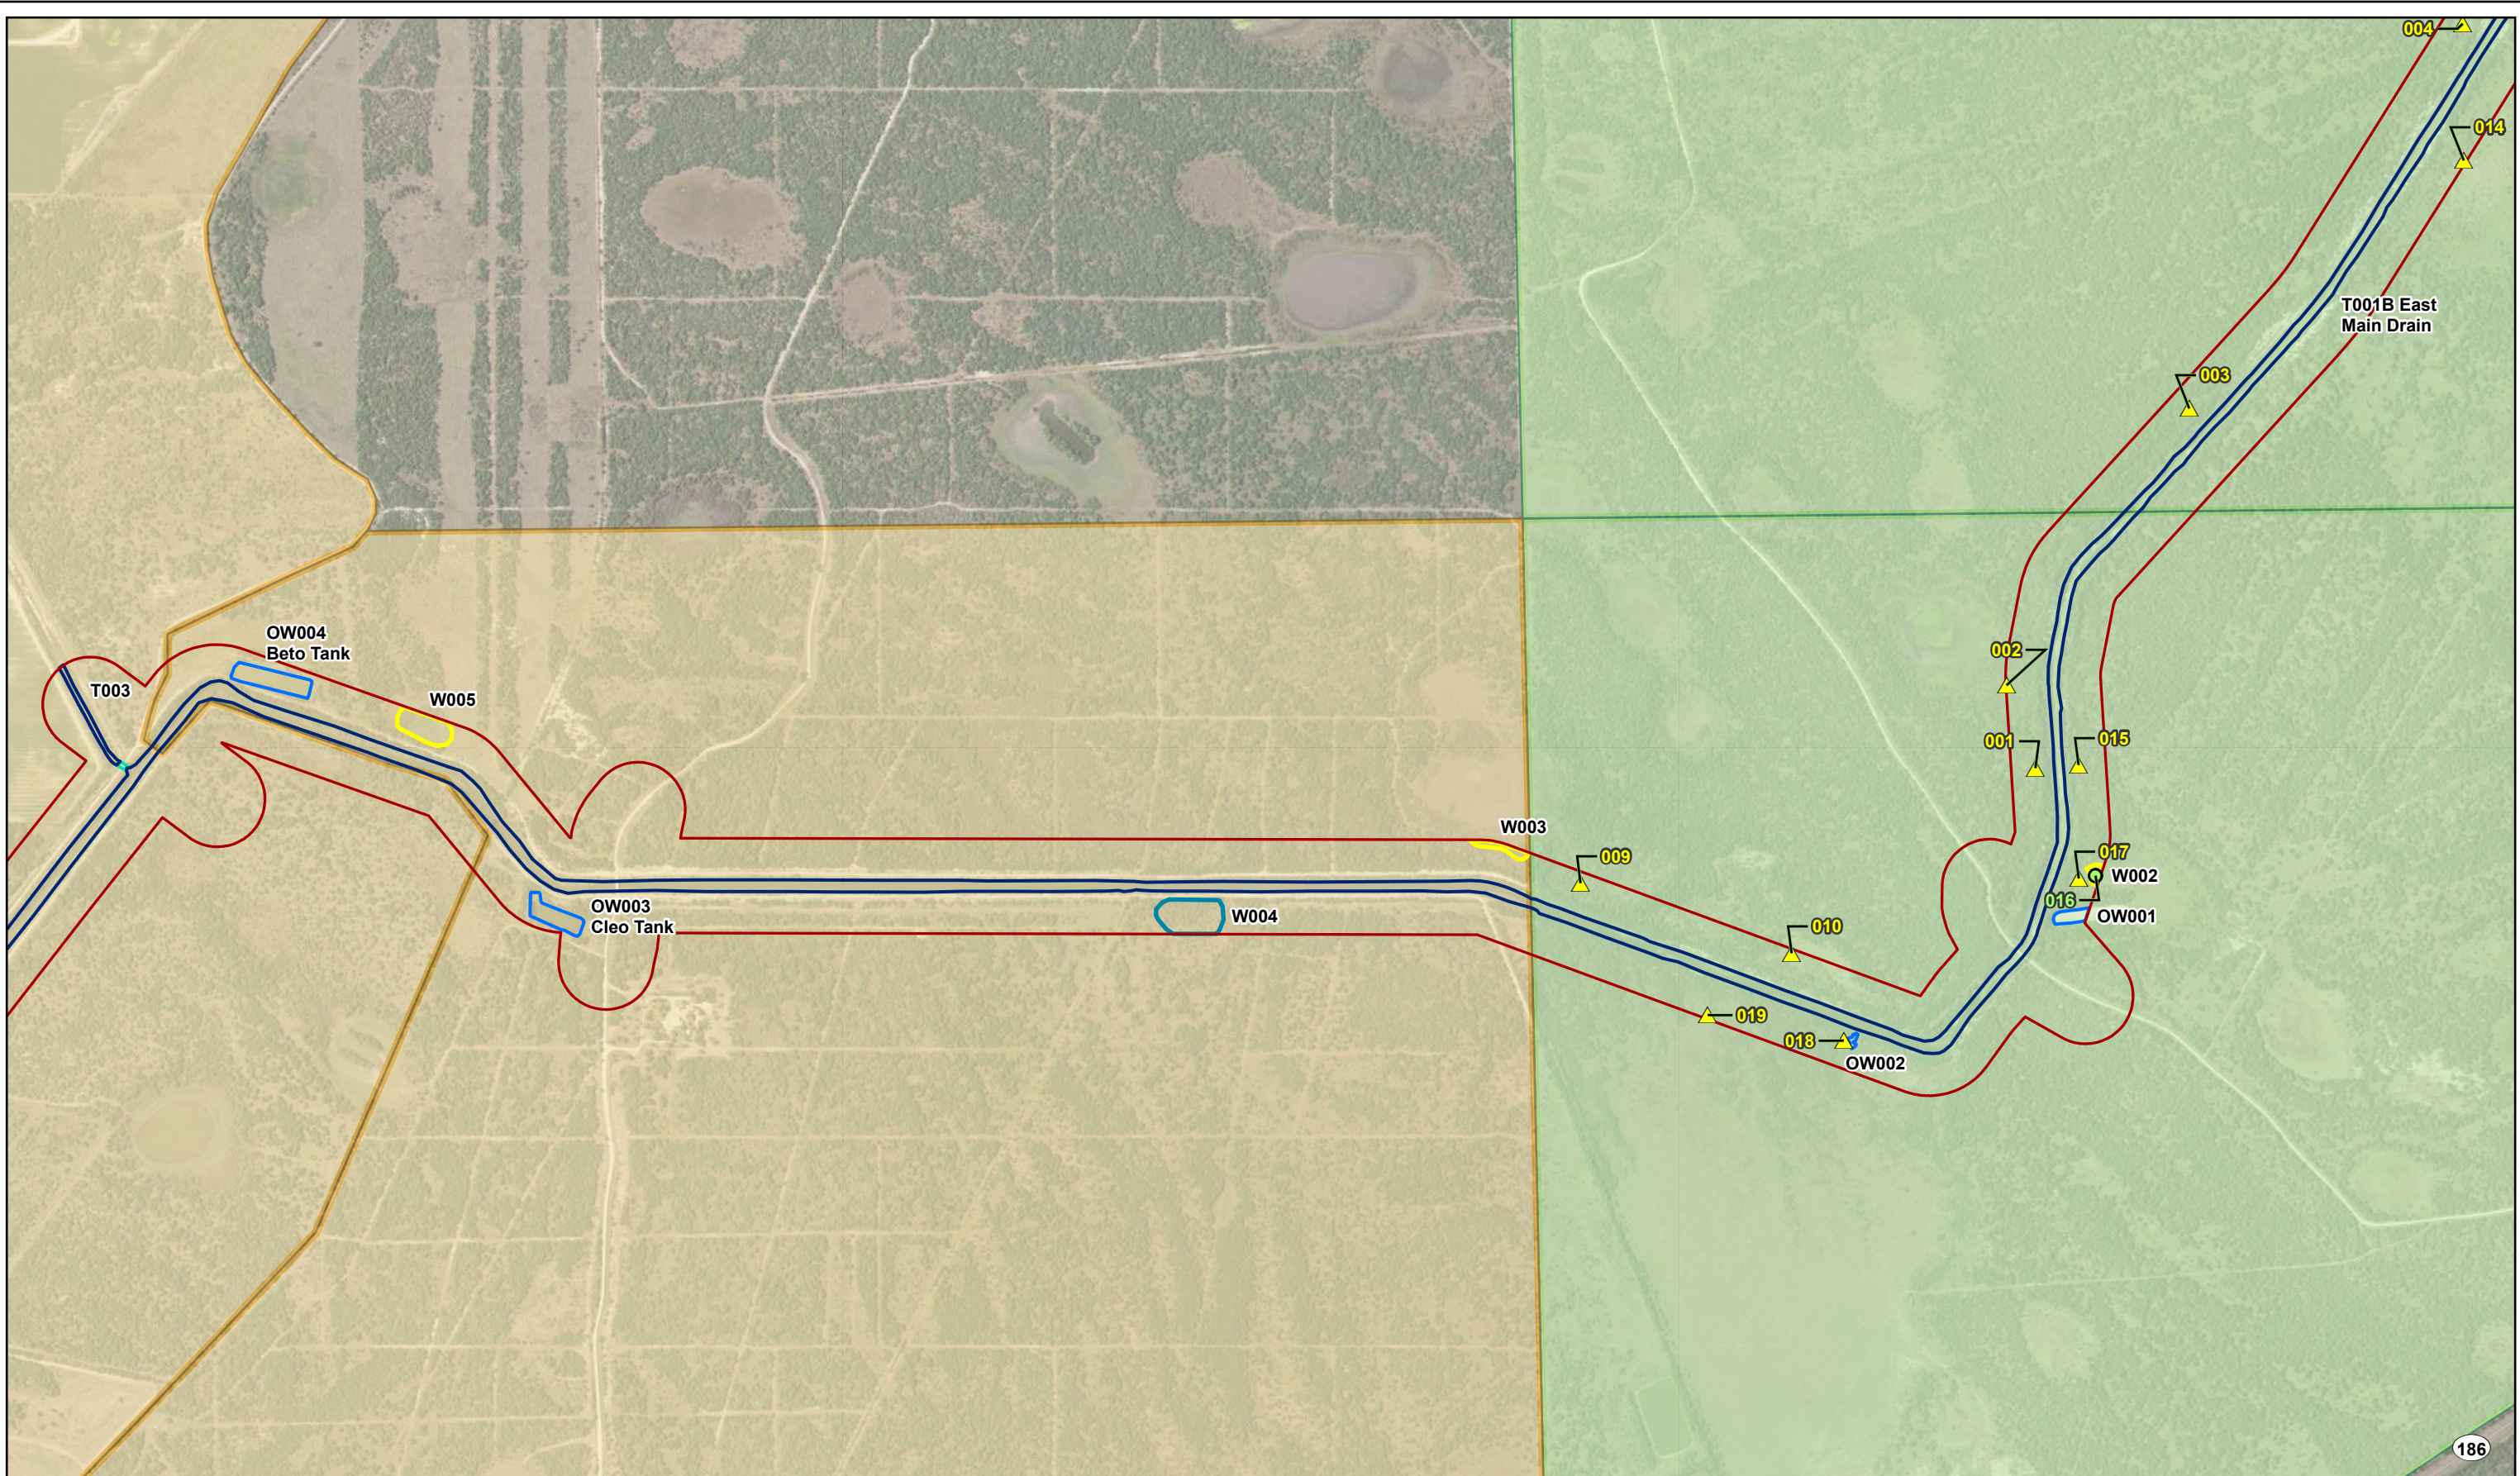
**Figure 7-16.**  
**Delineated Water Features**

OW001 is a delineated open water feature. The delineated boundary of OW001 correlates with NWI polygon data coded PUBHx. No aquatic features correlating with the delineated boundary of OW001 are depicted on USGS topographic maps. Approximately 24 inches of standing water was observed within this feature during the field investigation. OW001 is the result of an excavation for the apparent purpose of watering cattle and is best described as an upland stock tank. Additionally, a continuous surface connection between OW001 and a relatively permanent water is not apparent. Therefore, OW001 should be considered isolated and a potentially non-jurisdictional feature. The delineated boundary of OW001 is depicted on **Figure 7-16 in Appendix A**. See Photograph 161 in **Appendix B**.

OW002 is a delineated open water feature. The delineated boundary of OW002 partially correlates with NWI polygon data coded PEM1A. No aquatic features correlating with the delineated boundary of OW002 are depicted on USGS topographic maps. Approximately 36 inches of standing water was observed within this feature during the field investigation. This feature is the result of an excavation for the apparent purpose of watering cattle and is best described as an upland stock tank. Additionally, a continuous surface connection between OW002 and a relatively permanent water is not apparent. Therefore, OW002 should be considered isolated and a potentially non-jurisdictional feature. The delineated boundary of OW002 is depicted on **Figure 7-16 in Appendix A**. See Photograph 162 in **Appendix B**.

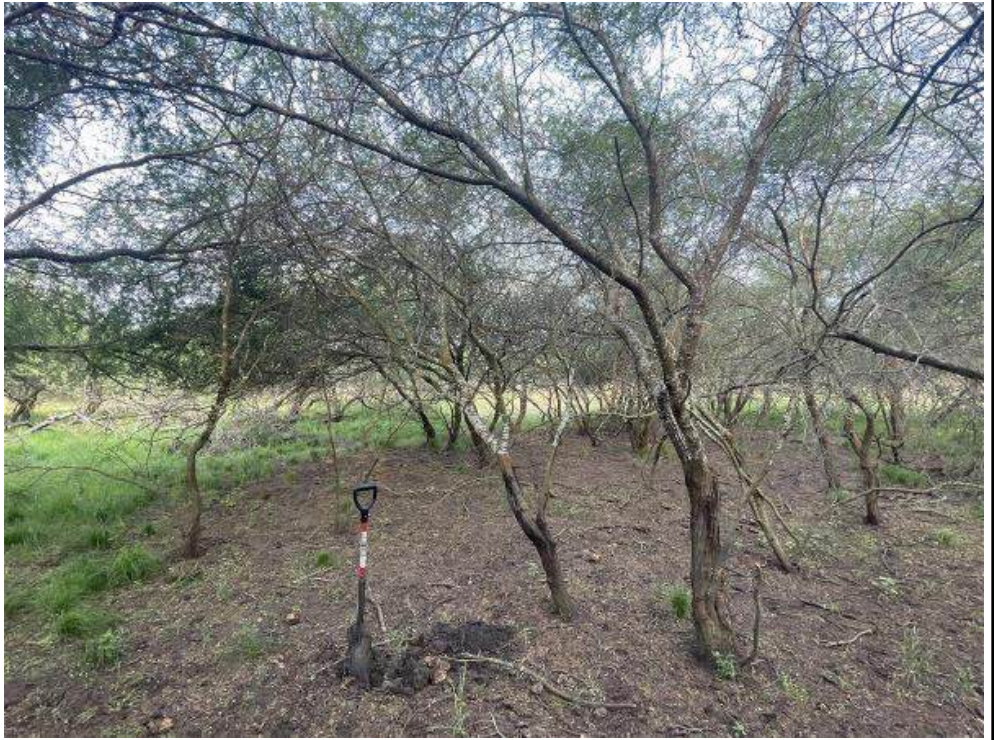
<b>Client:</b>	<b>Hidalgo County Drainage District No. 1</b>	<b>Project:</b>	<b>Raymondville Drain Project</b>
<b>Report:</b>	<b>Wetland Delineation Report</b>	<b>Site Location:</b>	<b>Hidalgo and Willacy County, Texas</b>
<b>Photograph ID: 1</b>

<b>Latitude/Longitude:</b> 26.5093377, -97.5243449			
<b>Photo Direction:</b> north			
<b>Description:</b> DP 001 (Upland)			
<b>Photograph ID: 2</b>

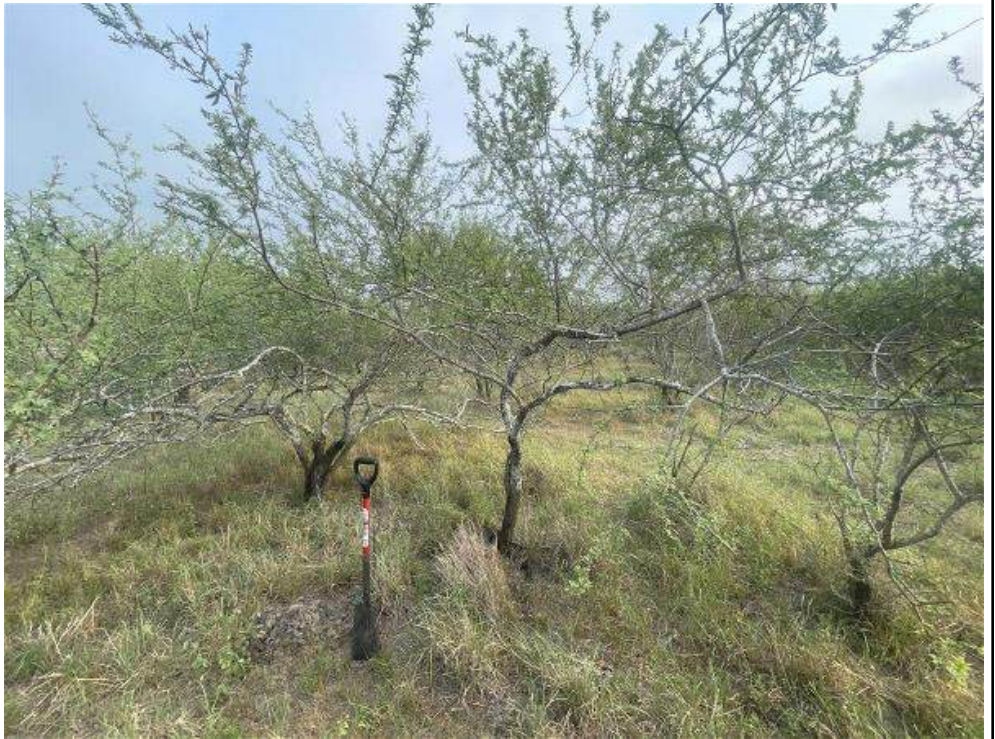
<b>Latitude/Longitude:</b> 26.51076852, -97.52488266			
<b>Photo Direction:</b> northeast			
<b>Description:</b> DP 002 (Upland)

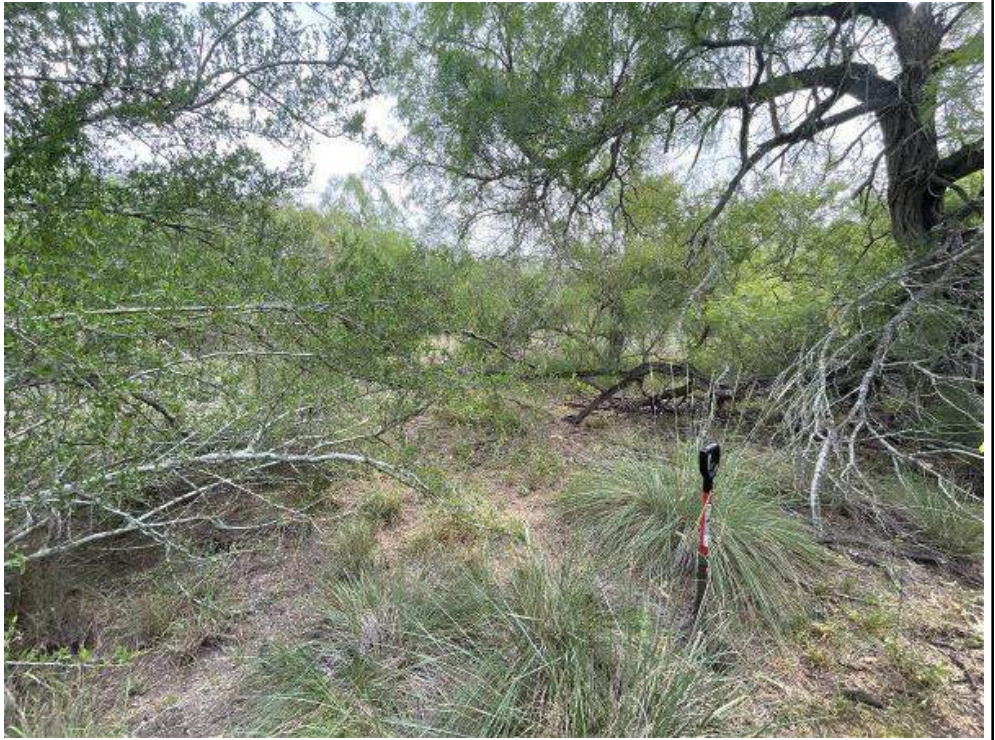
<b>Client:</b>	<b>Hidalgo County Drainage District No. 1</b>	<b>Project:</b>	<b>Raymondville Drain Project</b>
<b>Report:</b>	<b>Wetland Delineation Report</b>	<b>Site Location:</b>	<b>Hidalgo and Willacy County, Texas</b>
<b>Photograph ID: 3</b>

<b>Latitude/Longitude:</b> 26.51554771, -97.52136333			
<b>Photo Direction:</b> west			
<b>Description:</b> DP 003 (Upland)			
<b>Photograph ID: 4</b>

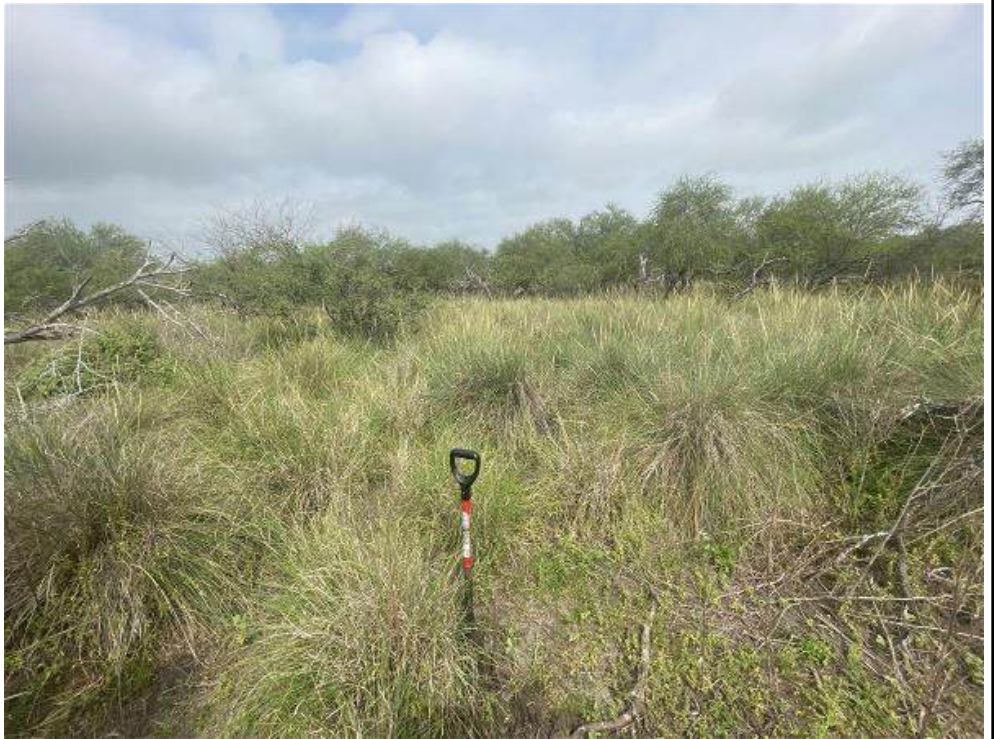
<b>Latitude/Longitude:</b> 26.52218032, -97.51600061			
<b>Photo Direction:</b> north			
<b>Description:</b> DP 004 (Upland)

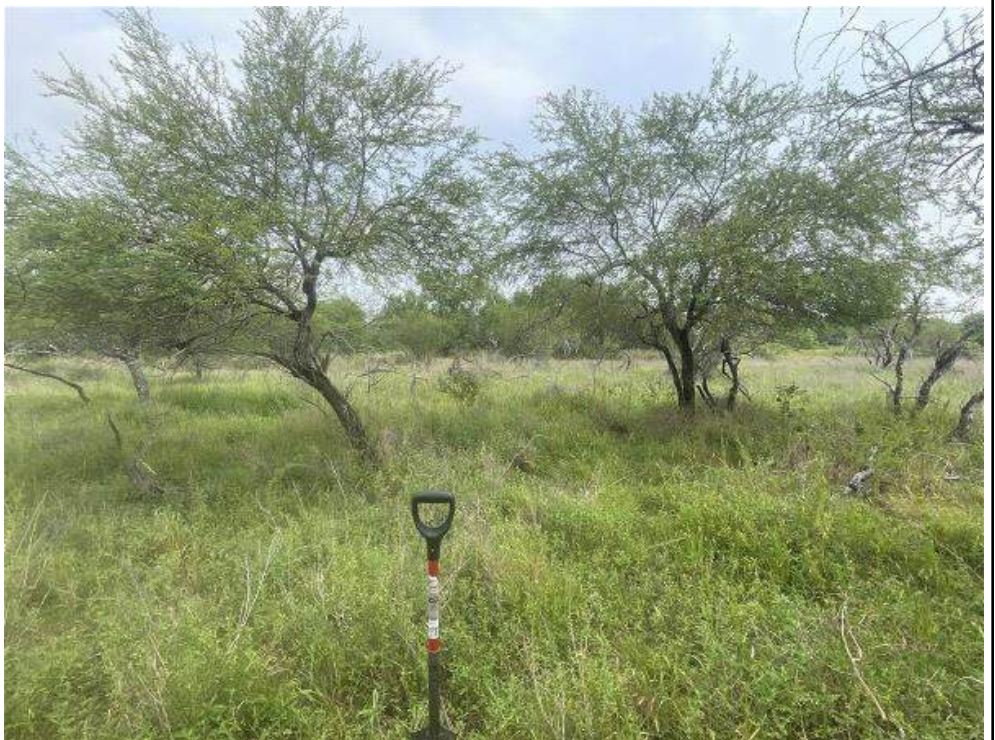
<b>Client:</b>	<b>Hidalgo County Drainage District No. 1</b>	<b>Project:</b>	<b>Raymondville Drain Project</b>
<b>Report:</b>	<b>Wetland Delineation Report</b>	<b>Site Location:</b>	<b>Hidalgo and Willacy County, Texas</b>
<b>Photograph ID: 5</b>

<b>Latitude/Longitude:</b> 26.52555406, -97.51367136			
<b>Photo Direction:</b> northwest			
<b>Description:</b> DP 005 (Upland)			
<b>Photograph ID: 6</b>

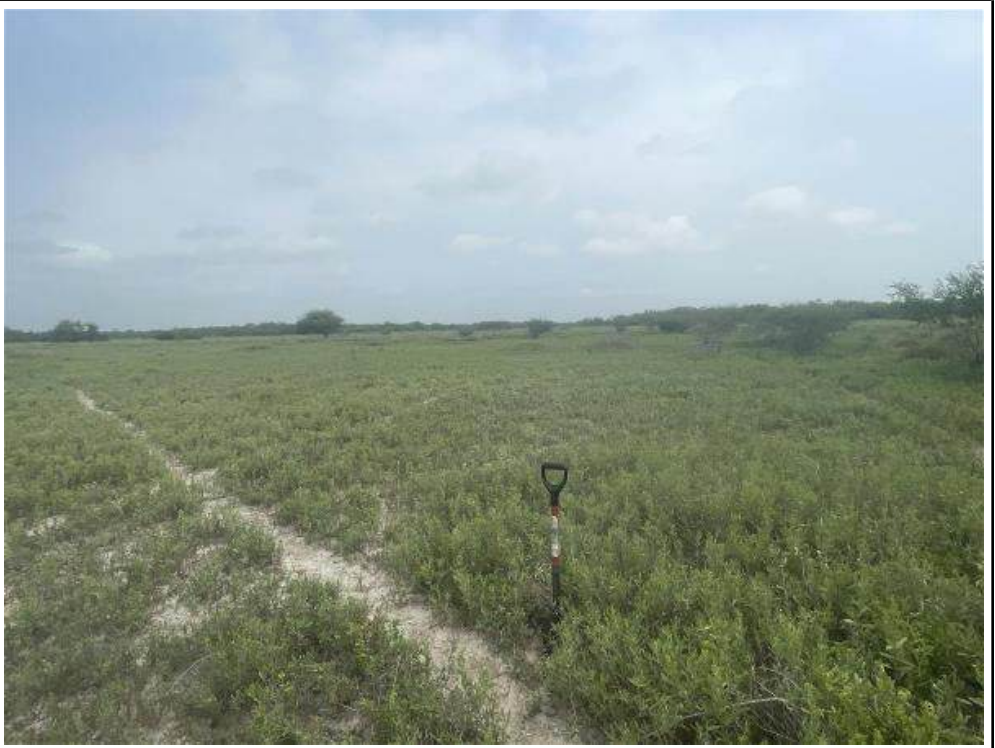
<b>Latitude/Longitude:</b> 26.52814781, -97.50901358			
<b>Photo Direction:</b> south			
<b>Description:</b> DP 006 (Wetland) at W001

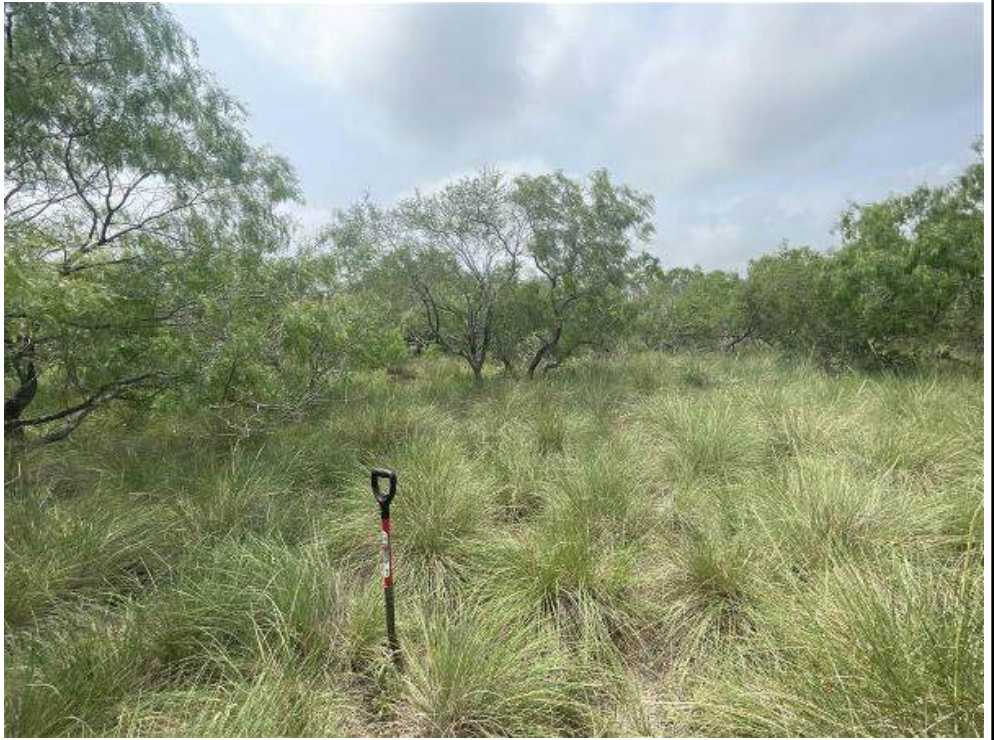
<b>Client:</b>	<b>Hidalgo County Drainage District No. 1</b>	<b>Project:</b>	<b>Raymondville Drain Project</b>
<b>Report:</b>	<b>Wetland Delineation Report</b>	<b>Site Location:</b>	<b>Hidalgo and Willacy County, Texas</b>
<b>Photograph ID: 7</b>

<b>Latitude/Longitude:</b> 26.52792849, -97.50935289			
<b>Photo Direction:</b> southeast			
<b>Description:</b> DP 007 (Upland)			
<b>Photograph ID: 8</b>
