## **Delineation Report**

Raymondville Drain Project  
Hidalgo and Willacy Counties, Texas

December 11, 2024

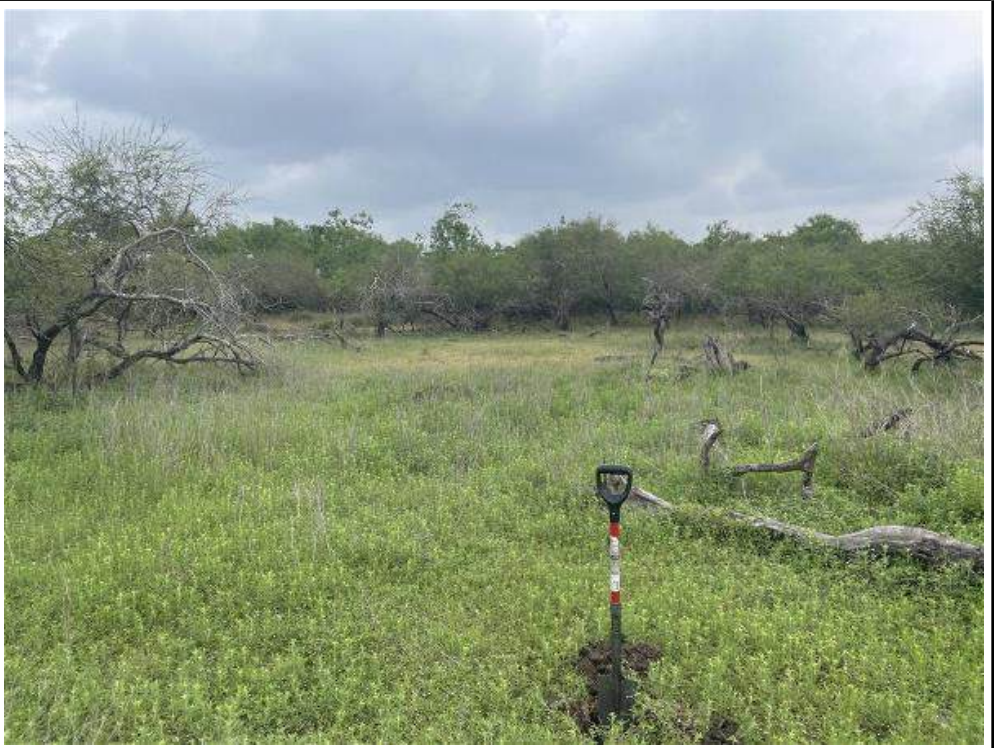
<b>Latitude/Longitude:</b> 26.50746811, -97.52325025			
<b>Photo Direction:</b> north			
<b>Description:</b> DP 016 (Wetland) at W002

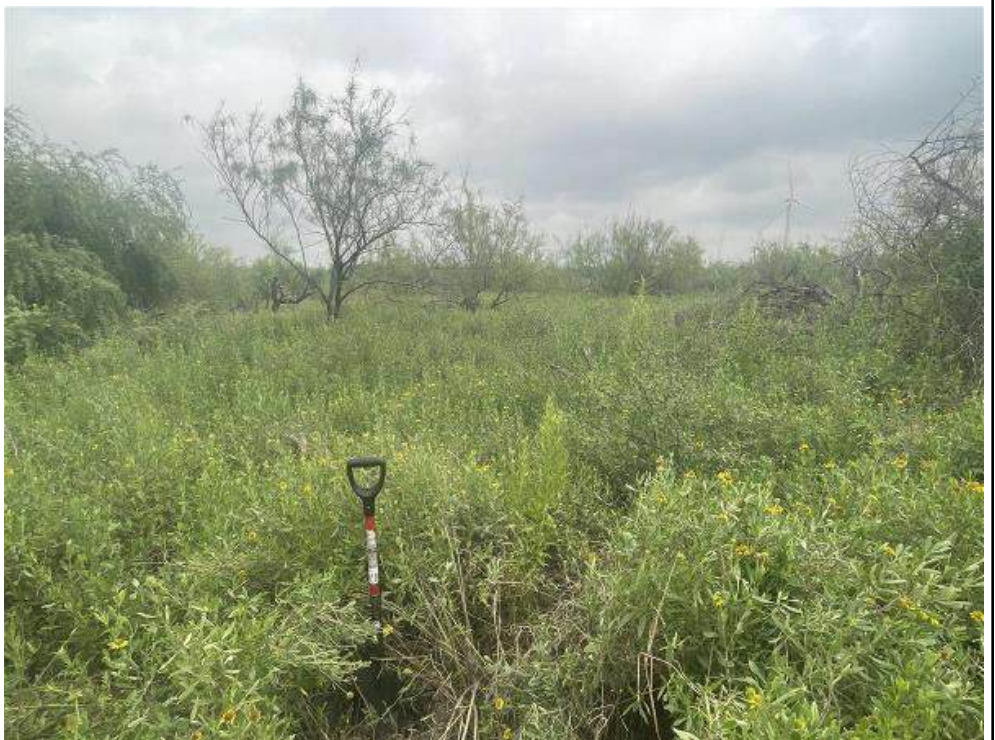
<b>Client:</b>	<b>Hidalgo County Drainage District No. 1</b>	<b>Project:</b>	<b>Raymondville Drain Project</b>
<b>Report:</b>	<b>Wetland Delineation Report</b>	<b>Site Location:</b>	<b>Hidalgo and Willacy County, Texas</b>
<b>Photograph ID: 21</b>

<b>Latitude/Longitude:</b> 26.51390049, -97.61365692			
<b>Photo Direction:</b> north			
<b>Description:</b> DP 021 (Wetland) at W007			
<b>Photograph ID: 22</b>

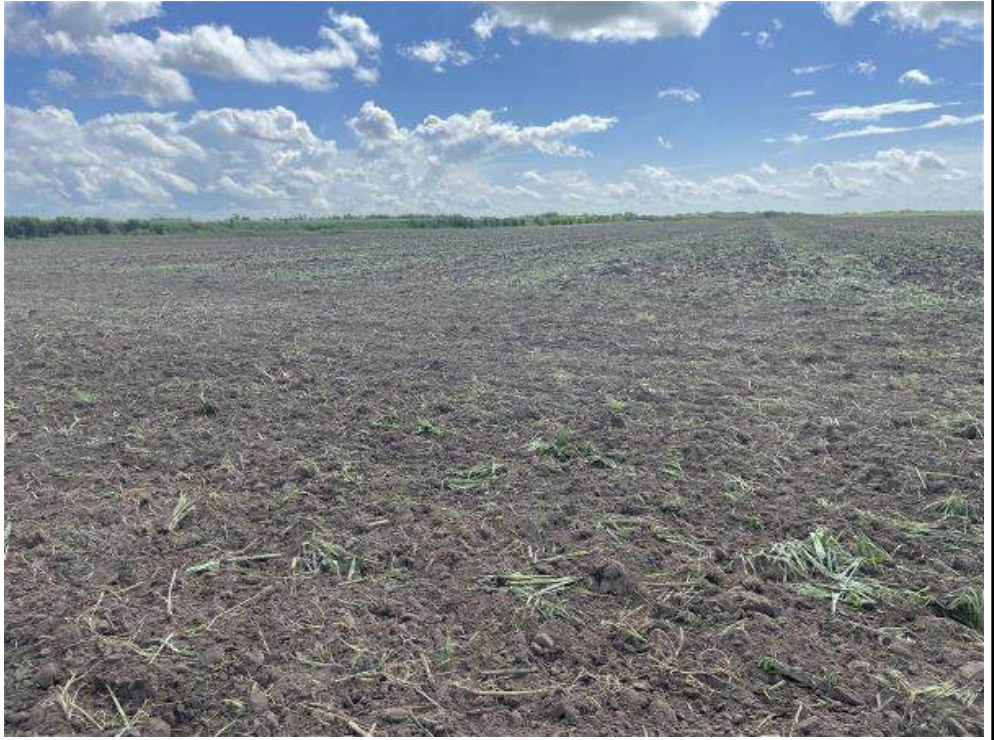
<b>Latitude/Longitude:</b> 26.47341306, -97.92550681			
<b>Photo Direction:</b> southeast			
<b>Description:</b> DP 040 (Upland)

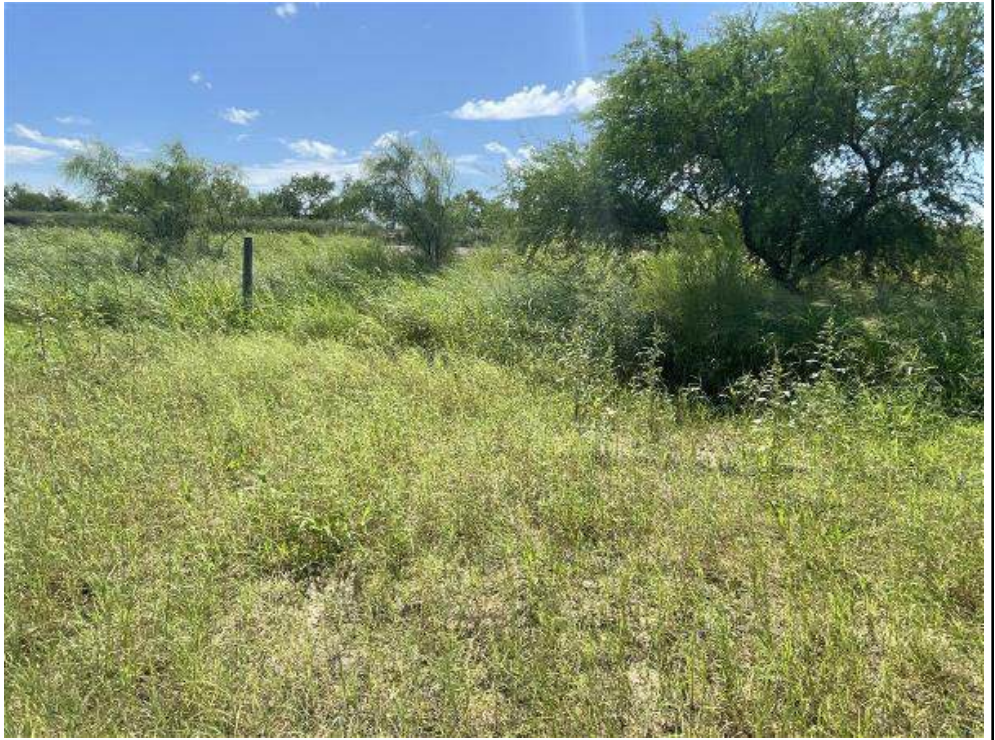
<b>Latitude/Longitude:</b> 26.47253396, -97.93076428			
<b>Photo Direction:</b> east			
<b>Description:</b> DP 041 (Upland)			
<b>Photograph ID: 42</b>

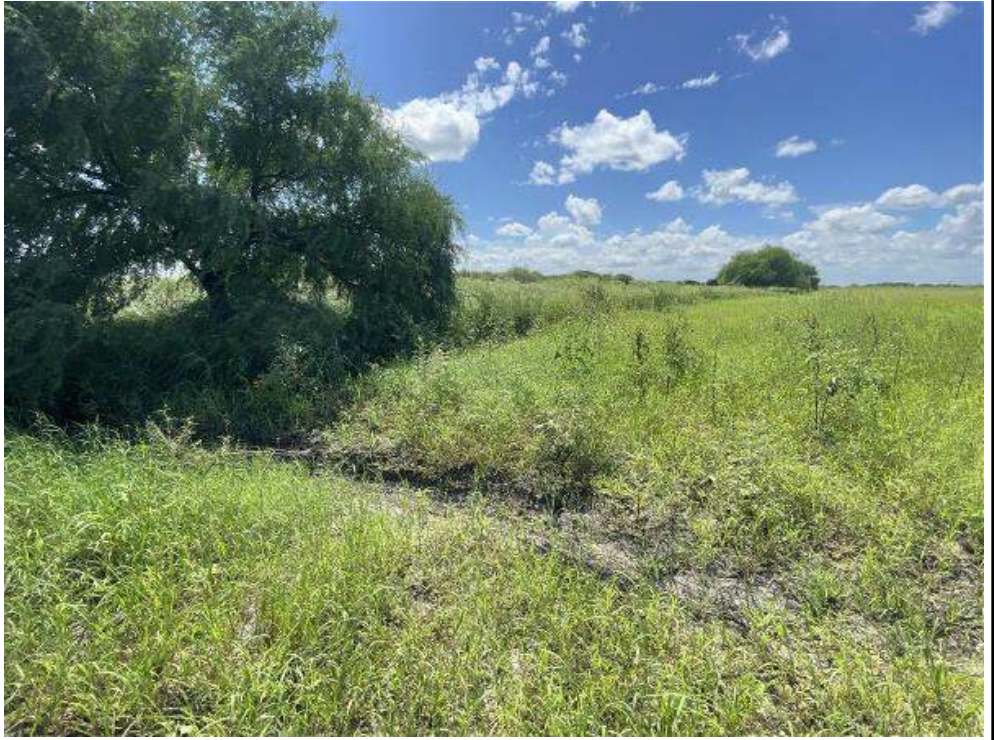
<b>Latitude/Longitude:</b> 26.47512168, -97.93407658			
<b>Photo Direction:</b> east			
<b>Description:</b> DP 042 (Upland)

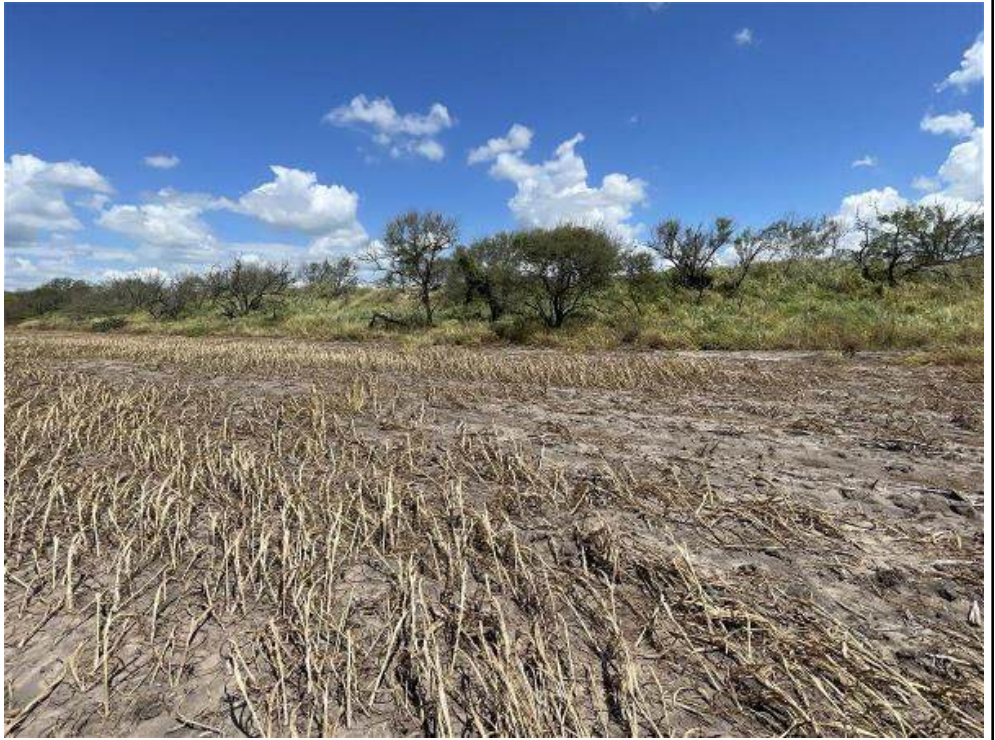
<b>Latitude/Longitude:</b> 26.47853015, -97.96110353			
<b>Photo Direction:</b> north			
<b>Description:</b> DP 043 (Upland)			
<b>Photograph ID: 44</b>

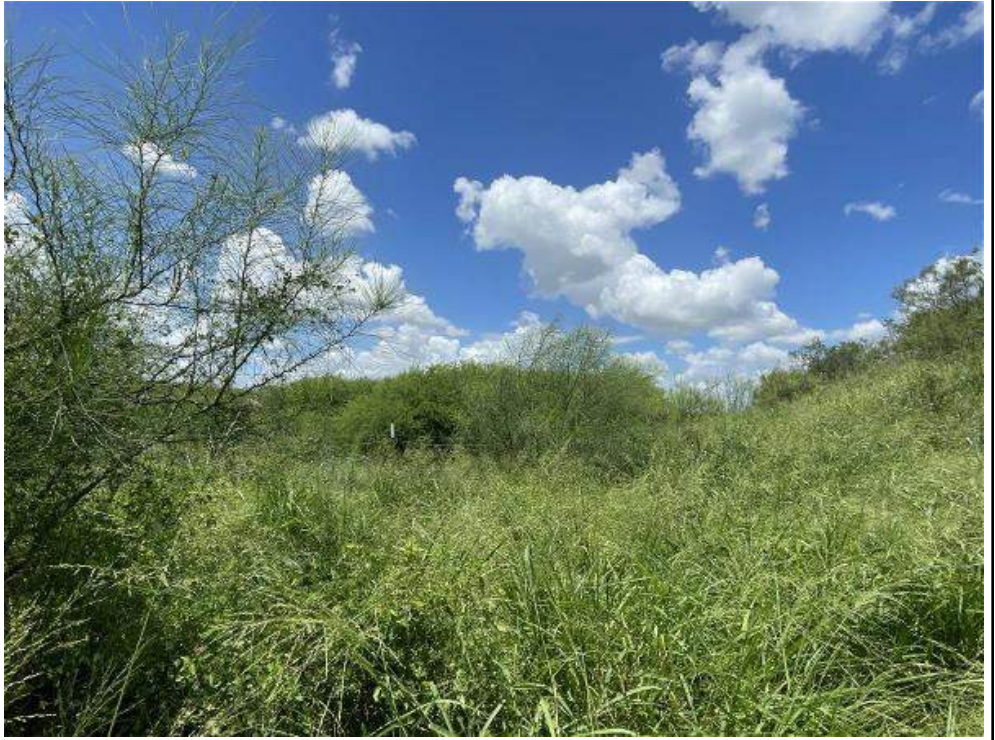
<b>Latitude/Longitude:</b> 26.47944335, -97.96644976			
<b>Photo Direction:</b> west			
<b>Description:</b> DP 044 (Upland)

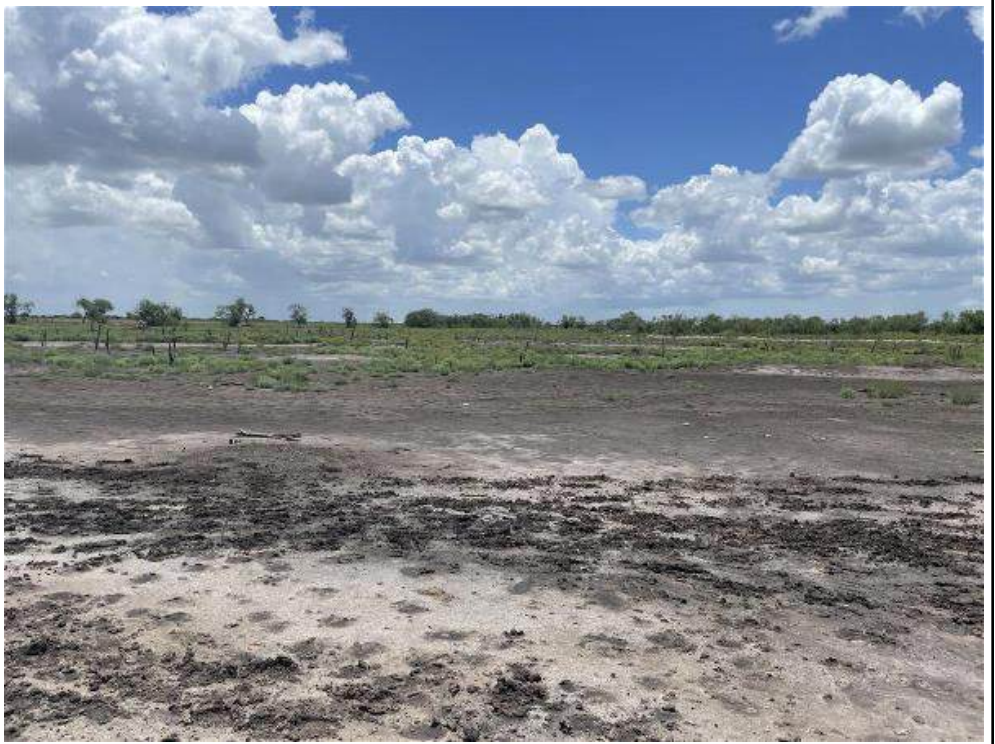
<b>Latitude/Longitude:</b> 26.48309629, -97.98785111			
<b>Photo Direction:</b> southeast			
<b>Description:</b> DP 045 (Wetland) at W014			
<b>Photograph ID: 46</b>

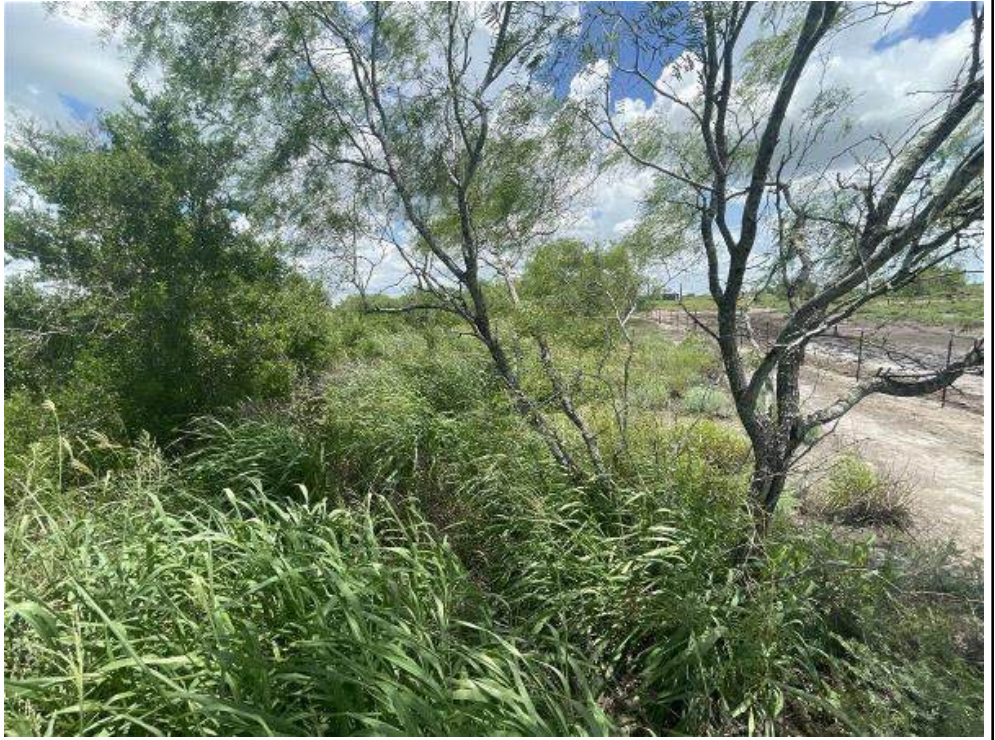
<b>Latitude/Longitude:</b> 26.48328428, -97.98782702			
<b>Photo Direction:</b> southeast			
<b>Description:</b> DP 046 (Upland)

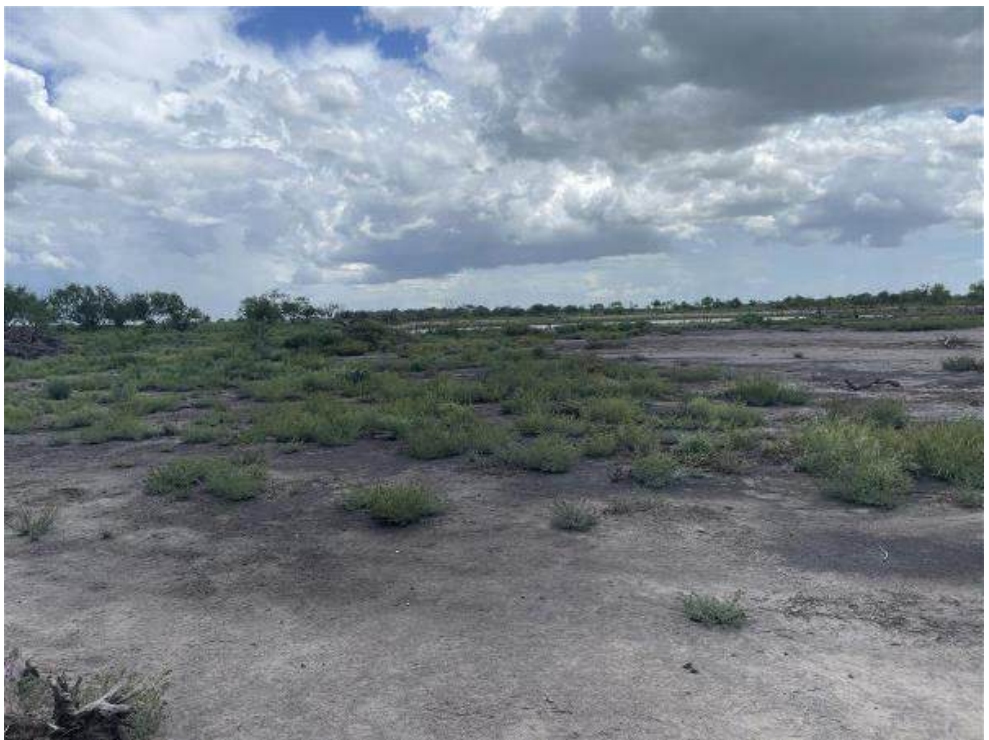
<b>Latitude/Longitude:</b> 26.48171674, -97.99529972			
<b>Photo Direction:</b> south			
<b>Description:</b> DP 047 (Wetland) at W015			
<b>Photograph ID: 48</b>

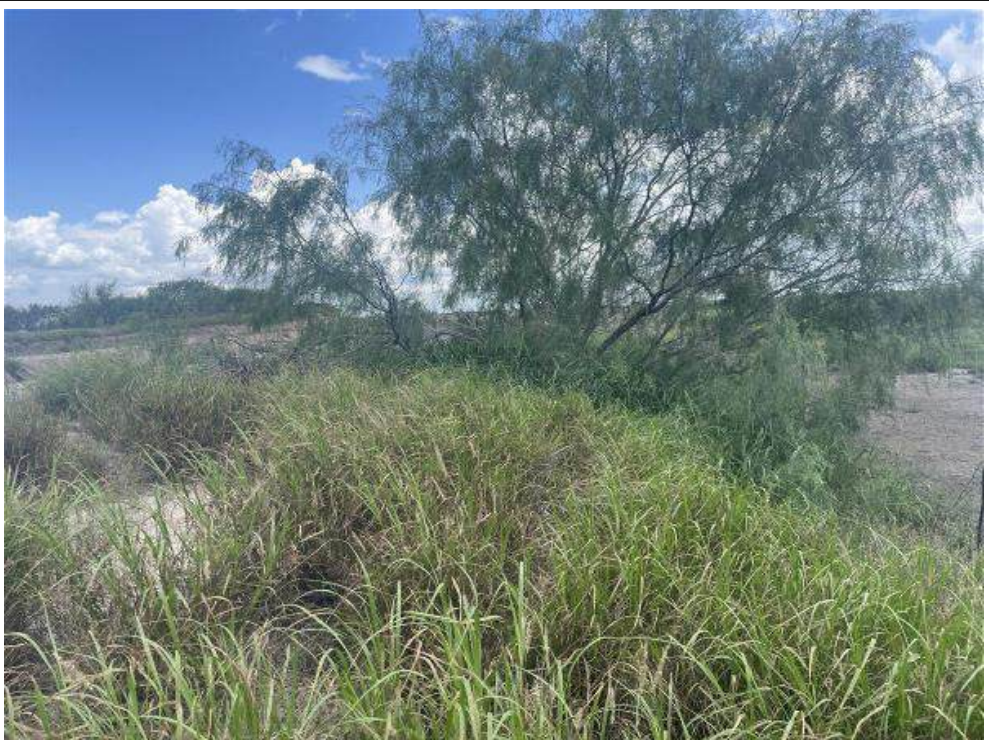
<b>Latitude/Longitude:</b> 26.48193109, -97.99535973			
<b>Photo Direction:</b> east			
<b>Description:</b> DP 048 (Upland)

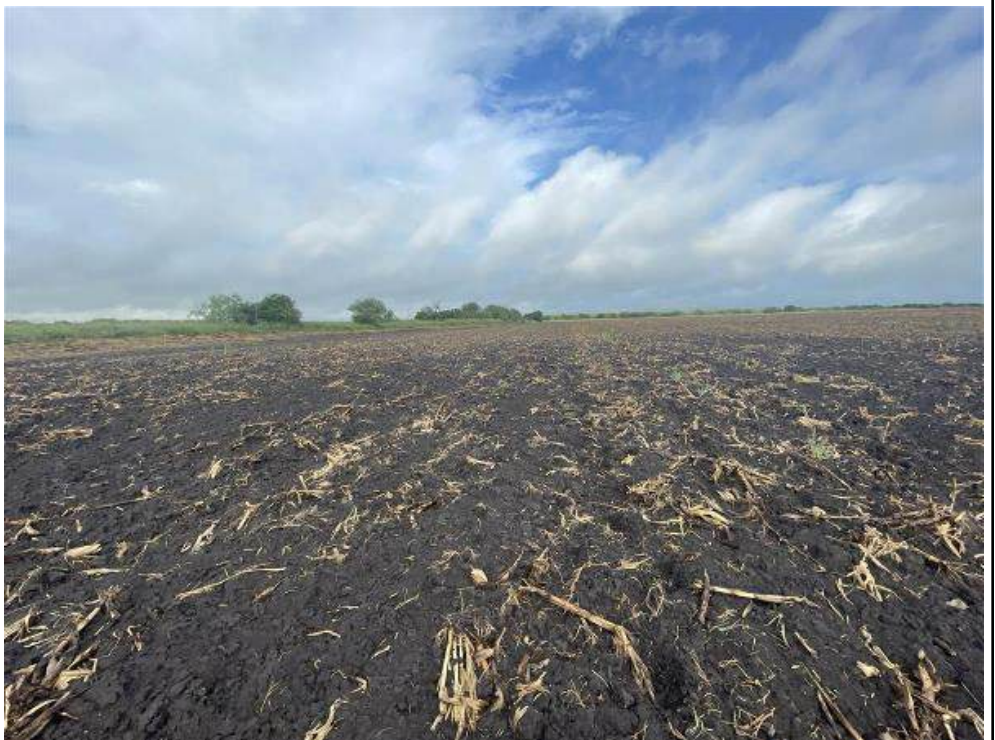
<b>Latitude/Longitude:</b> 26.45453726, -98.05143783			
<b>Photo Direction:</b> west			
<b>Description:</b> DP 049 (upland)			
<b>Photograph ID:</b> 50

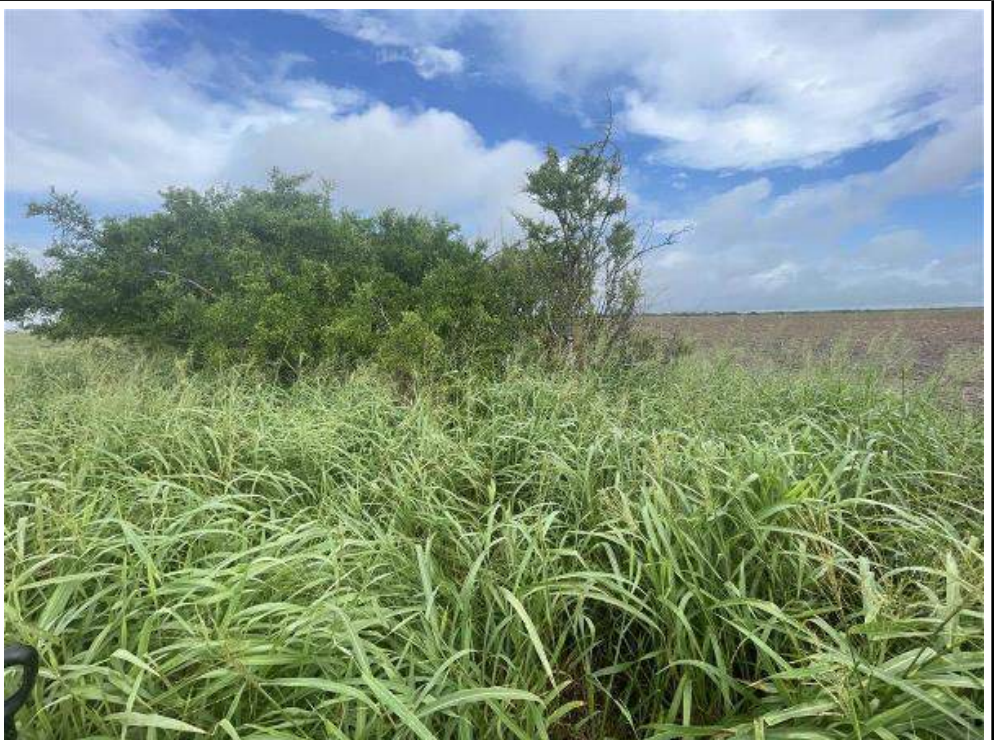
<b>Latitude/Longitude:</b> 26.45443423, -98.05262598			
<b>Photo Direction:</b> northwest			
<b>Description:</b> DP 050 (Upland)

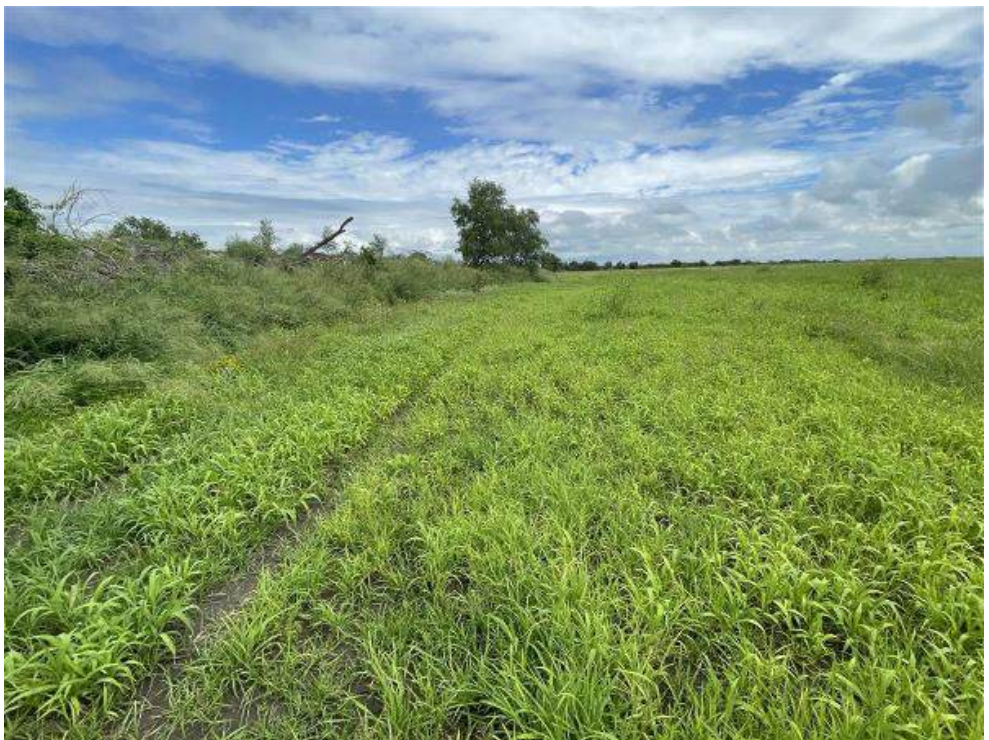
<b>Latitude/Longitude:</b> 26.48338004, -98.02744389			
<b>Photo Direction:</b> north			
<b>Description:</b> DP 051 (Upland)			
<b>Photograph ID: 52</b>

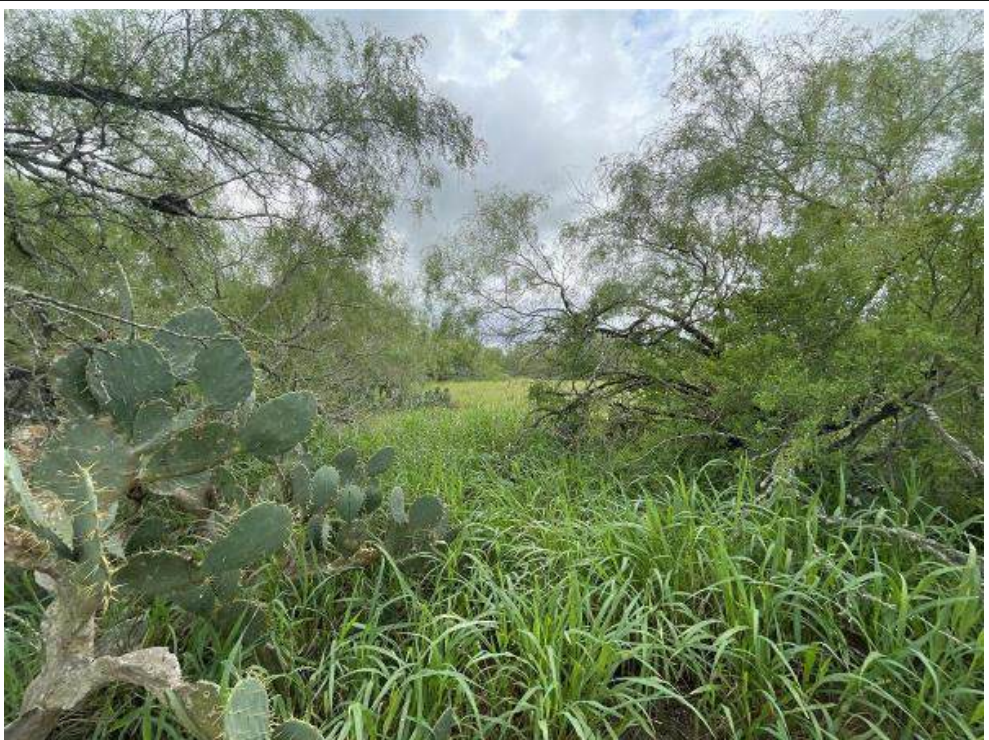
<b>Latitude/Longitude:</b> 26.45272975, -98.03514715			
<b>Photo Direction:</b> south			
<b>Description:</b> DP 052 (Upland)

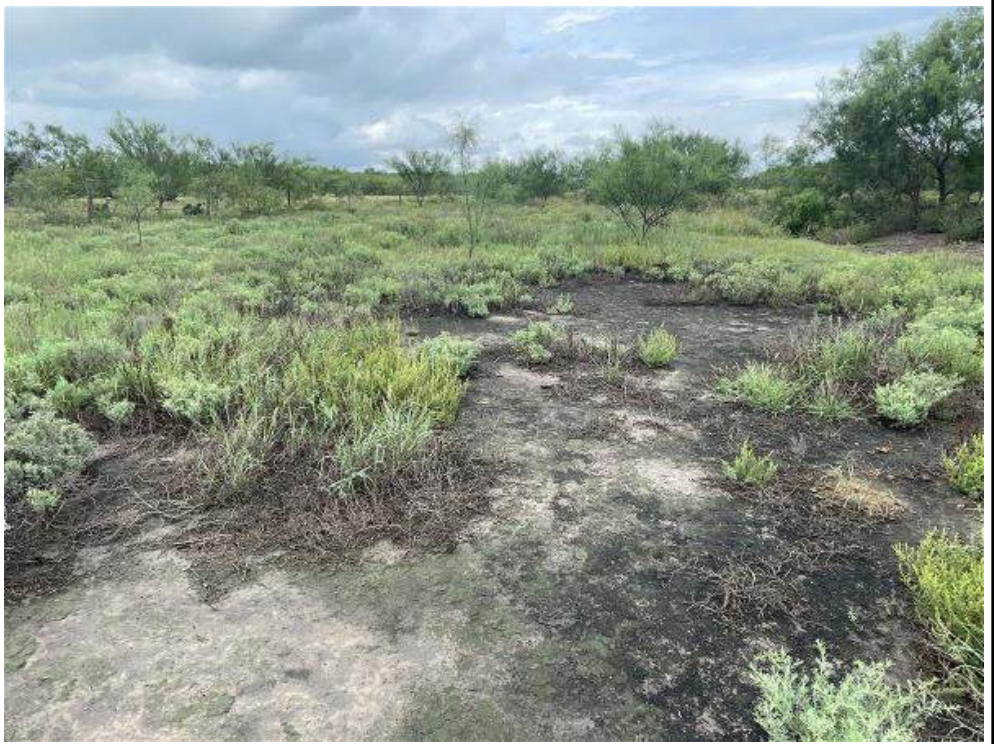
<b>Latitude/Longitude:</b> 26.45133099, -98.03491771			
<b>Photo Direction:</b> west			
<b>Description:</b> DP 053 (Wetland) at W022			
<b>Photograph ID: 54</b>

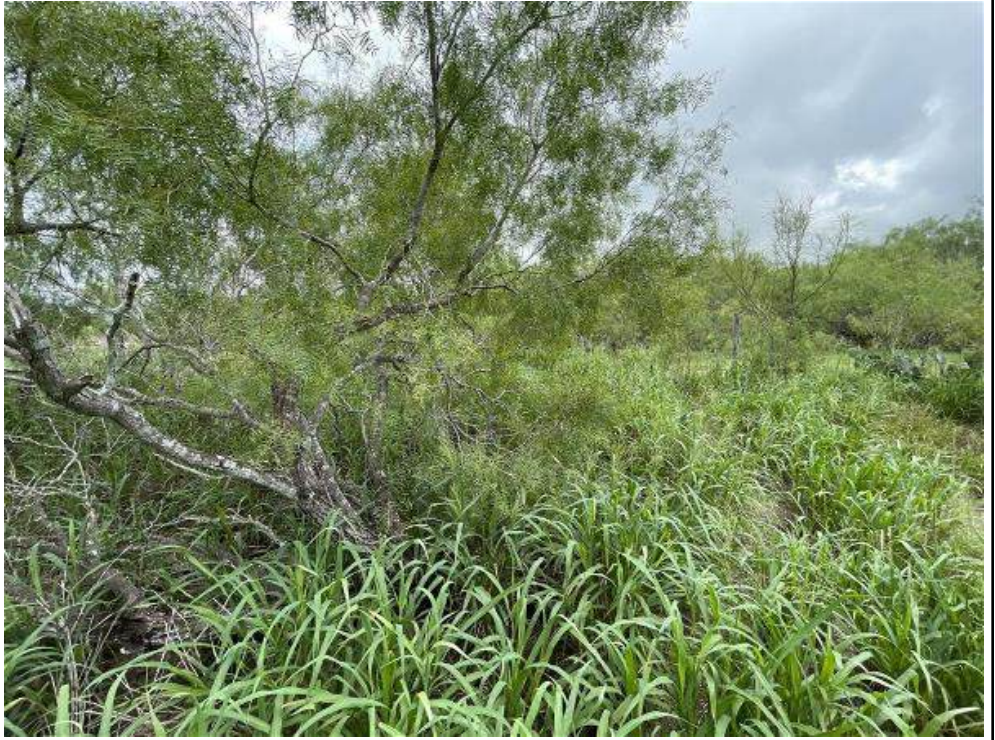
<b>Latitude/Longitude:</b> 26.45116135, -98.03468616			
<b>Photo Direction:</b> east			
<b>Description:</b> DP 054 (Upland)

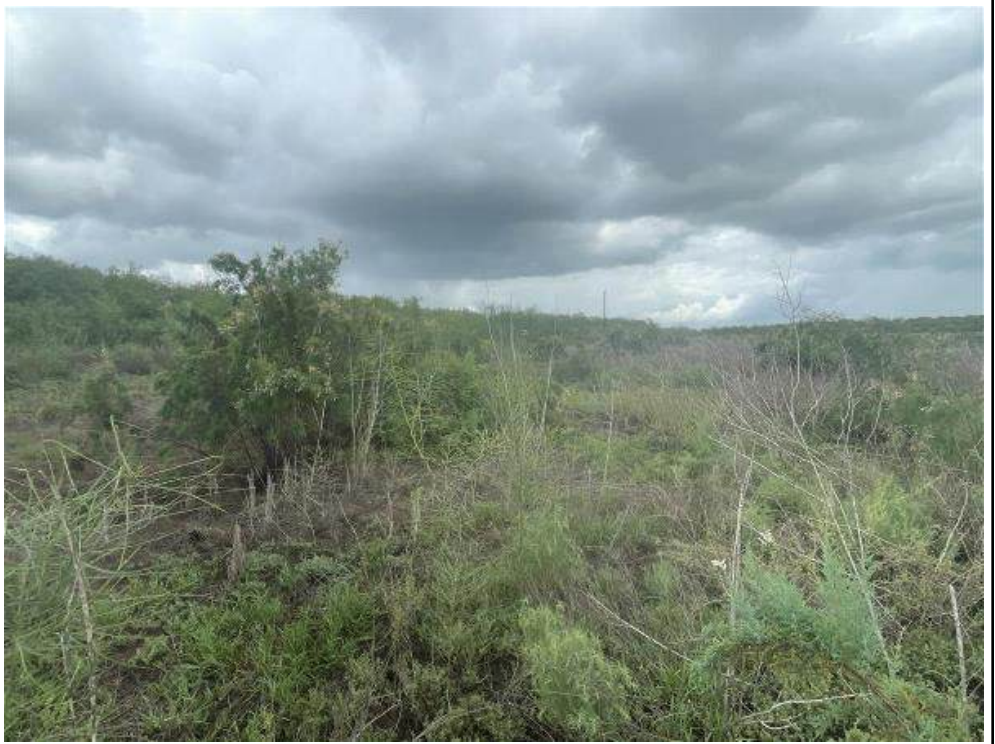
<b>Latitude/Longitude:</b> 26.45307626, -98.04111871			
<b>Photo Direction:</b> north			
<b>Description:</b> DP 055 (Wetland) at W023			
<b>Photograph ID: 56</b>

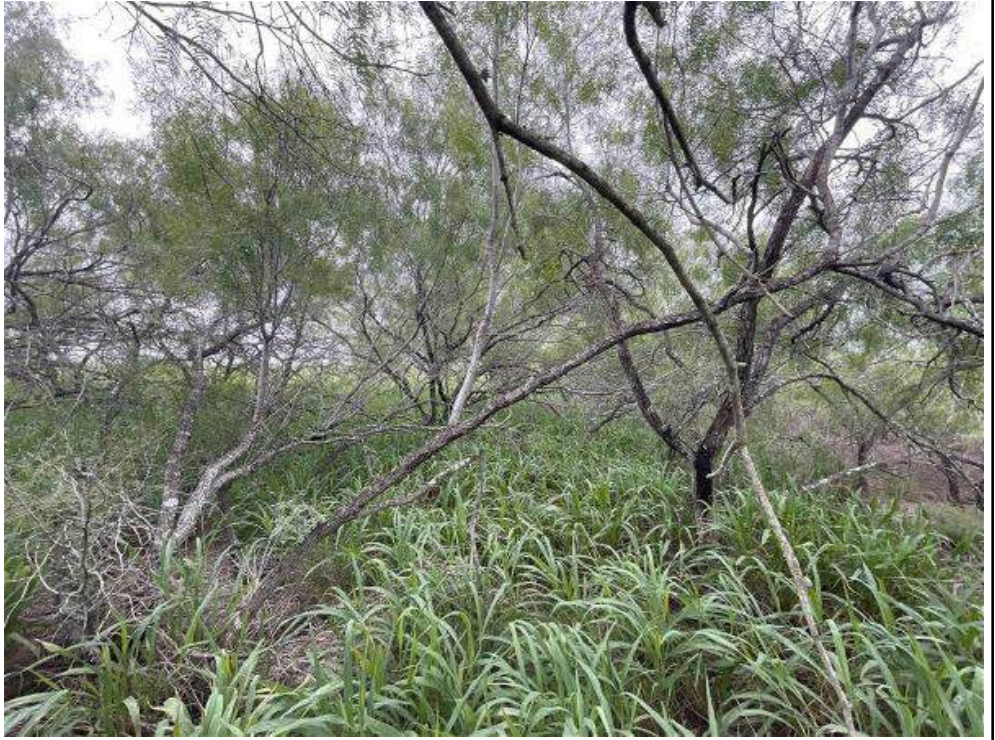
<b>Latitude/Longitude:</b> 26.4531614, -98.04140074			
<b>Photo Direction:</b> north			
<b>Description:</b> DP 056 (Upland)

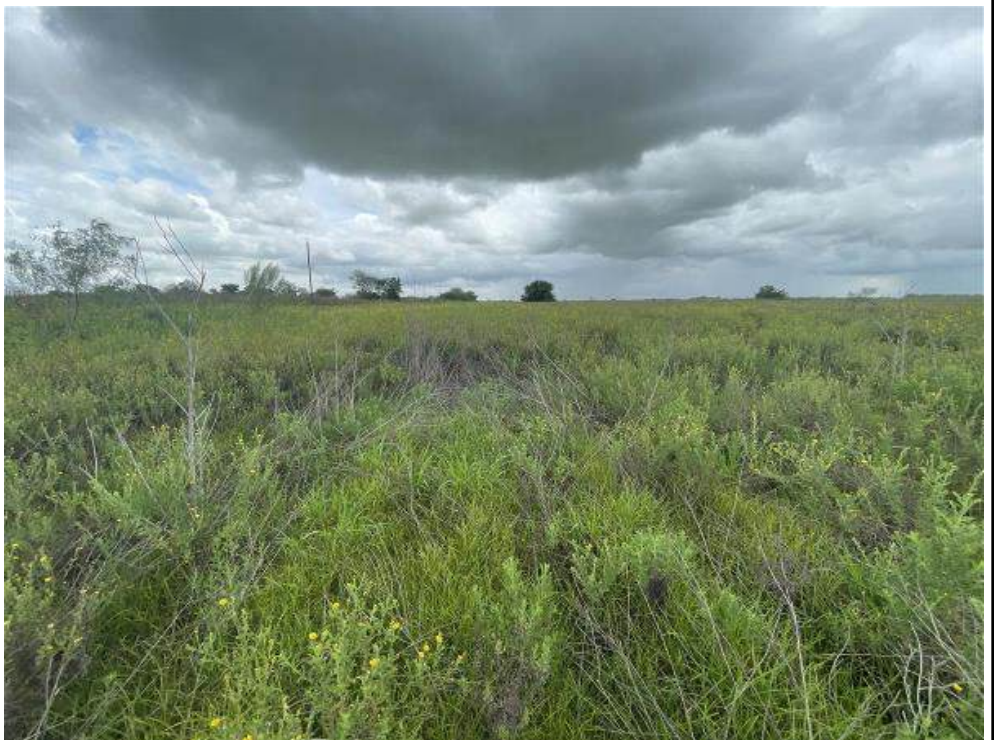
<b>Latitude/Longitude:</b> 26.4540876, -98.0444312			
<b>Photo Direction:</b> south			
<b>Description:</b> DP 057 (Upland)			
<b>Photograph ID: 58</b>

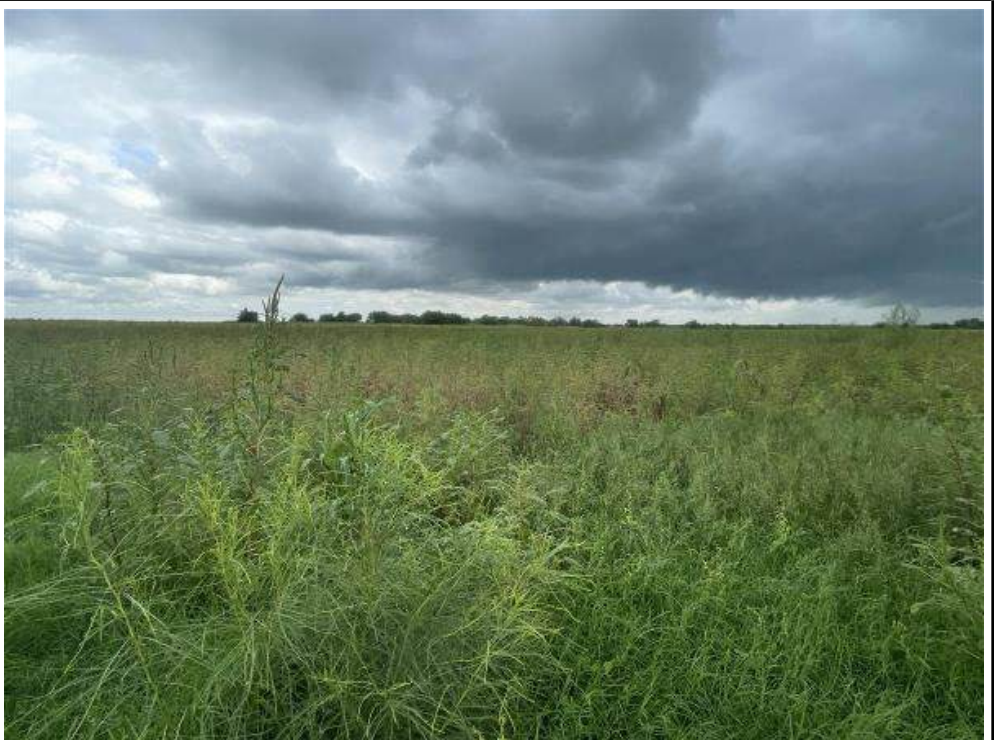
<b>Latitude/Longitude:</b> 26.44007276, -98.05622423			
<b>Photo Direction:</b> south			
<b>Description:</b> DP 058 (Upland)

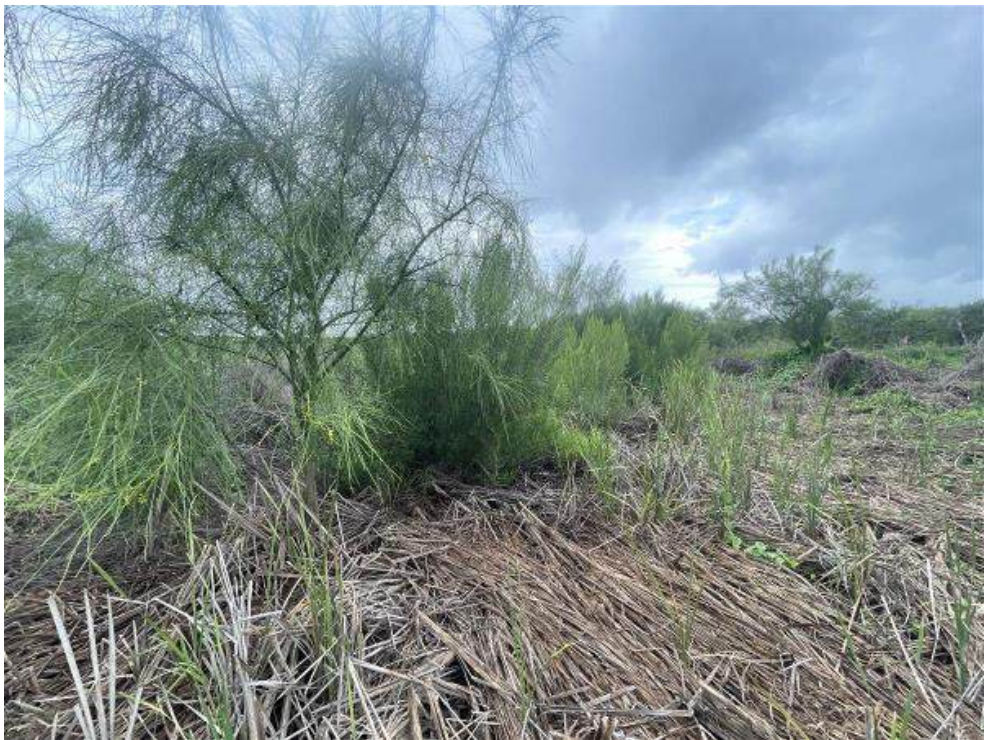
<b>Latitude/Longitude:</b> 26.44021715, -98.05615023			
<b>Photo Direction:</b> east			
<b>Description:</b> DP 059 (Wetland) at W025			
<b>Photograph ID: 60</b>

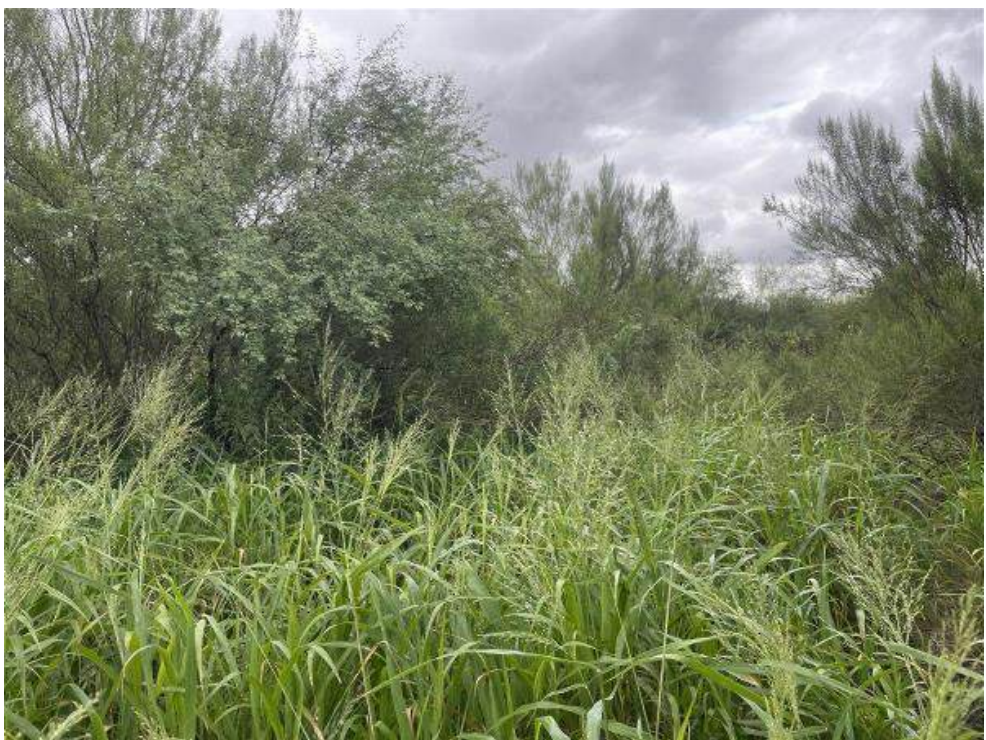
<b>Latitude/Longitude:</b> 26.44195163, -98.0548886			
<b>Photo Direction:</b> east			
<b>Description:</b> DP 060 (Upland)

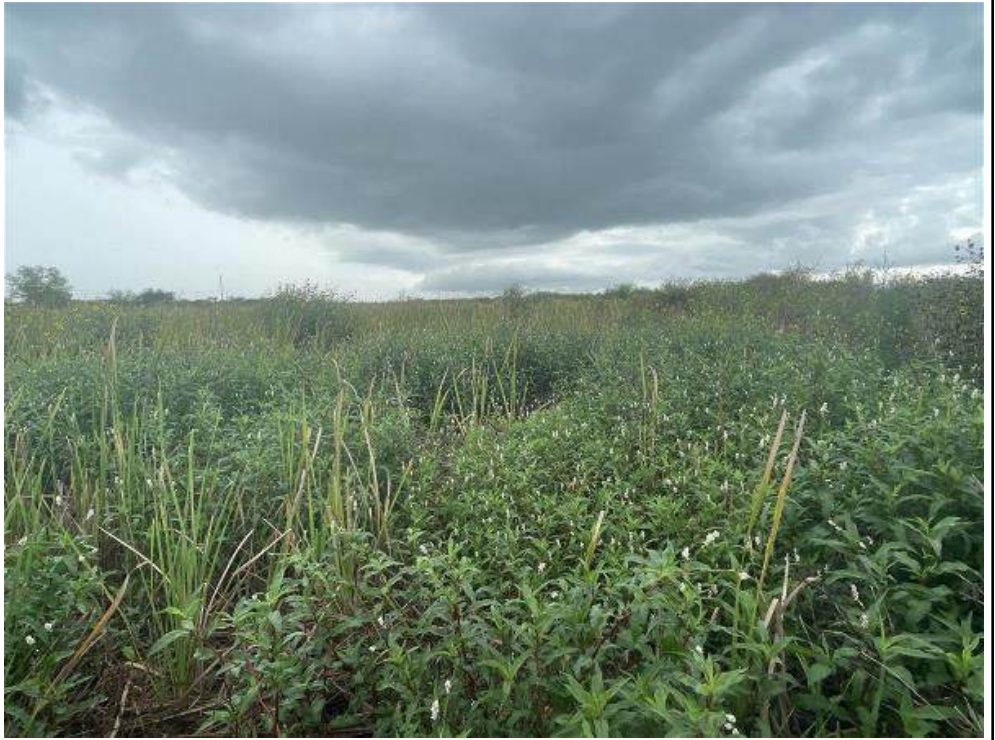
<b>Latitude/Longitude:</b> 26.44198148, -98.05523048			
<b>Photo Direction:</b> west			
<b>Description:</b> DP 061 (Wetland) at W024			
<b>Photograph ID: 62</b>

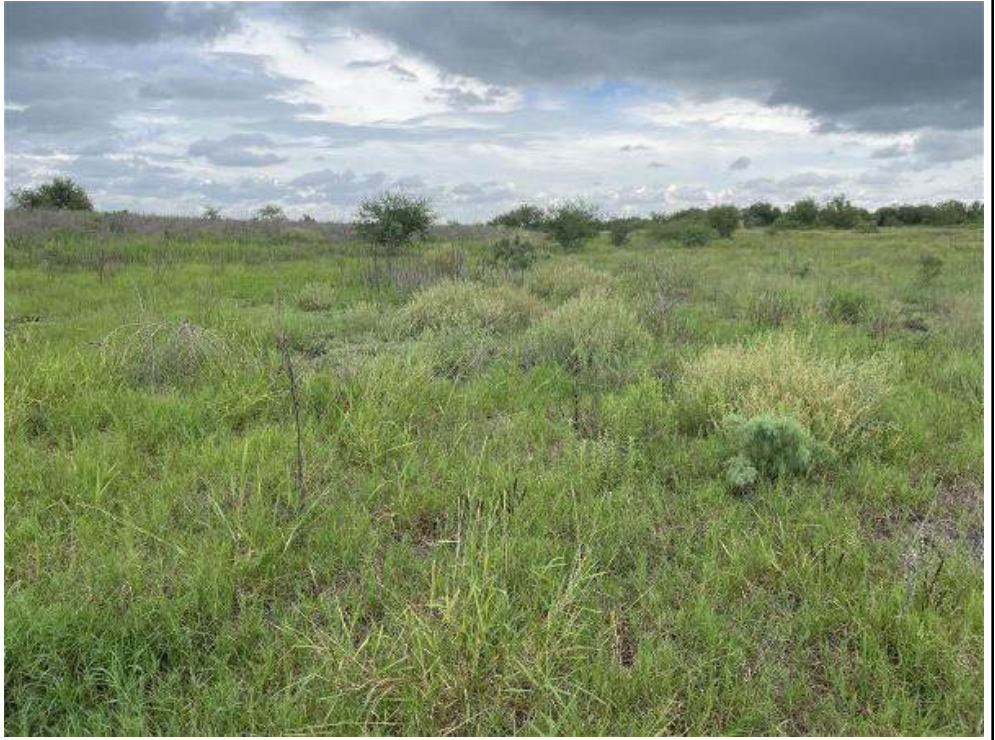
<b>Latitude/Longitude:</b> 26.43535635, -98.05707299			
<b>Photo Direction:</b> east			
<b>Description:</b> DP 062 (Upland)

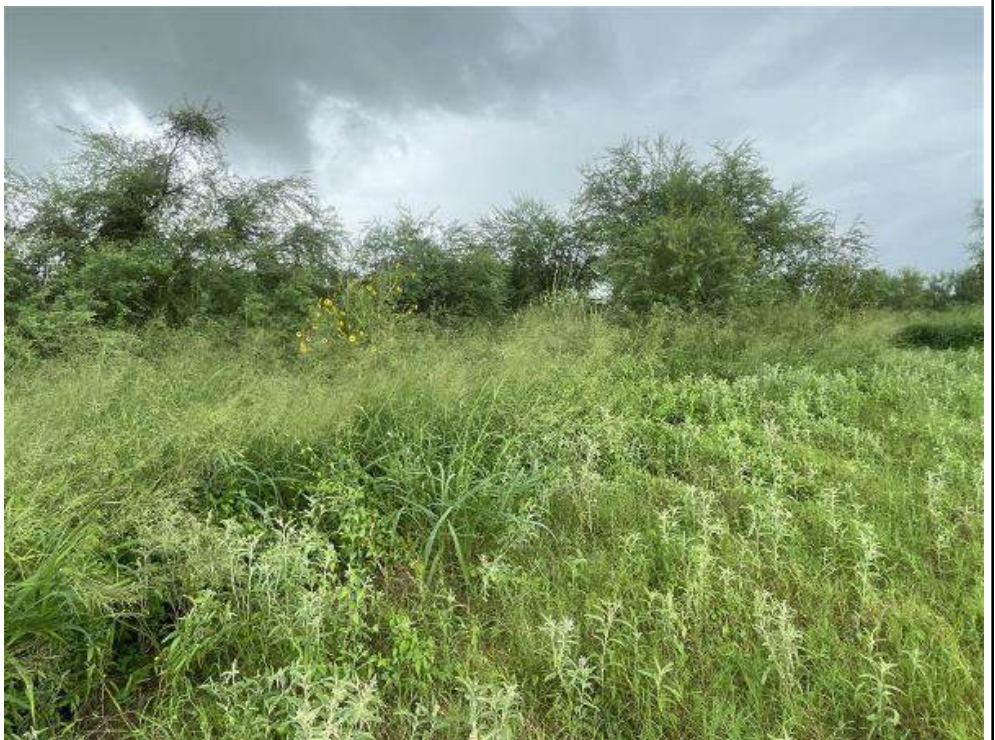
<b>Latitude/Longitude:</b> 26.42682686, -98.05653679			
<b>Photo Direction:</b> northwest			
<b>Description:</b> DP 063 (Upland)			
<b>Photograph ID: 64</b>

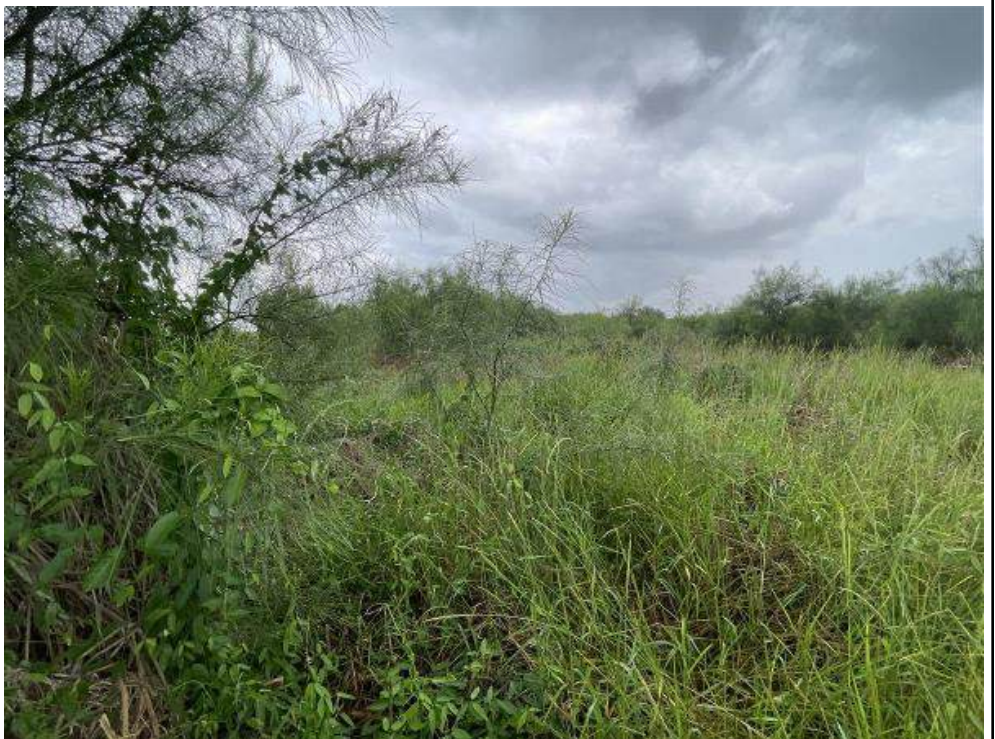
<b>Latitude/Longitude:</b> 26.42691068, -98.05670746			
<b>Photo Direction:</b> south			
<b>Description:</b> DP 064 (Wetland) at W029

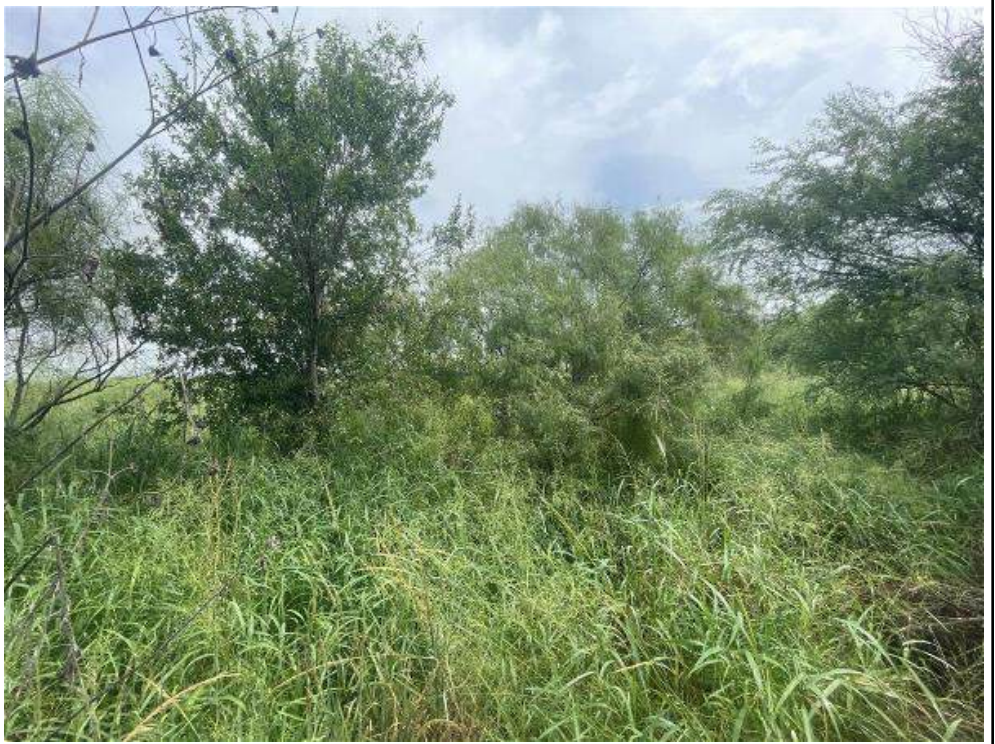
<b>Latitude/Longitude:</b> 26.42604761, -98.05756799			
<b>Photo Direction:</b> south			
<b>Description:</b> DP 065 (Upland)			
<b>Photograph ID: 66</b>

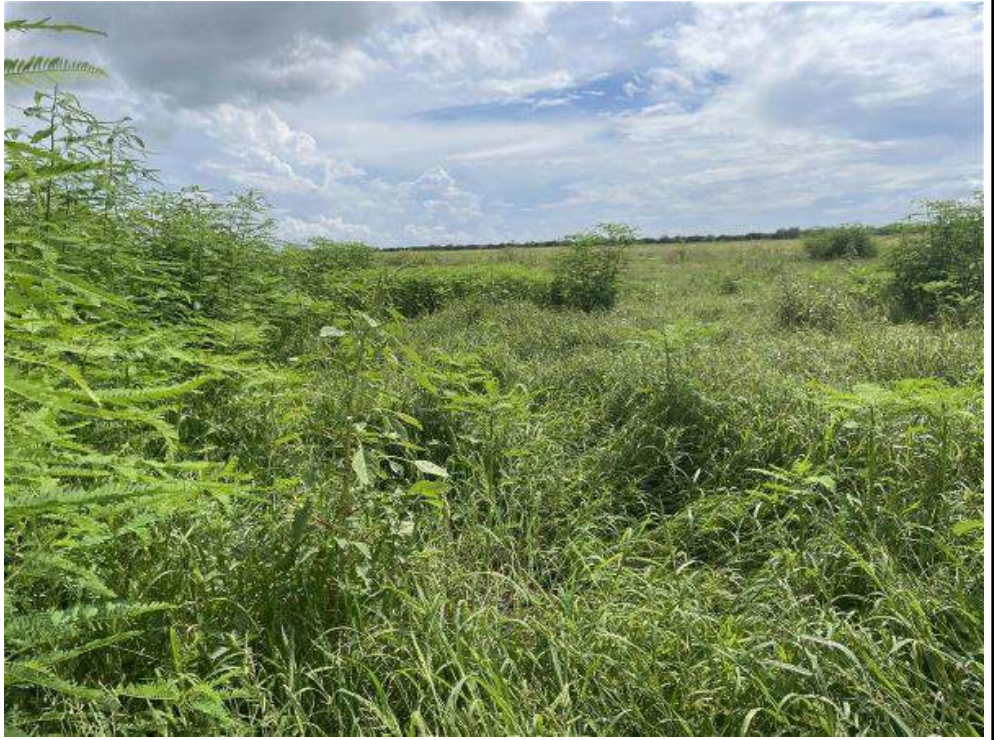
<b>Latitude/Longitude:</b> 26.42418867, -98.05809074			
<b>Photo Direction:</b> south			
<b>Description:</b> DP 066 (Upland)
