## **Delineation Report**

Raymondville Drain Project  
Hidalgo and Willacy Counties, Texas

December 11, 2024

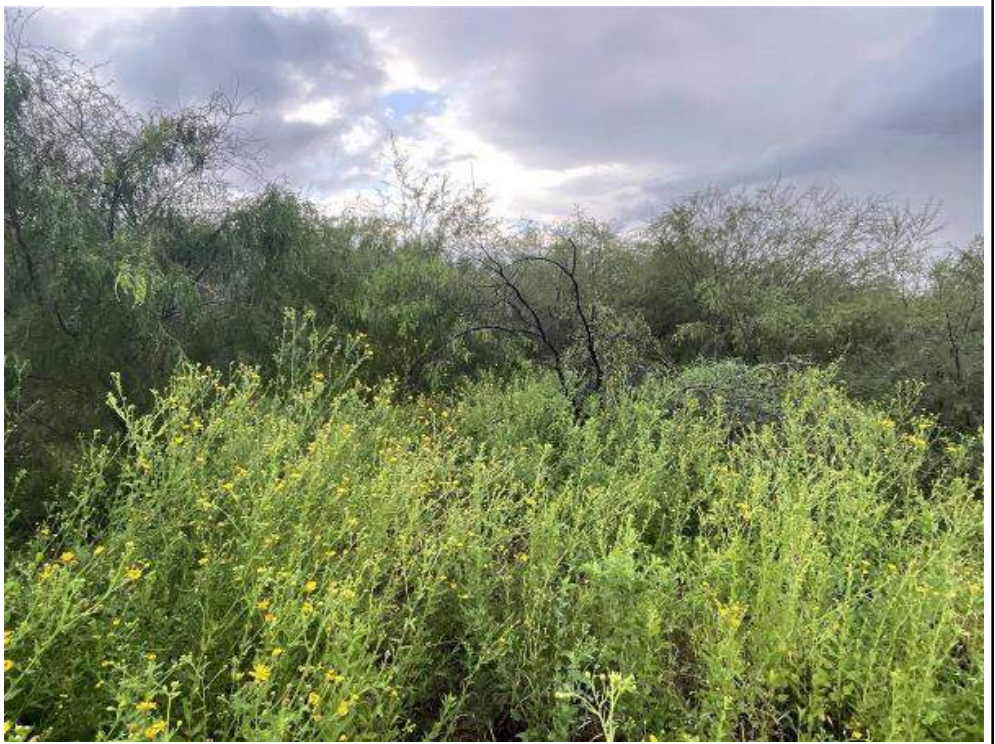
<b>Latitude/Longitude:</b> 26.41697699, -98.10902083			
<b>Photo Direction:</b> north			
<b>Description:</b> DP 067 (Upland)			
<b>Photograph ID: 68</b>

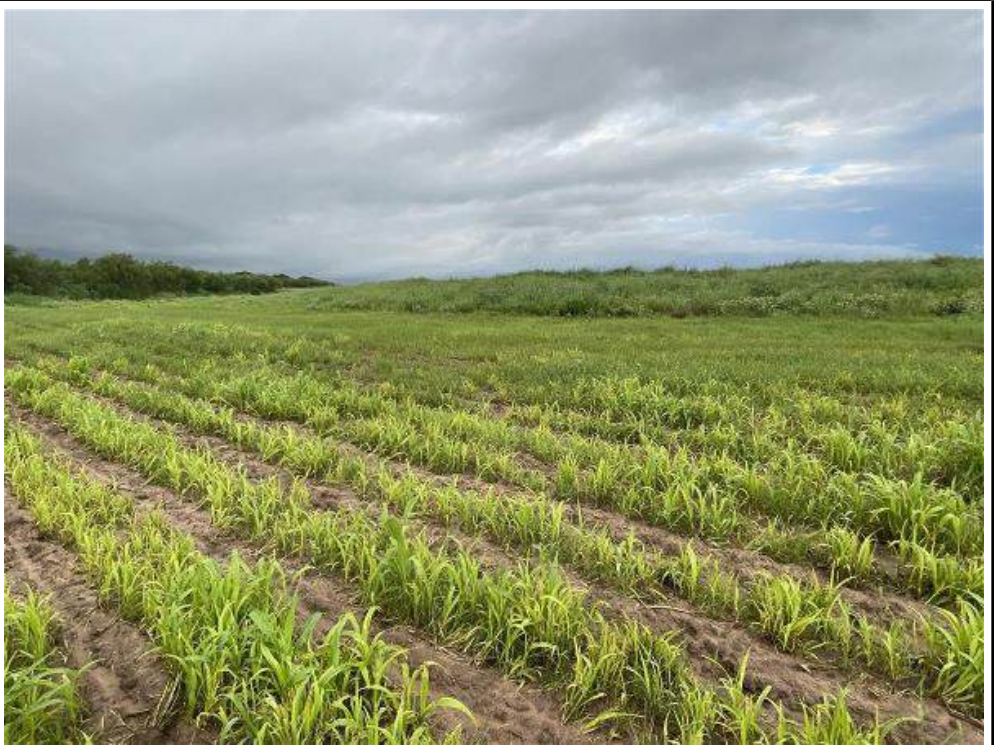
<b>Latitude/Longitude:</b> 26.4214891, -98.11160057			
<b>Photo Direction:</b> west			
<b>Description:</b> DP 068 (Upland)

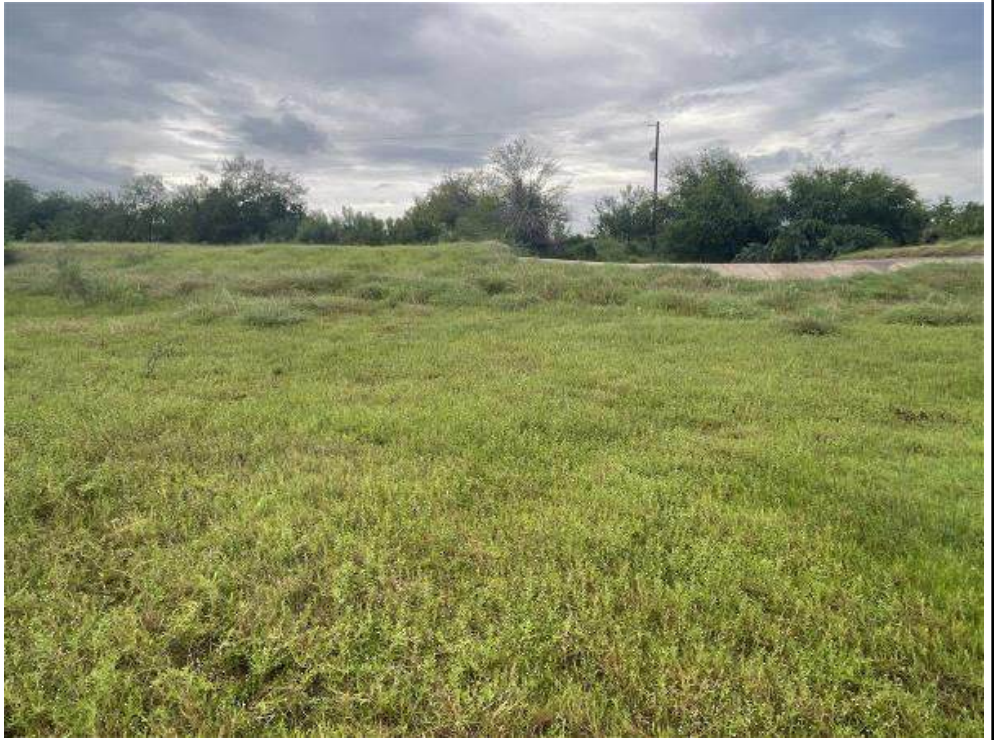
<b>Latitude/Longitude:</b> 26.42586679, -98.12421794			
<b>Photo Direction:</b> north			
<b>Description:</b> DP 069 (Upland)			
<b>Photograph ID: 70</b>

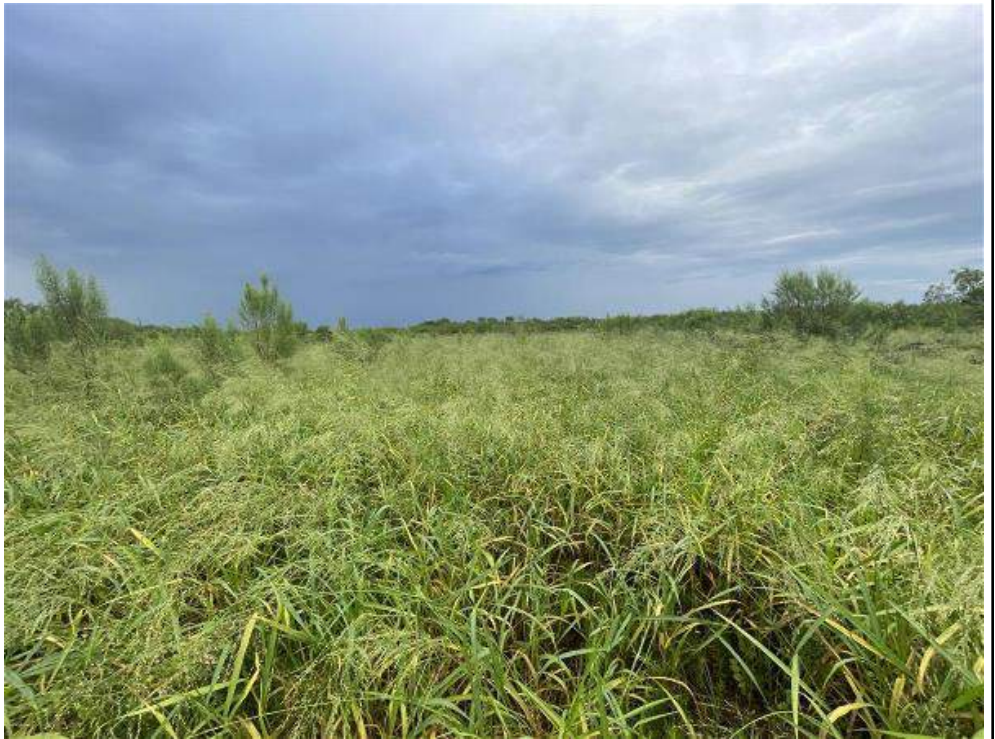
<b>Latitude/Longitude:</b> 26.42656329, -98.12779629			
<b>Photo Direction:</b> east			
<b>Description:</b> DP 070 (Upland)

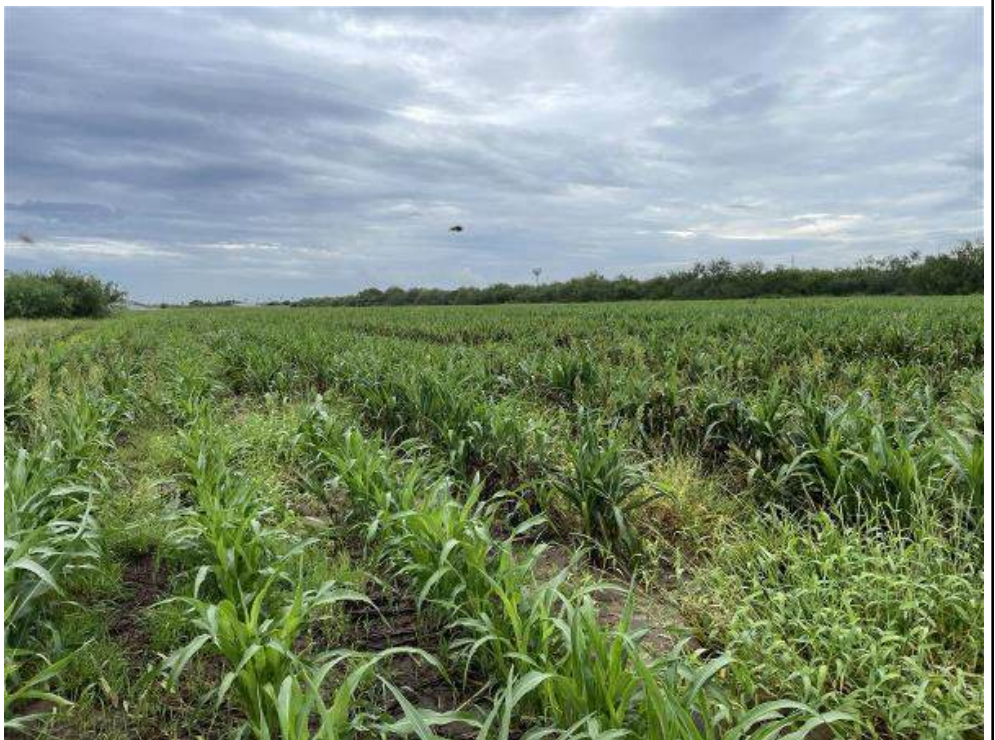
<b>Latitude/Longitude:</b> 26.42590476, -98.12856572			
<b>Photo Direction:</b> south			
<b>Description:</b> DP 071 (Upland)			
<b>Photograph ID: 72</b>

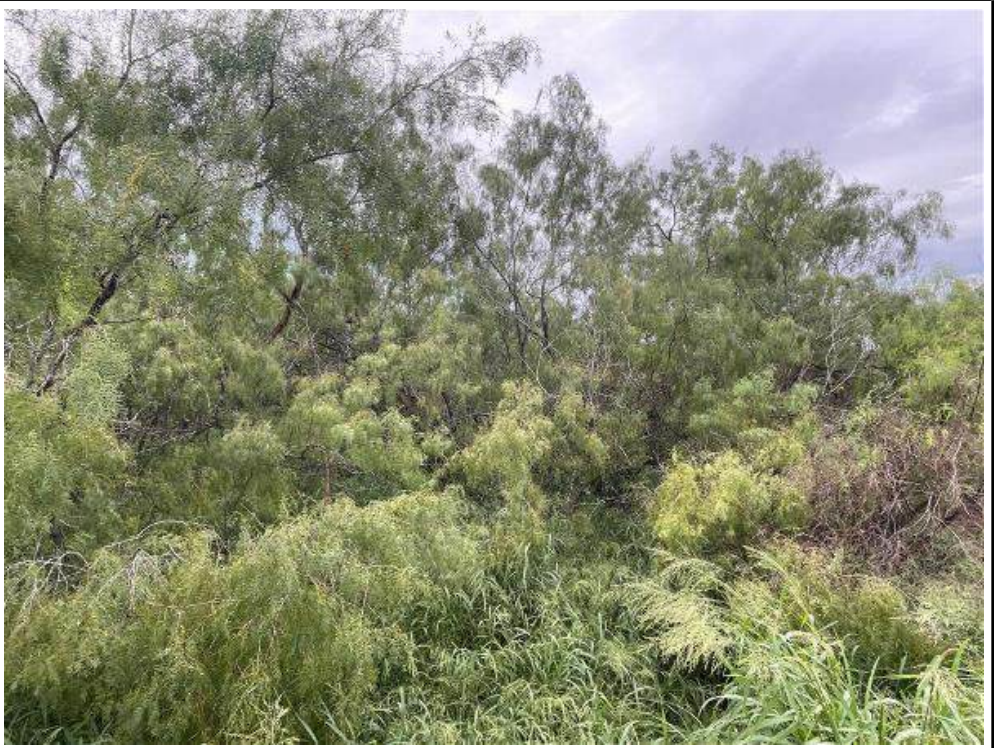
<b>Latitude/Longitude:</b> 26.42630428, -98.13169839			
<b>Photo Direction:</b> east			
<b>Description:</b> DP 072 (Upland)

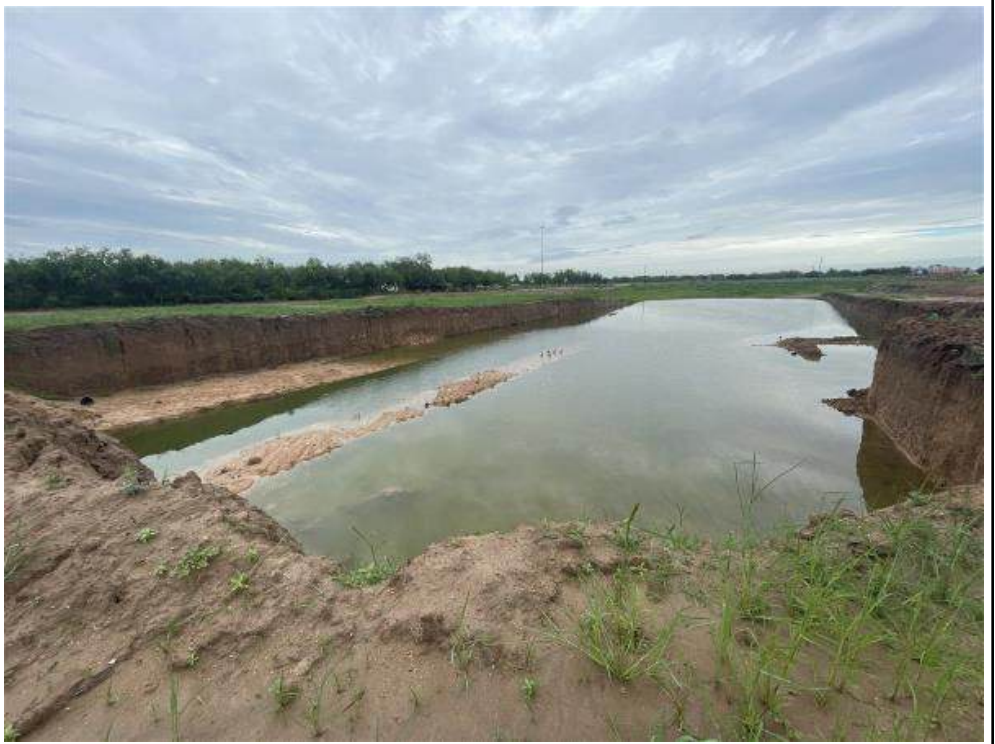
<b>Latitude/Longitude:</b> 26.42674258, -98.13456061			
<b>Photo Direction:</b> southwest			
<b>Description:</b> DP 073 (Upland), site of water filled depression incidental to construction.			
<b>Photograph ID: 74</b>

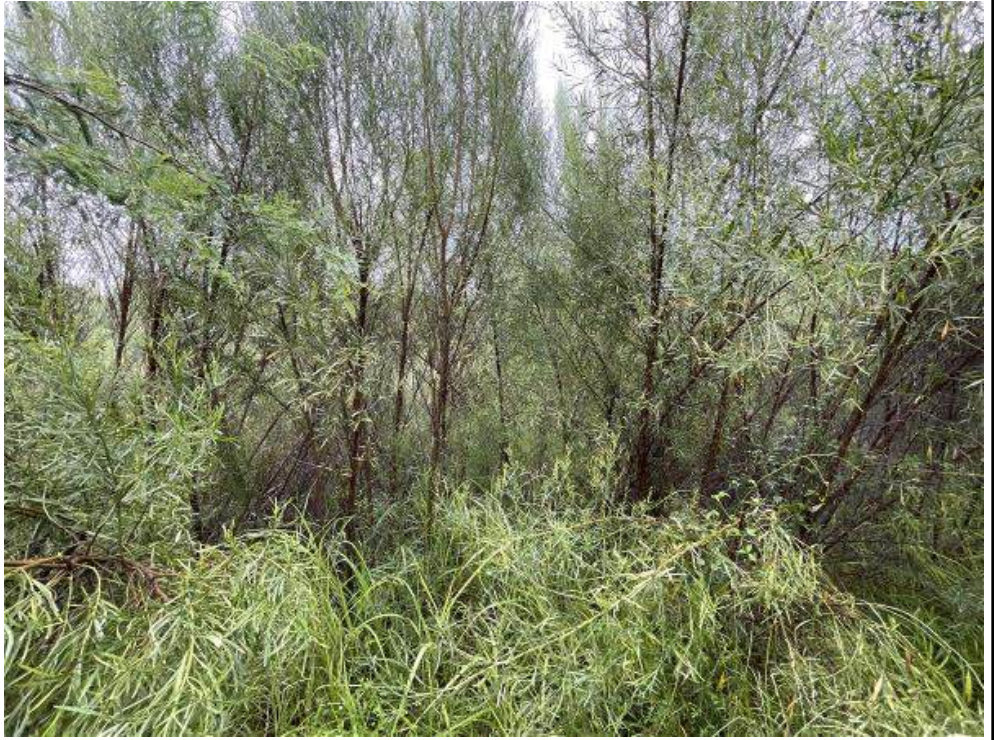
<b>Latitude/Longitude:</b> 26.4270734, -98.13379406			
<b>Photo Direction:</b> north			
<b>Description:</b> DP 074 (Upland)

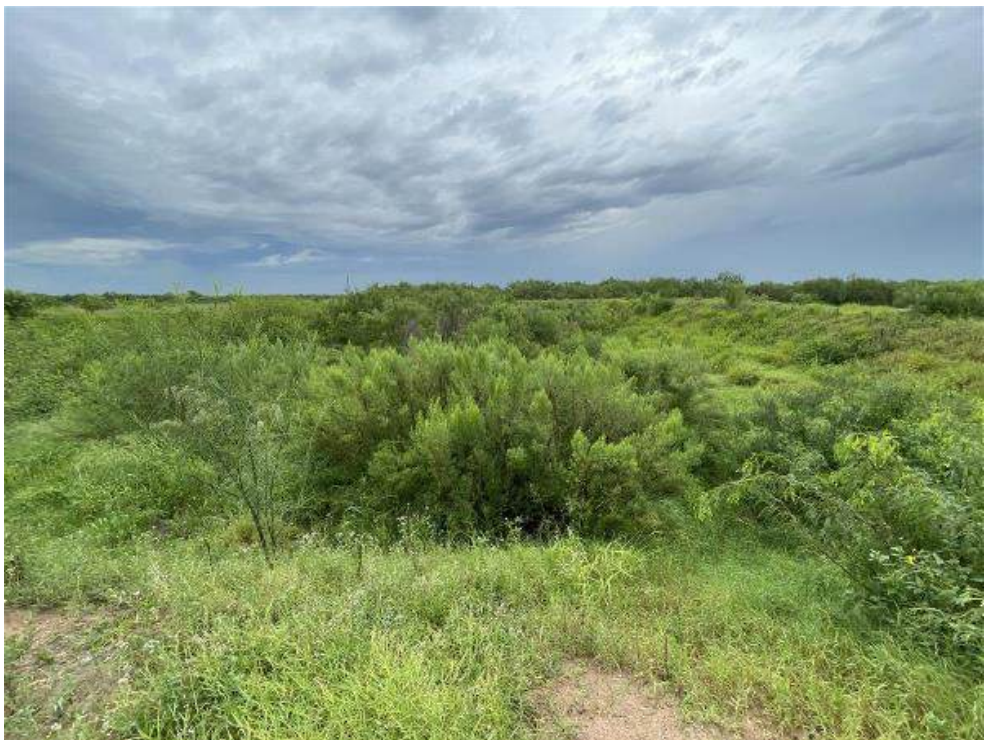
<b>Latitude/Longitude:</b> 26.4270252, -98.1328768			
<b>Photo Direction:</b> east			
<b>Description:</b> DP 075 (Upland)			
<b>Photograph ID: 76</b>

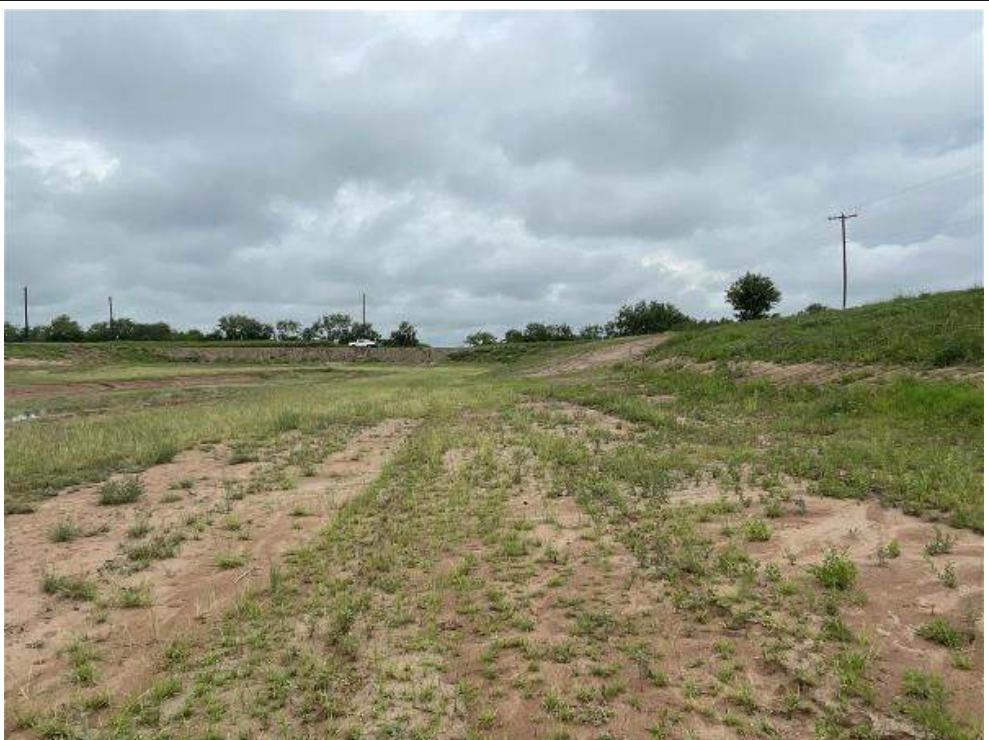
<b>Latitude/Longitude:</b> 26.39280611, -98.15495868			
<b>Photo Direction:</b> north			
<b>Description:</b> DP 076 (Upland)

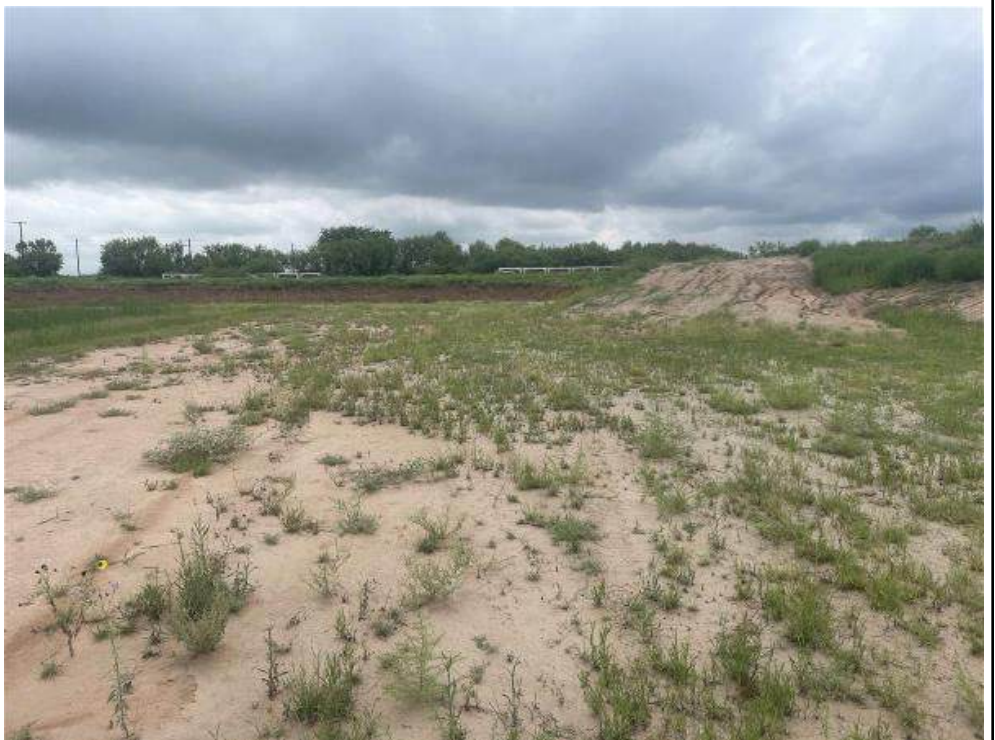
<b>Latitude/Longitude:</b> 26.38395406, -98.15690395			
<b>Photo Direction:</b> south			
<b>Description:</b> DP 077 (Upland)			
<b>Photograph ID: 78</b>

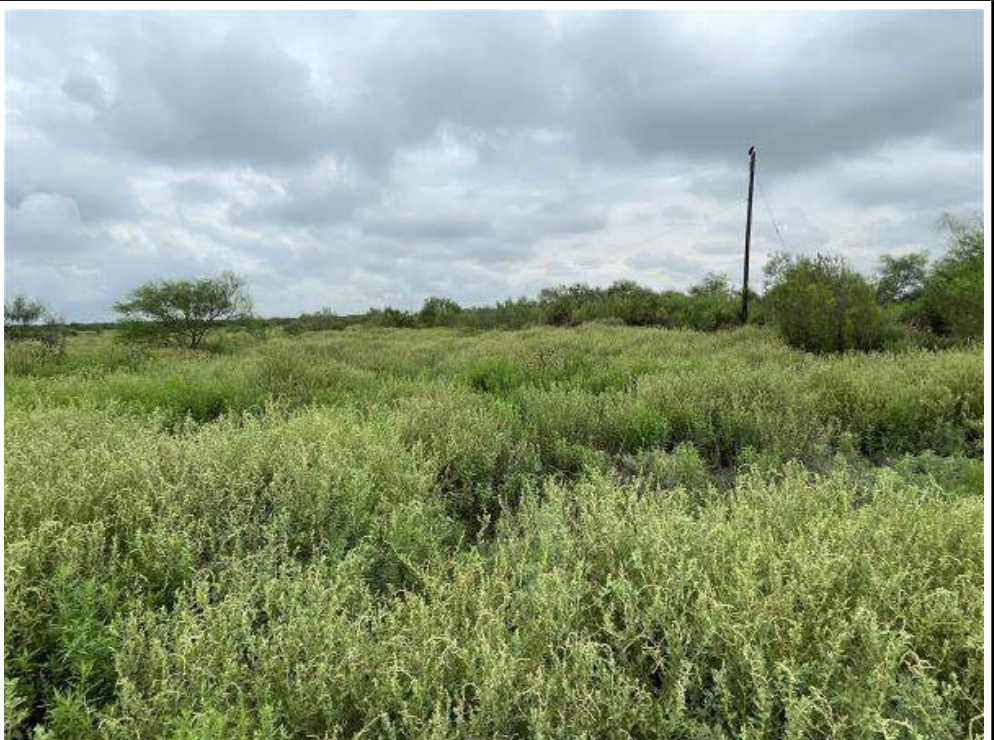
<b>Latitude/Longitude:</b> 26.43426508, -98.05485461			
<b>Photo Direction:</b> east			
<b>Description:</b> DP 078 (Upland)

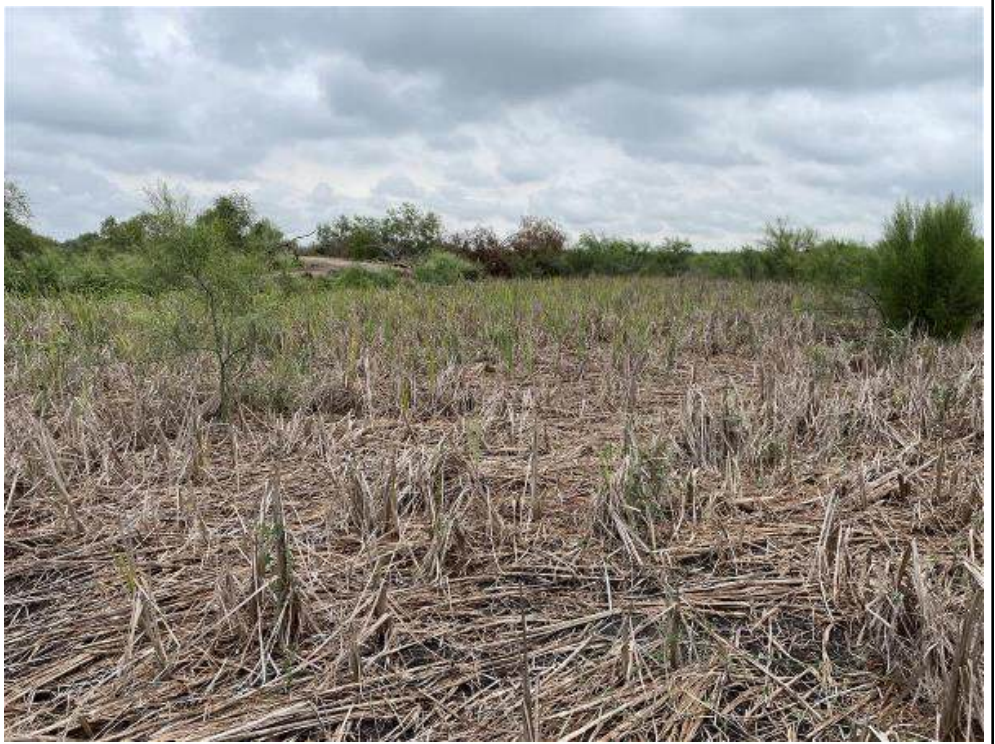
<b>Latitude/Longitude:</b> 26.43389068, -98.05480044			
<b>Photo Direction:</b> east			
<b>Description:</b> DP 079 (Wetland) at W027			
<b>Photograph ID: 80</b>

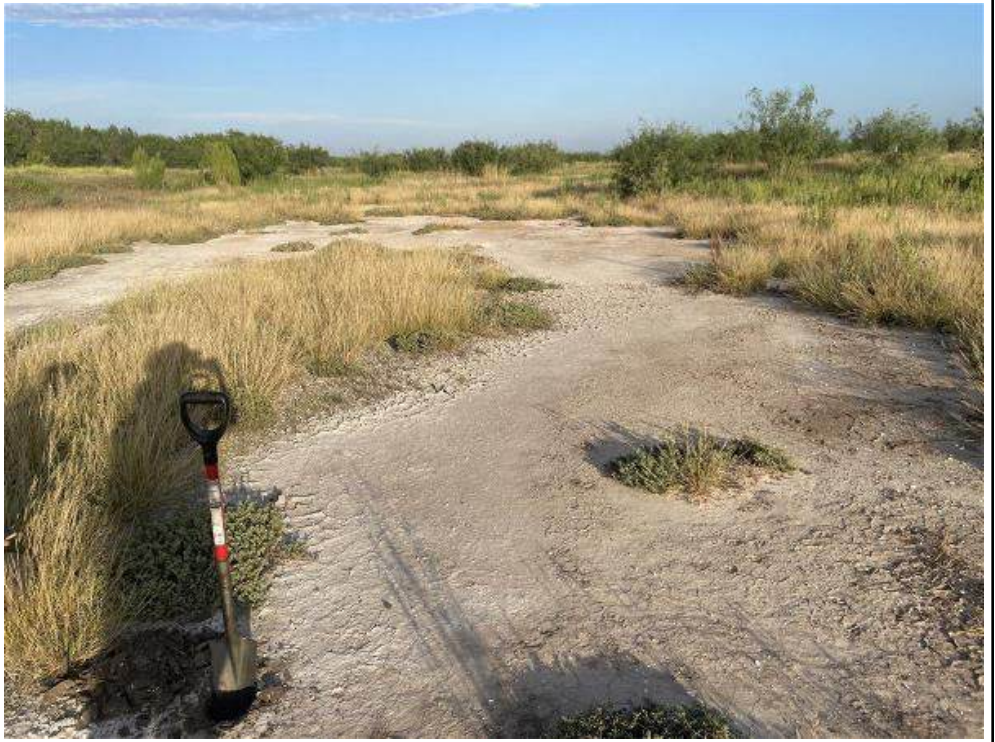
<b>Latitude/Longitude:</b> 26.40251737, -98.1620458			
<b>Photo Direction:</b> west			
<b>Description:</b> DP 080 (Upland)

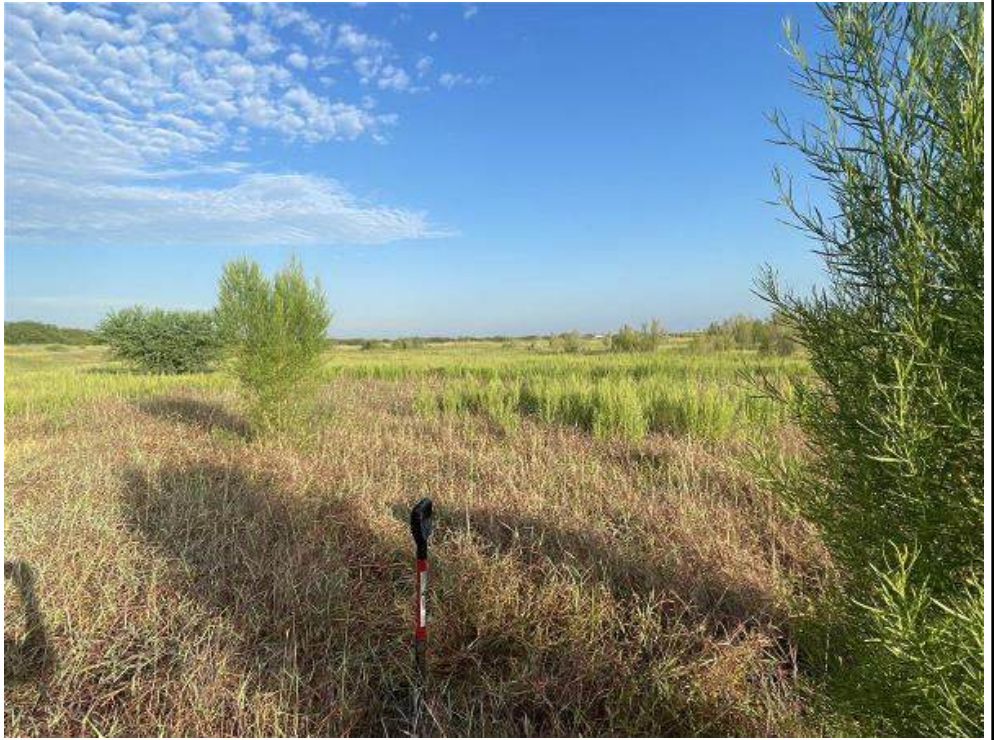
<b>Latitude/Longitude:</b> 26.40234954, -98.1607293			
<b>Photo Direction:</b> west			
<b>Description:</b> DP 081 (Upland)			
<b>Photograph ID: 82</b>

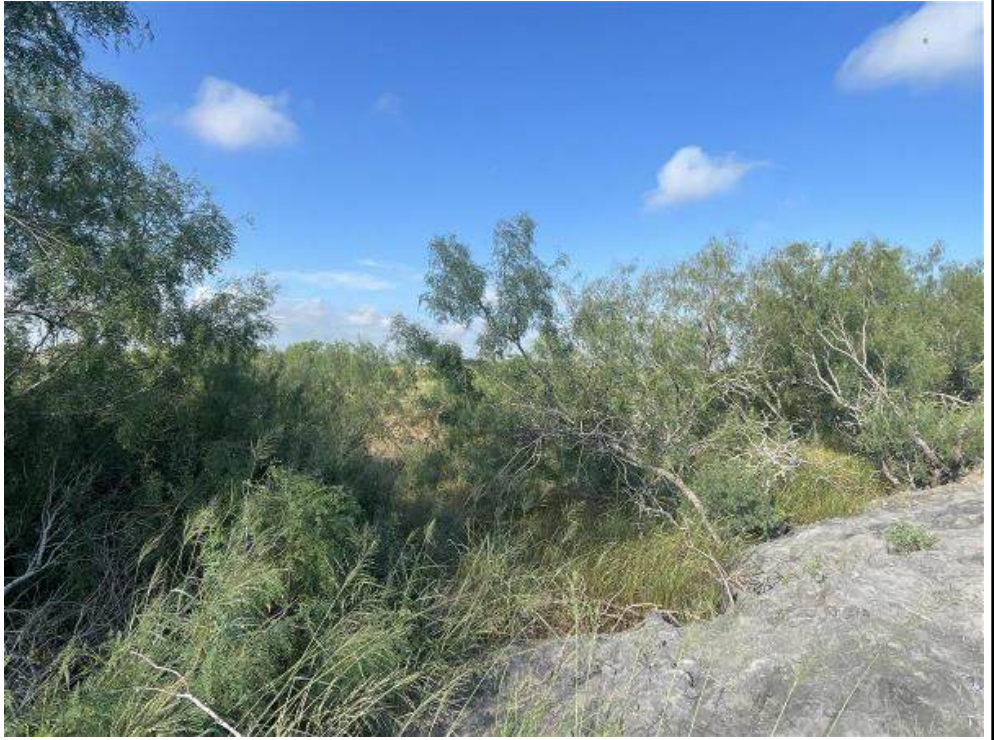
<b>Latitude/Longitude:</b> 26.4842014, -98.01434905			
<b>Photo Direction:</b> southwest			
<b>Description:</b> DP 082 (Upland)

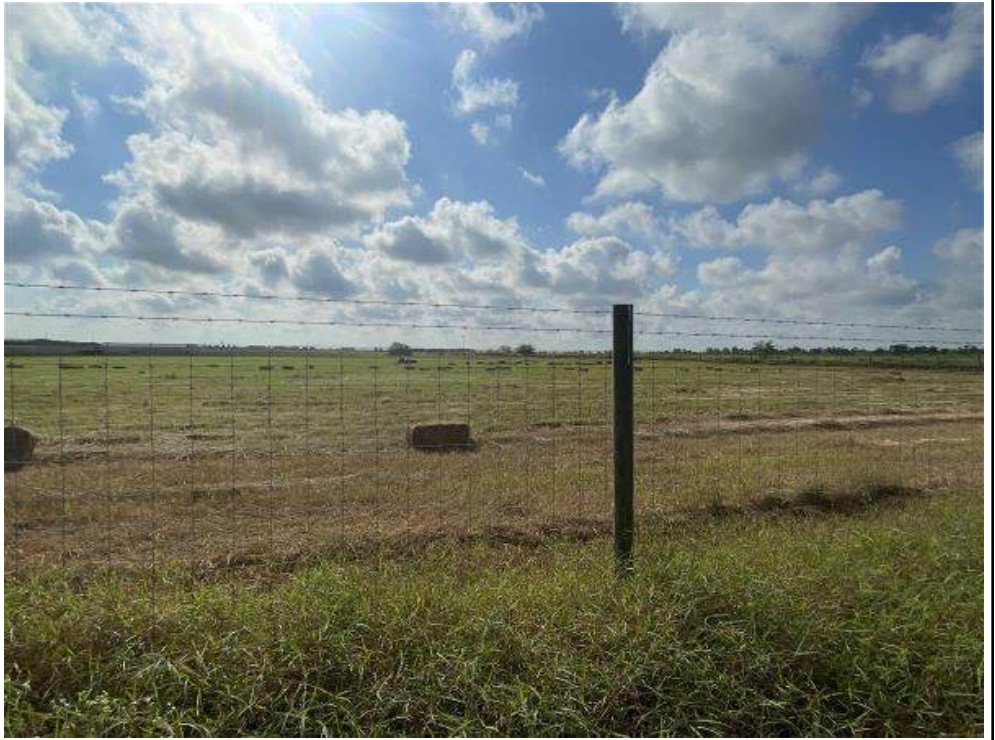
<b>Latitude/Longitude:</b> 26.47832634, -97.94171591			
<b>Photo Direction:</b> east			
<b>Description:</b> DP 083 (Upland)			
<b>Photograph ID: 84</b>

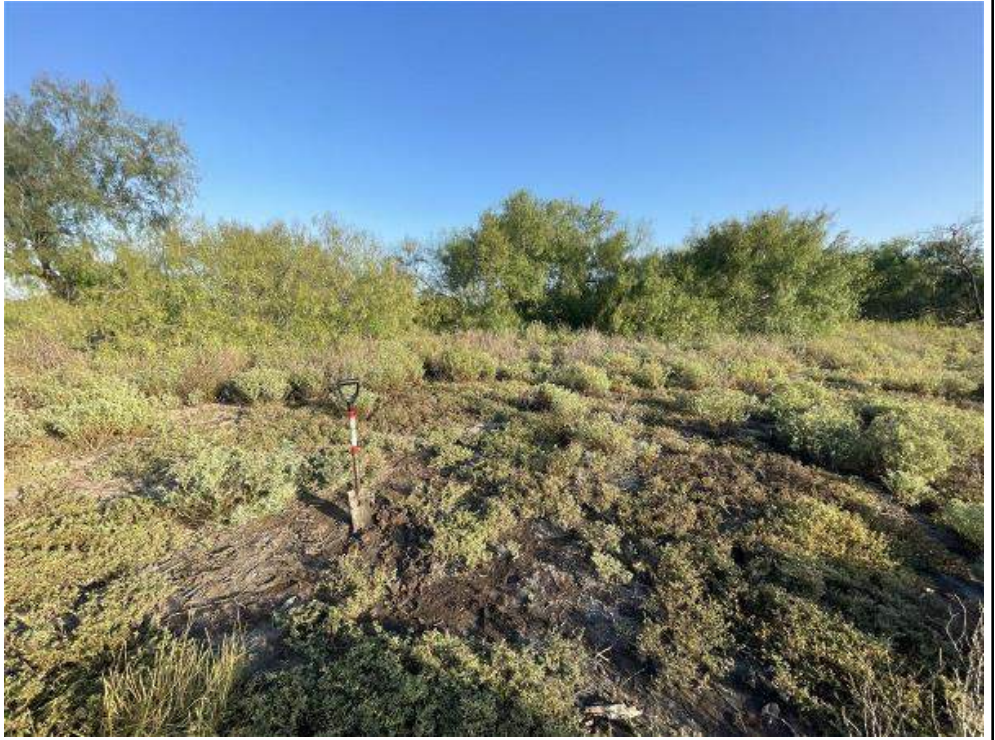
<b>Latitude/Longitude:</b> 26.42989475, -98.05649527			
<b>Photo Direction:</b> west			
<b>Description:</b> DP 084 (Upland)

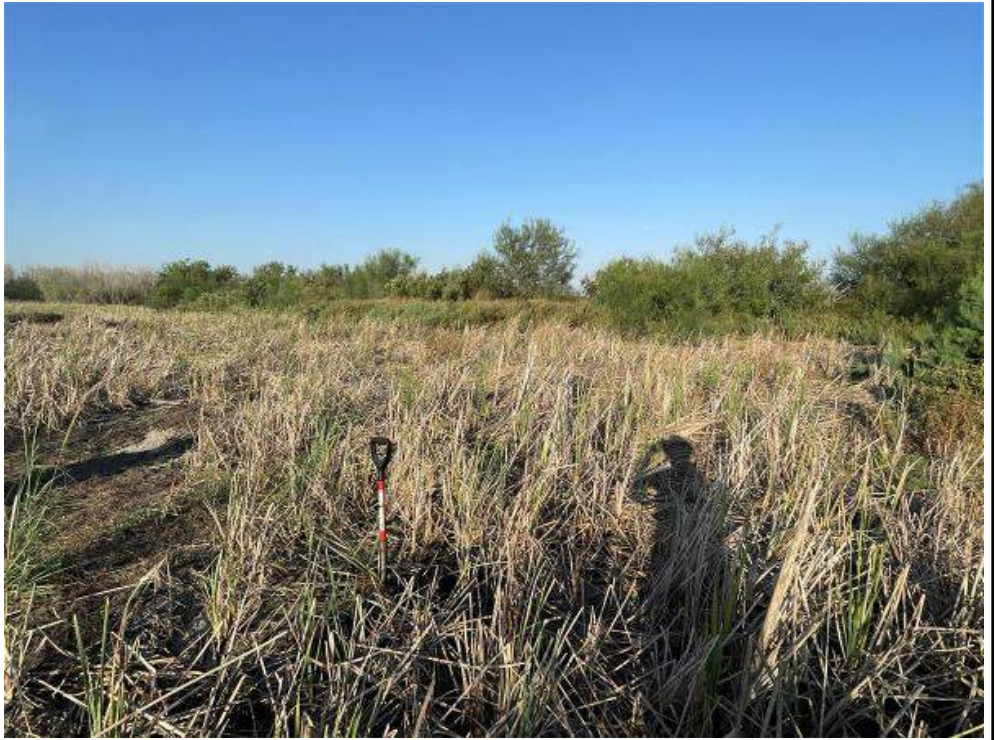
<b>Latitude/Longitude:</b> 26.42975122, -98.05641223			
<b>Photo Direction:</b> southwest			
<b>Description:</b> DP 085 (Wetland) at W028			
<b>Photograph ID:</b> 86

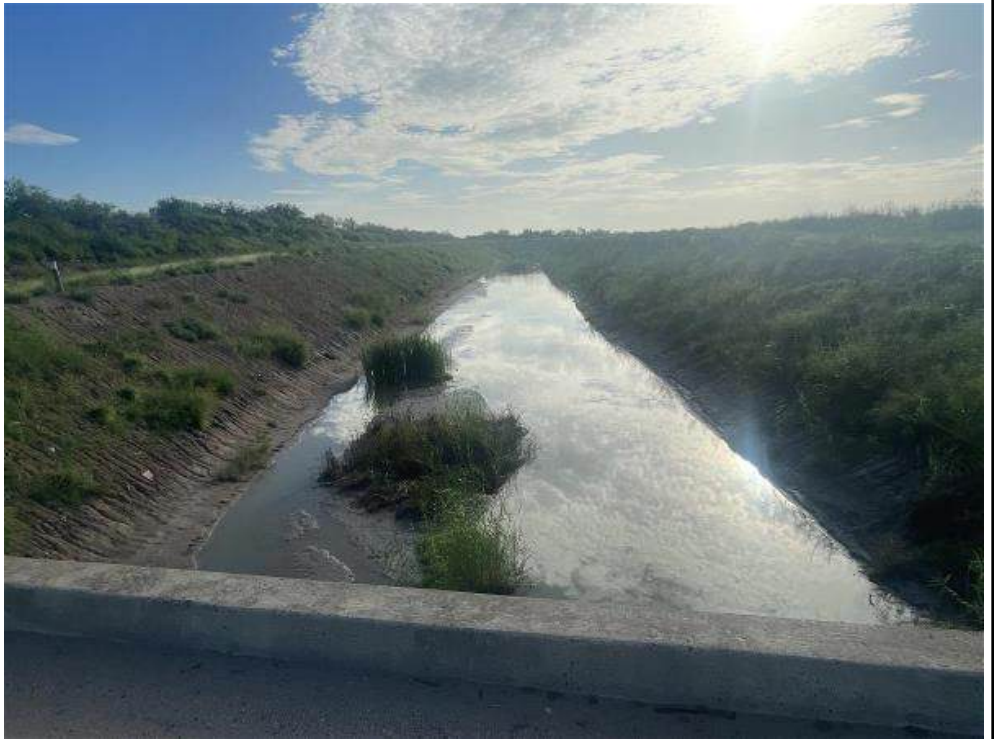
<b>Latitude/Longitude:</b> 26.494551, -97.880125			
<b>Photo Direction:</b> east			
<b>Description:</b> T001A West Main Drain (Perennial Drainage Ditch) looking downstream

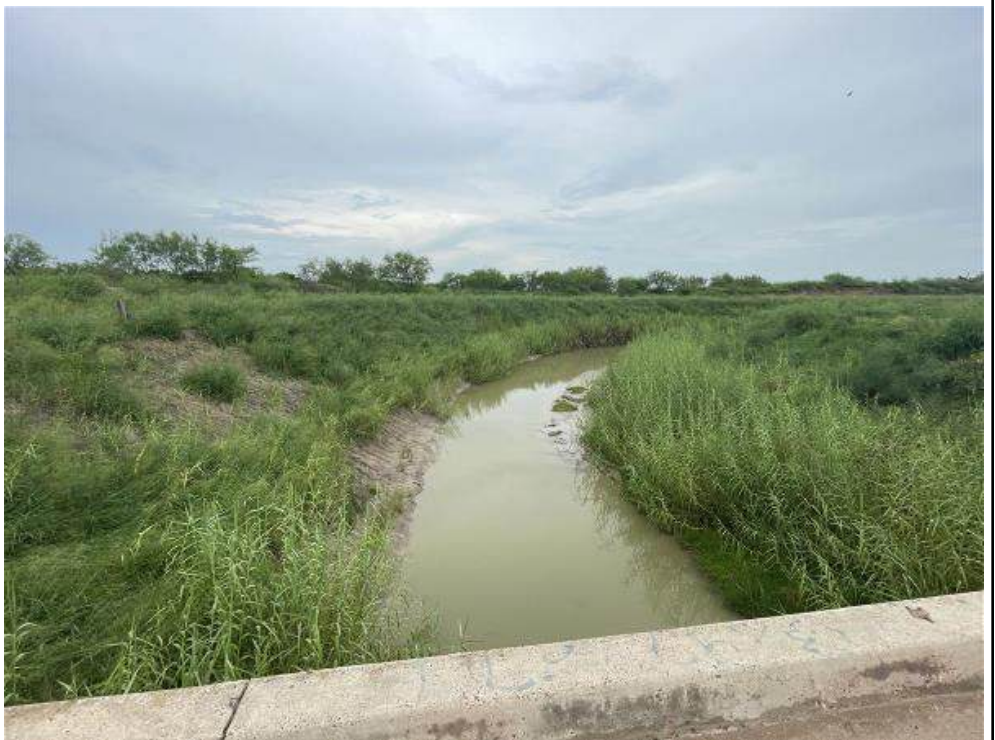
<b>Latitude/Longitude:</b> 26.518209, -97.861081			
<b>Photo Direction:</b> east			
<b>Description:</b> T001A West Main Drain (Perennial Drainage Ditch) looking upstream			
<b>Photograph ID: 88</b>

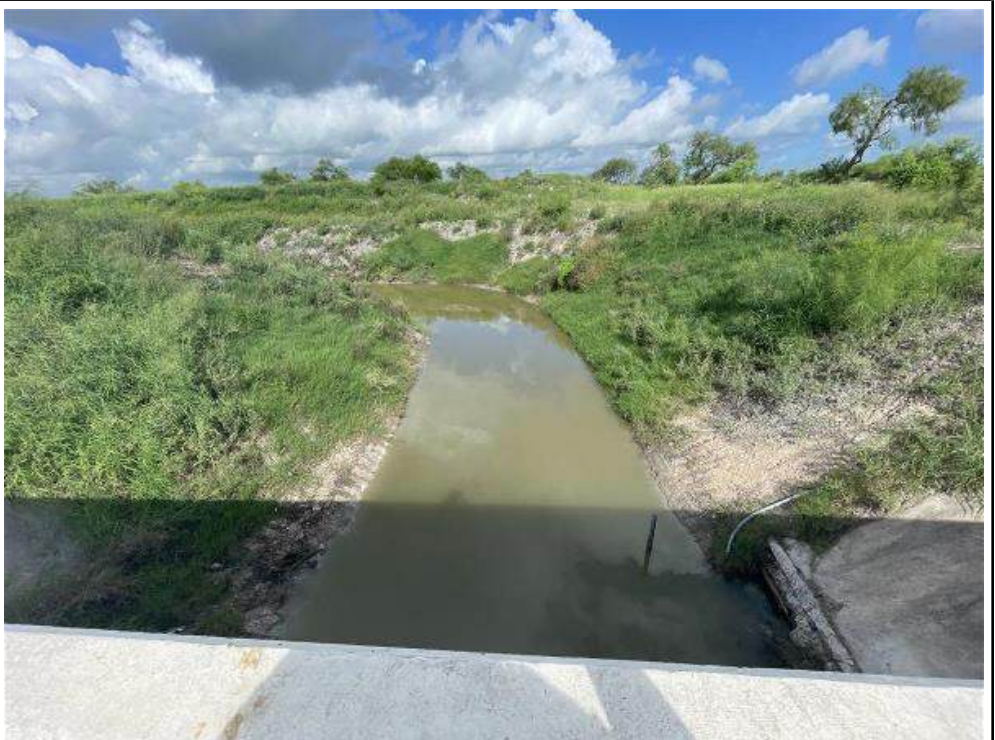
<b>Latitude/Longitude:</b> 26.471715, -97.910317			
<b>Photo Direction:</b> southeast			
<b>Description:</b> T001A West Main Drain (Perennial Drainage Ditch) looking upstream

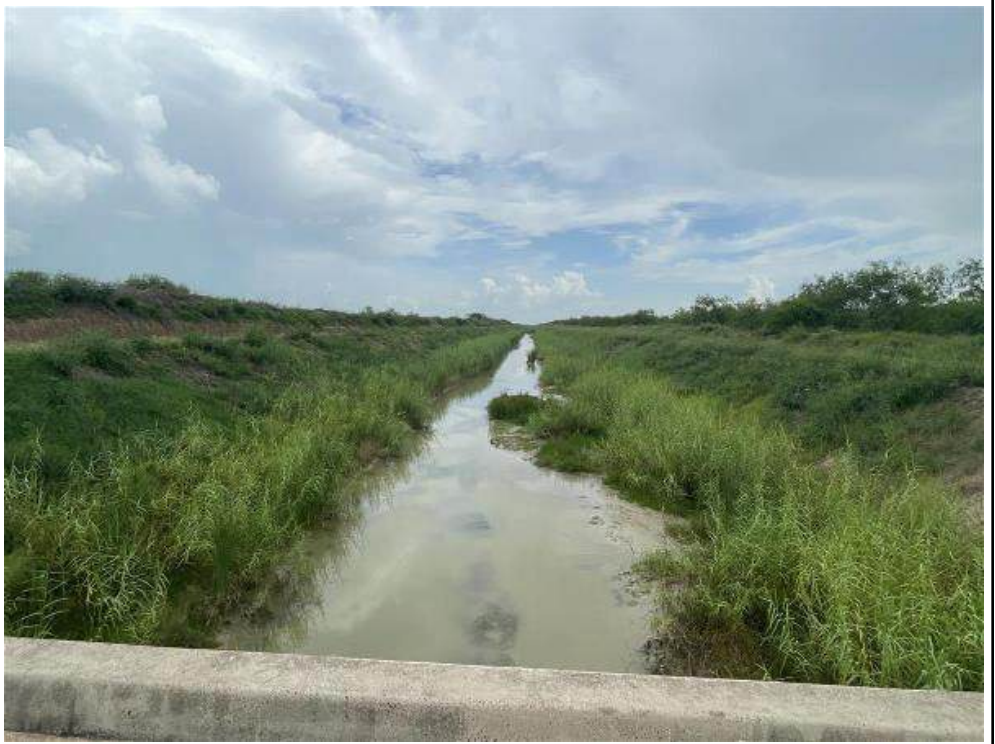
<b>Latitude/Longitude:</b> 26.518184, -97.8611			
<b>Photo Direction:</b> south			
<b>Description:</b> T001A West Main Drain (Perennial Drainage Ditch) looking upstream			
<b>Photograph ID:</b> 90

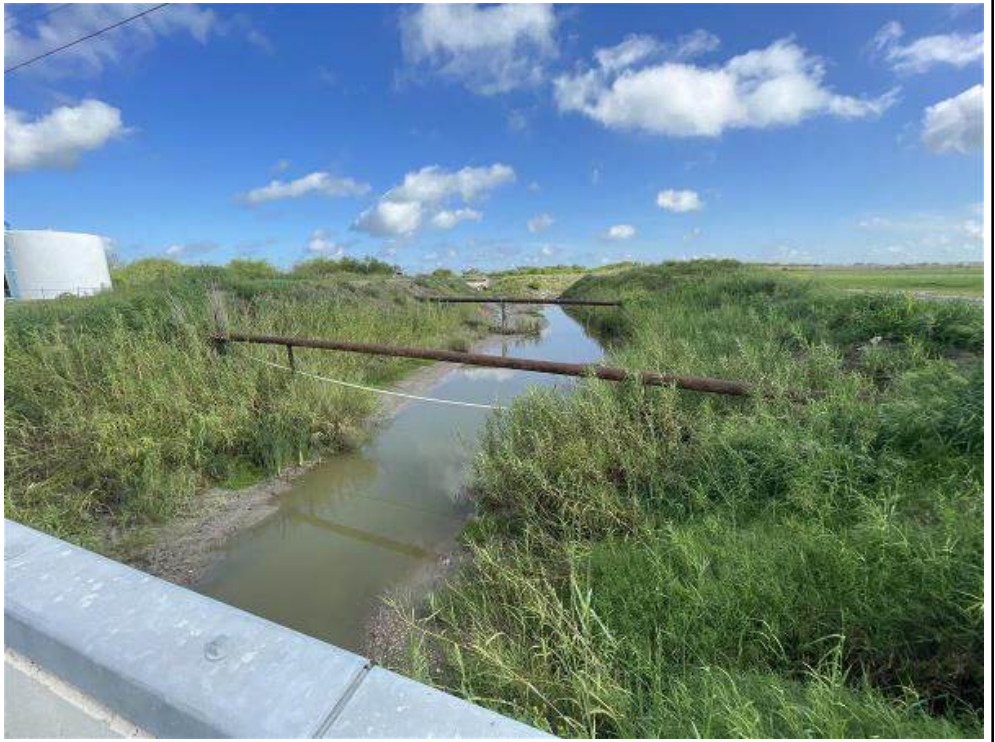
<b>Latitude/Longitude:</b> 26.47825, -97.899969			
<b>Photo Direction:</b> north			
<b>Description:</b> T001A West Main Drain (Perennial Drainage Ditch) near T001A terminus, looking downstream

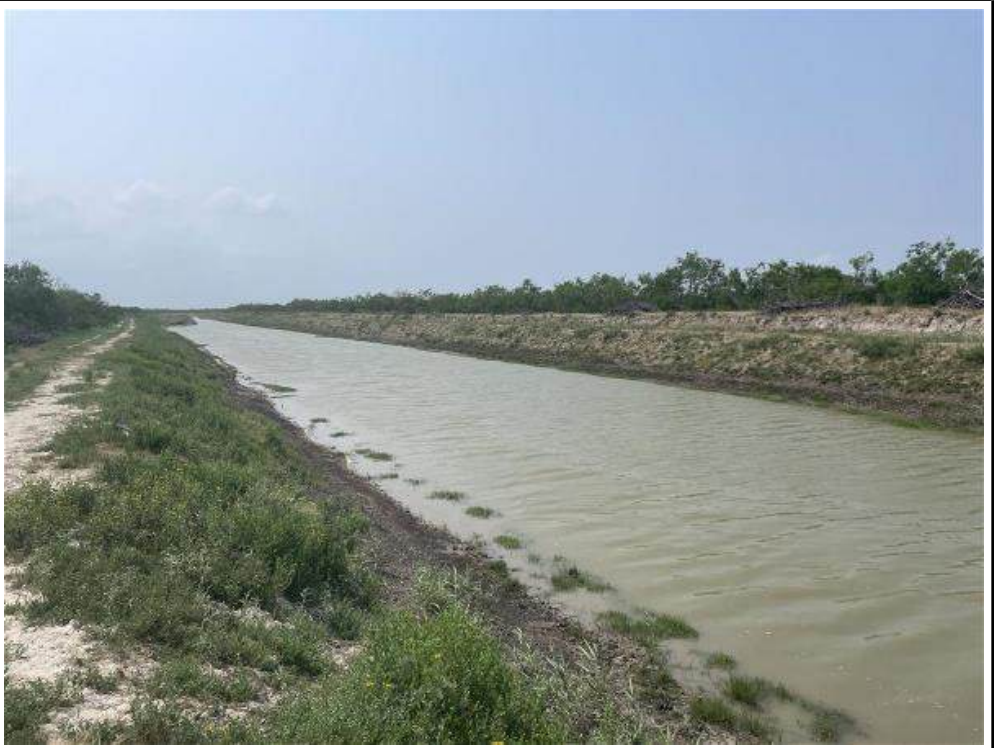
<b>Latitude/Longitude:</b> 26.524222, -97.502983			
<b>Photo Direction:</b> southeast			
<b>Description:</b> T001B East Main Drain (Perennial Drainage Ditch) at eastern terminus looking downstream

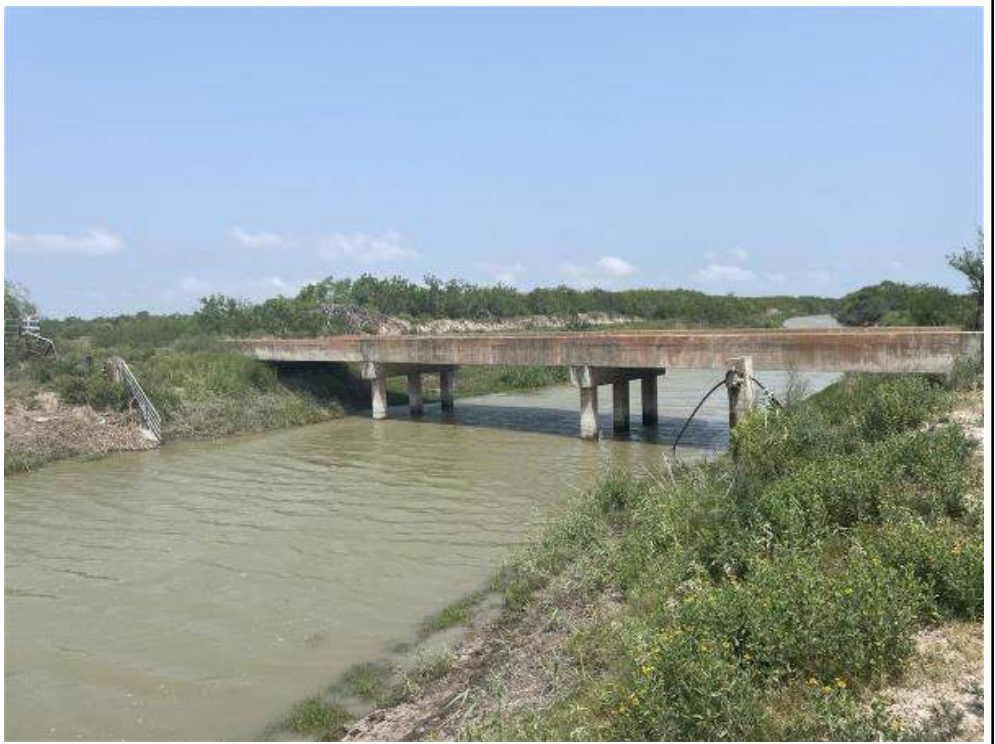
<b>Latitude/Longitude:</b> 26.524223, -97.502983			
<b>Photo Direction:</b> northwest			
<b>Description:</b> T001B East Main Drain (Perennial Drainage Ditch) at eastern terminus looking upstream			
<b>Photograph ID:</b> 94

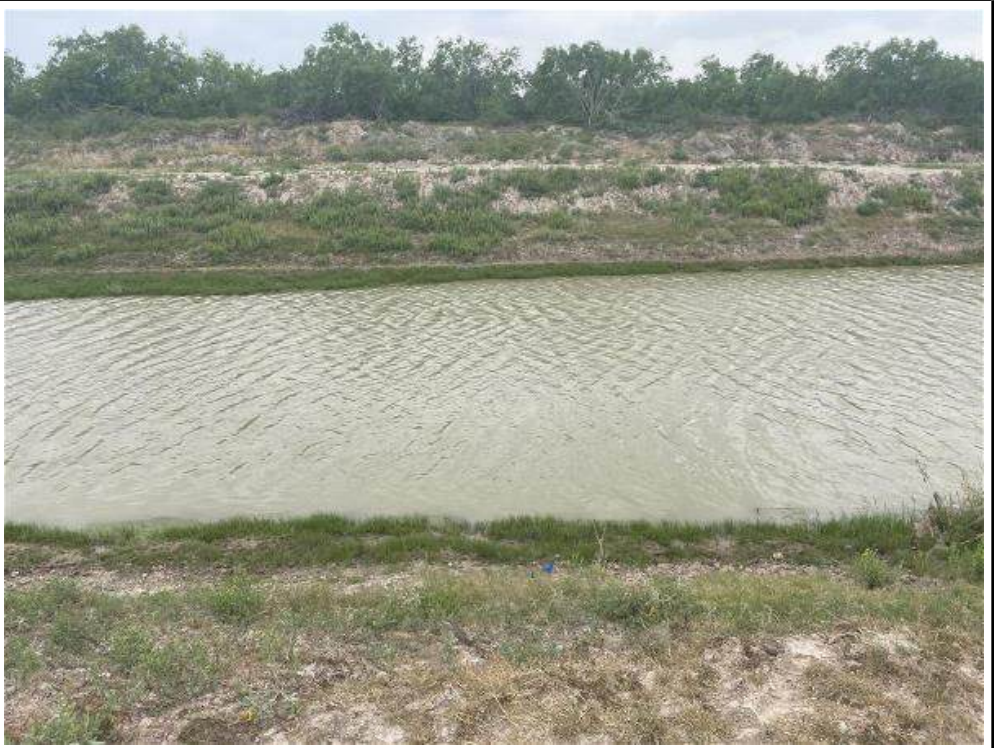
<b>Latitude/Longitude:</b> 26.5055, -97.529977			
<b>Photo Direction:</b> northeast			
<b>Description:</b> T001B East Main Drain (Perennial Drainage Ditch) looking across

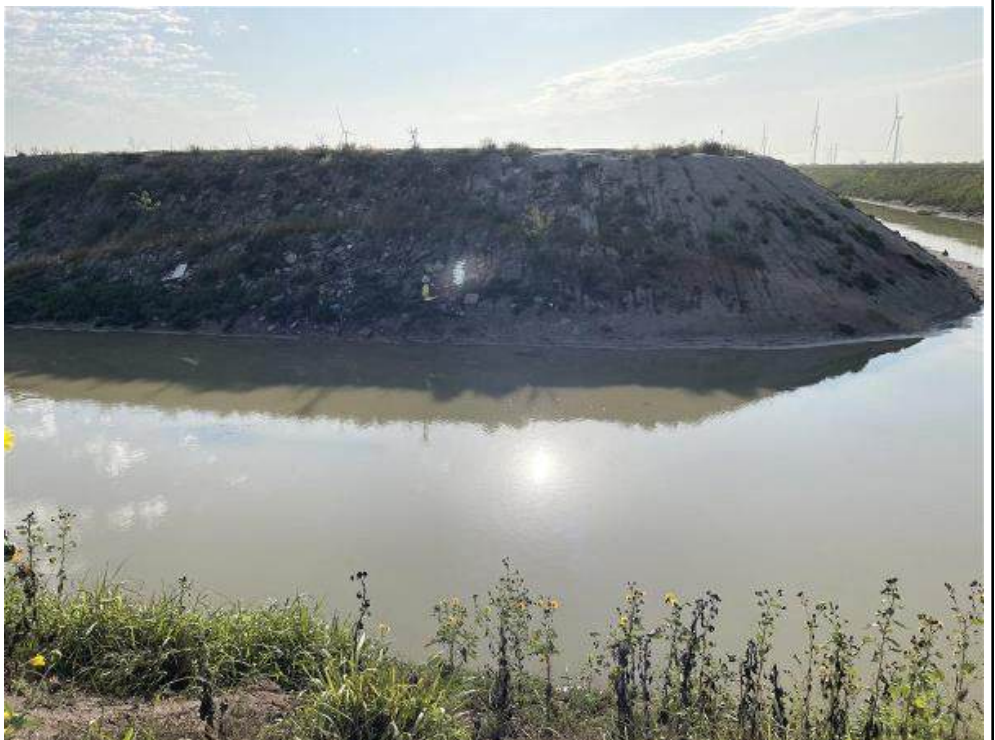
<b>Latitude/Longitude:</b> 26.518465, -97.759472			
<b>Photo Direction:</b> north			
<b>Description:</b> T001B East Main Drain (Perennial Drainage Ditch) looking across			
<b>Photograph ID: 96</b>

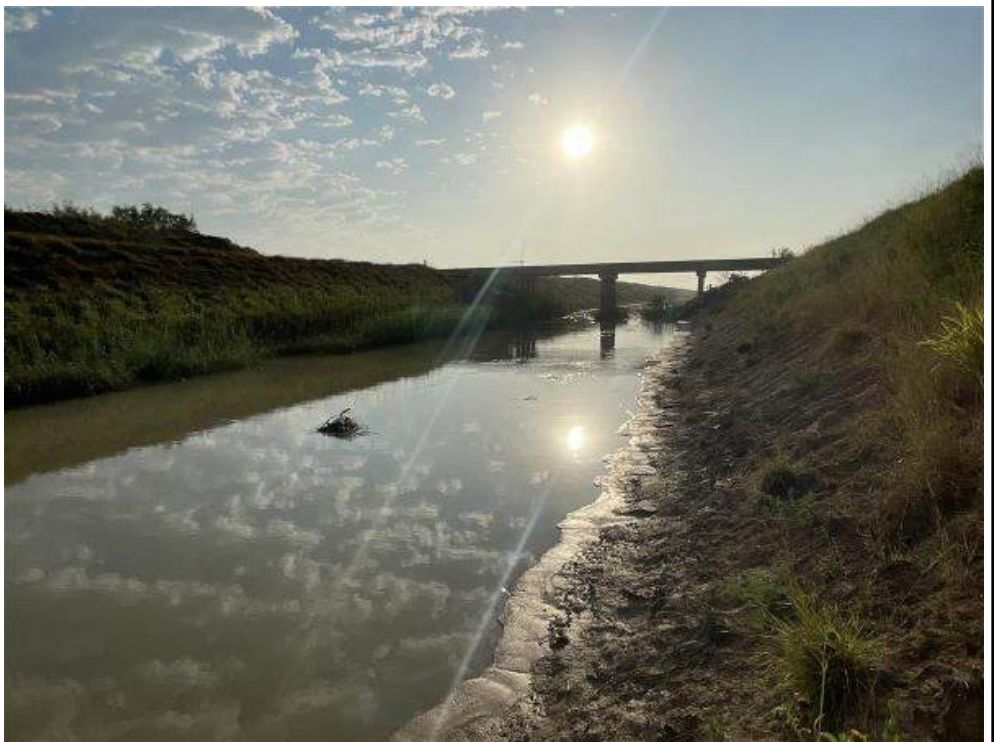
<b>Latitude/Longitude:</b> 26.519183, -97.7698			
<b>Photo Direction:</b> east			
<b>Description:</b> T001B East Main Drain (Perennial Drainage Ditch) looking downstream
