## **Delineation Report**

Raymondville Drain Project  
Hidalgo and Willacy Counties, Texas

December 11, 2024

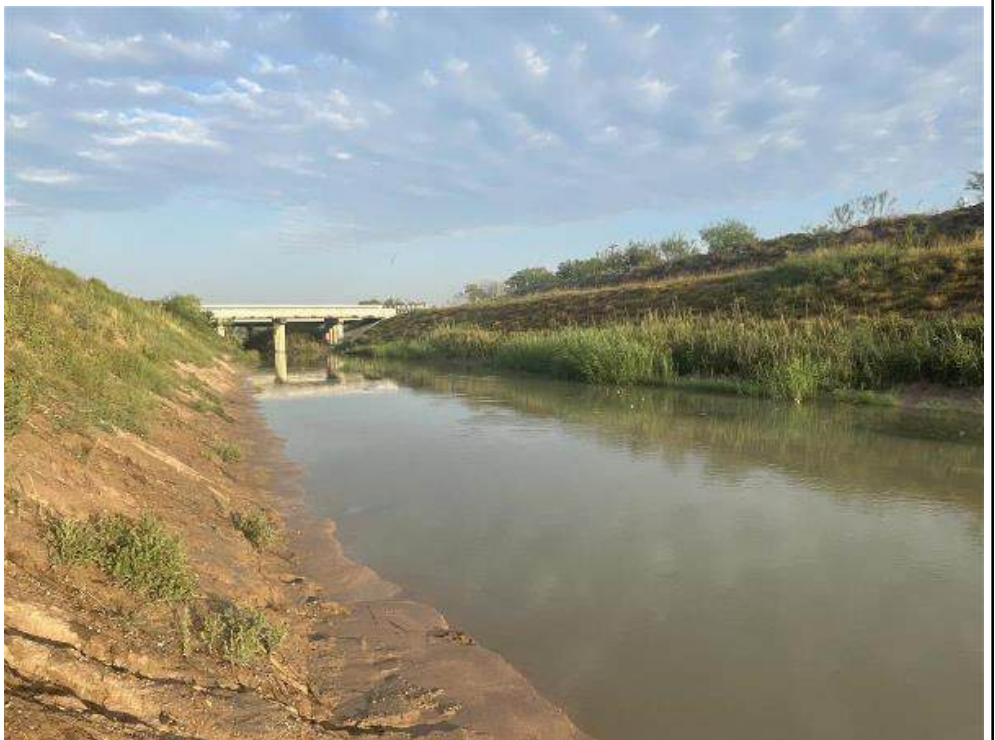
<b>Latitude/Longitude:</b> 26.519146, -97.772677			
<b>Photo Direction:</b> west			
<b>Description:</b> T001B East Main Drain (Perennial Drainage Ditch) looking upstream			
<b>Photograph ID: 98</b>

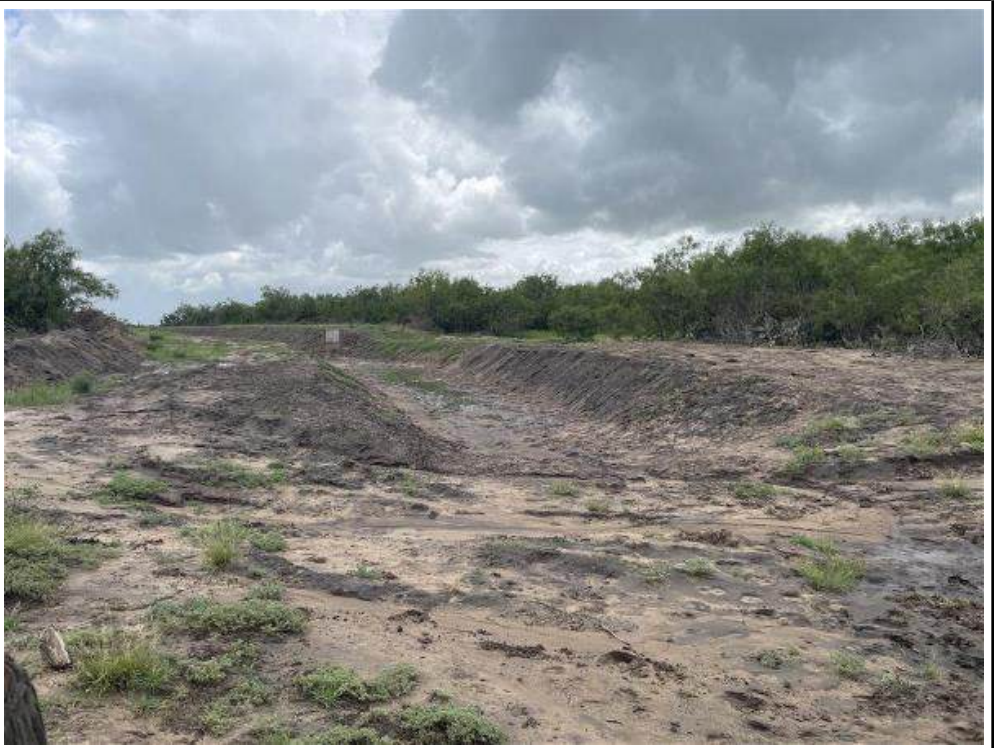
<b>Latitude/Longitude:</b> 26.45157591, -98.03452951			
<b>Photo Direction:</b> west			
<b>Description:</b> T002A (Upland Drainage Ditch) beginning of drainage ditch, looking downstream

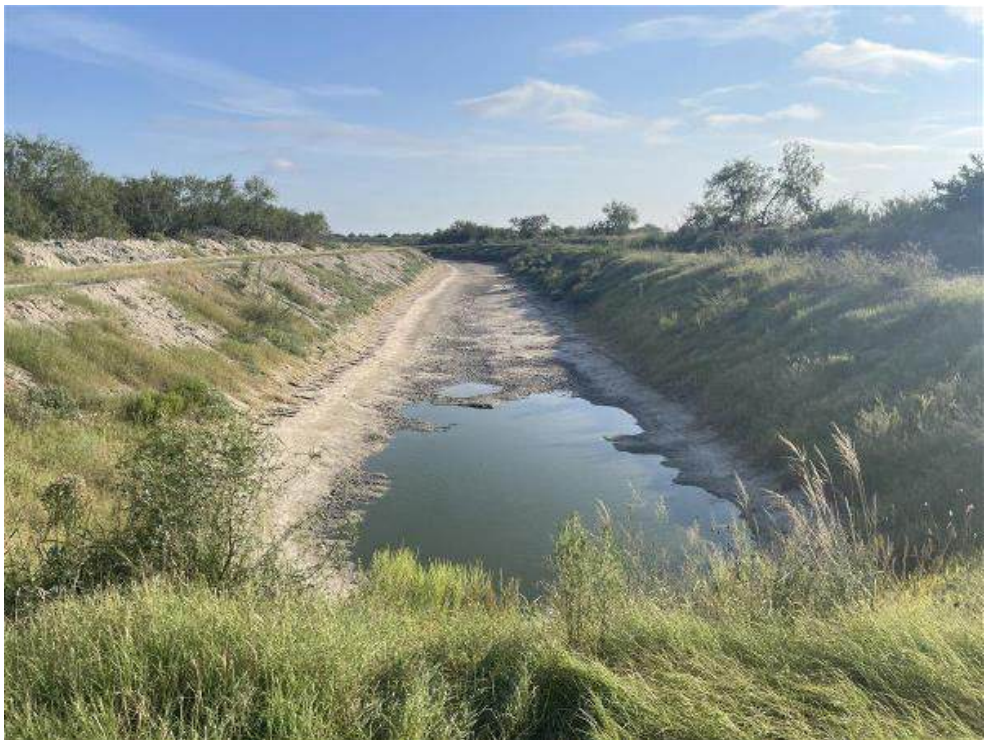
<b>Latitude/Longitude:</b> 26.453064, -98.033236			
<b>Photo Direction:</b> northeast			
<b>Description:</b> T002A (Upland Drainage Ditch) looking downstream			
<b>Photograph ID:</b> 100

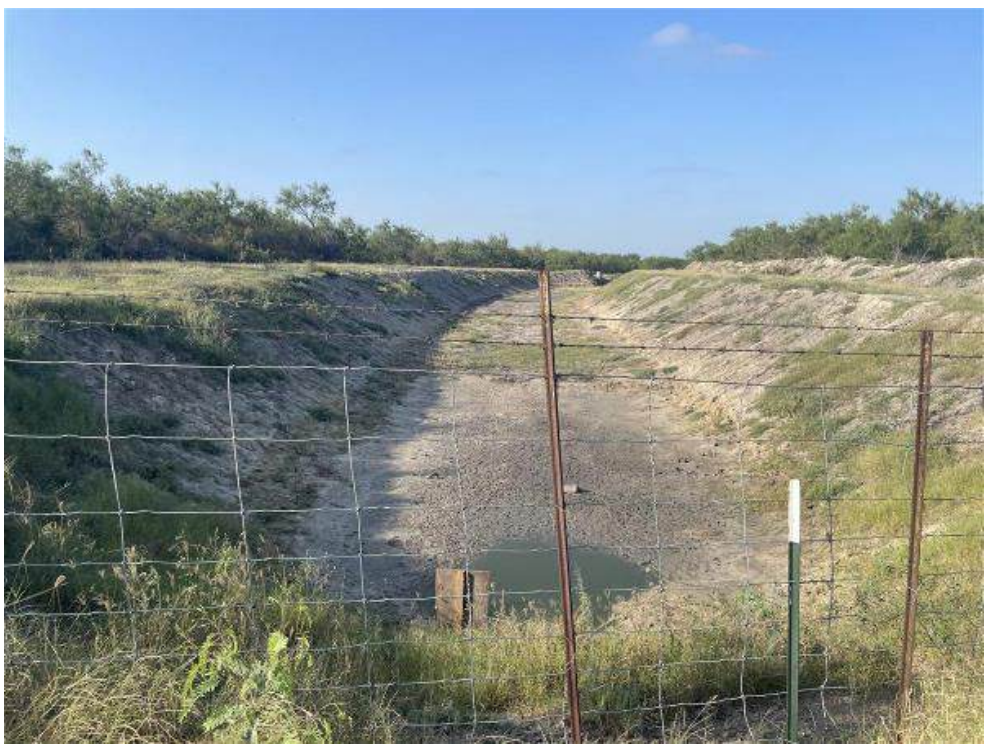
<b>Latitude/Longitude:</b> 26.453064, -98.033237			
<b>Photo Direction:</b> southwest			
<b>Description:</b> T002A (Upland Drainage Ditch) looking upstream

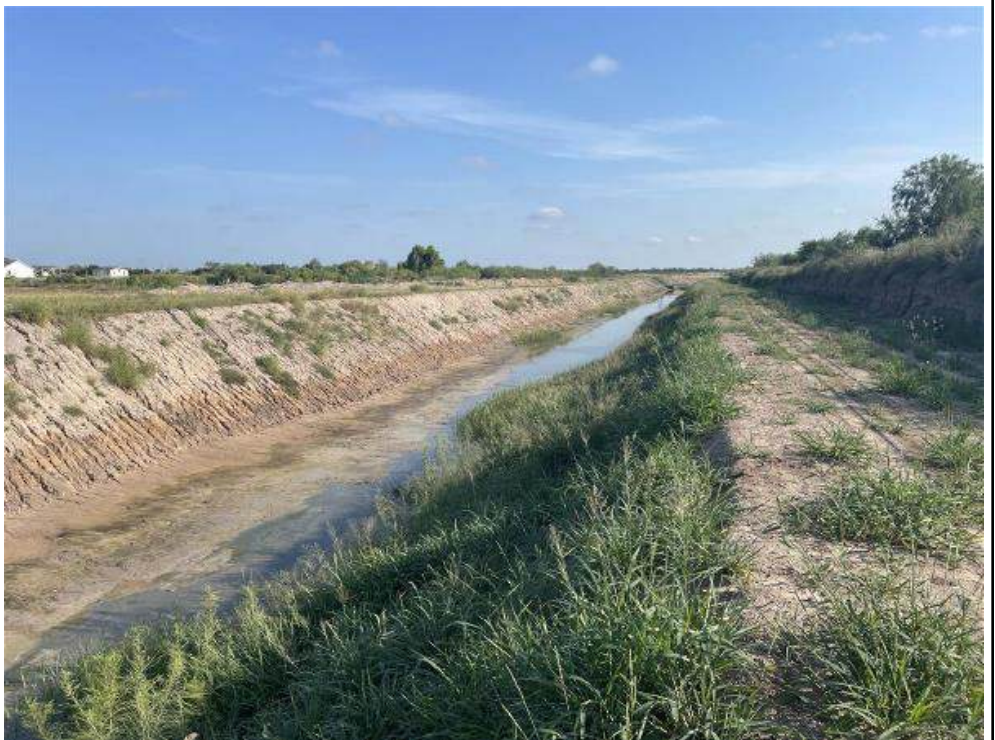
<b>Latitude/Longitude:</b> 26.464938, -98.0317883			
<b>Photo Direction:</b> northeast			
<b>Description:</b> T002A/T002B (Upland Drainage Ditch to Perennial Drainage Ditch Transition) looking downstream towards T002B			
<b>Photograph ID:</b> 102

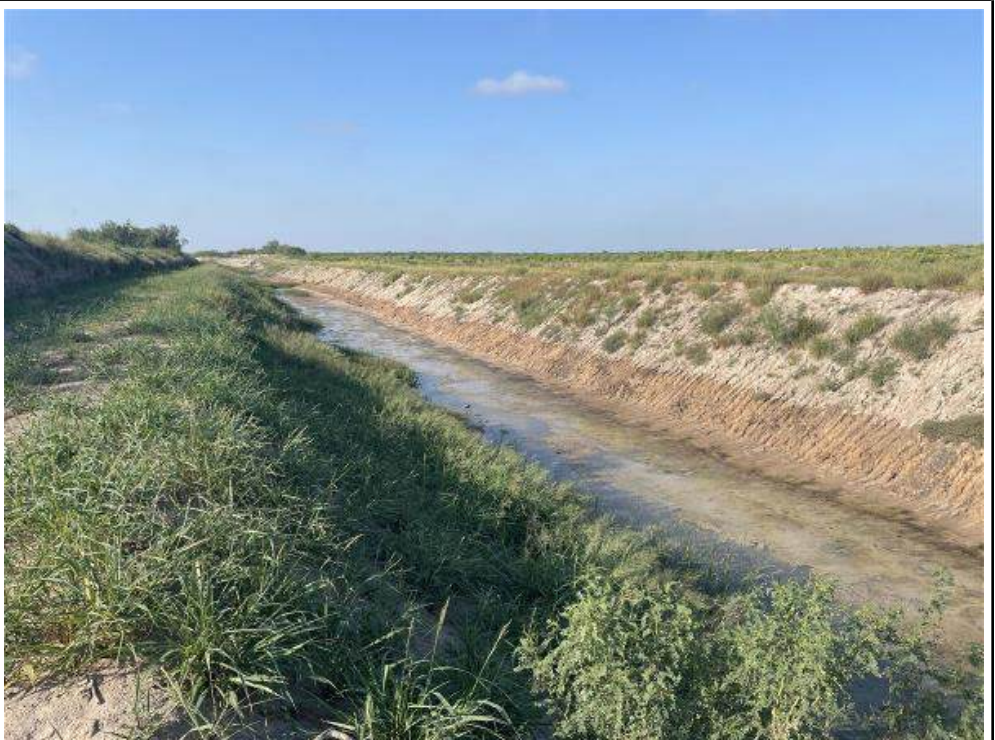
<b>Latitude/Longitude:</b> 26.464938, -98.0317883			
<b>Photo Direction:</b> northeast			
<b>Description:</b> T002A/T002B (Upland Drainage Ditch to Perennial Drainage Ditch Transition) looking upstream towards T002A

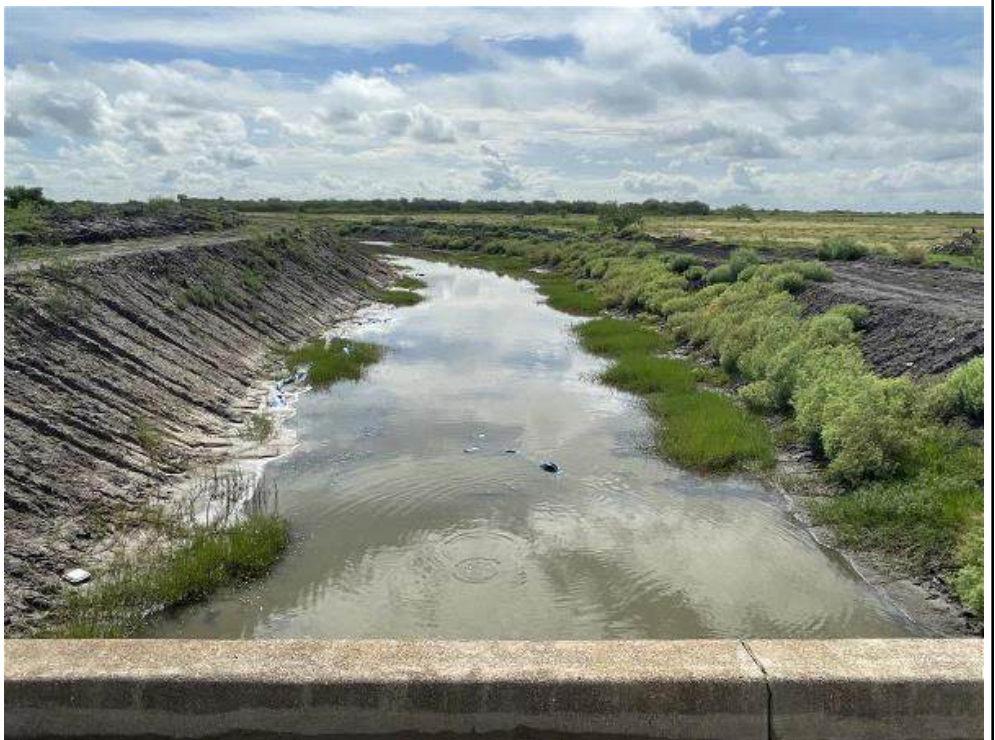
<b>Latitude/Longitude:</b> 26.484351, -98.014251			
<b>Photo Direction:</b> east			
<b>Description:</b> T002B (Perennial Drainage Ditch) looking downstream			
<b>Photograph ID:</b> 104

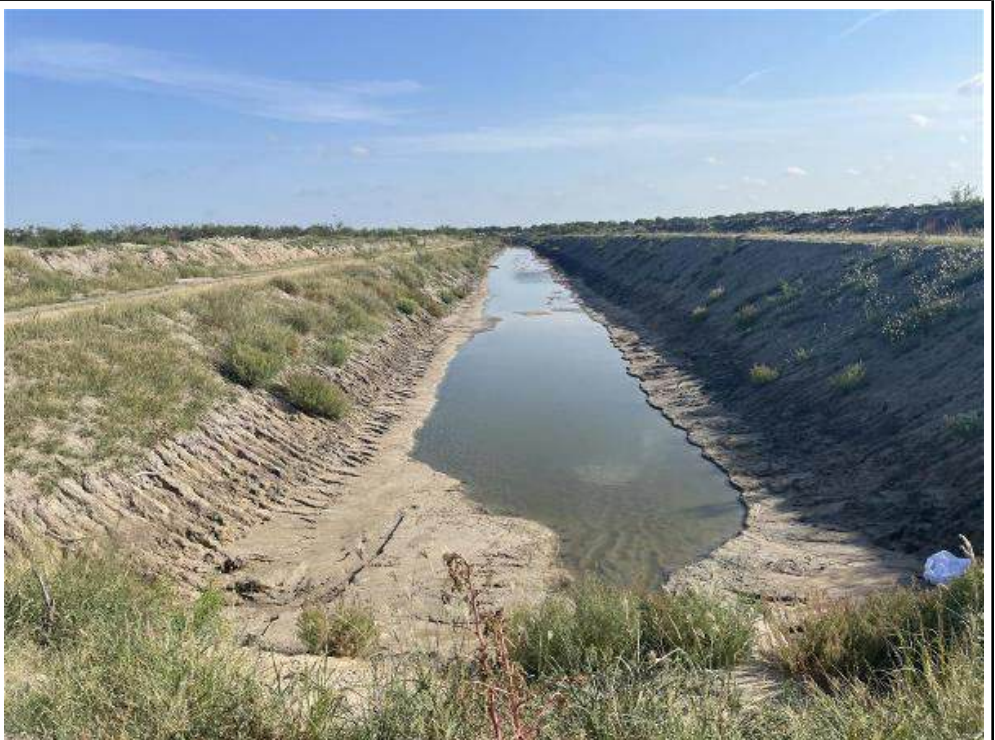
<b>Latitude/Longitude:</b> 26.474356, -98.027776			
<b>Photo Direction:</b> northeast			
<b>Description:</b> T002B (Perennial Drainage Ditch) looking downstream, at the beginning of perennial flow

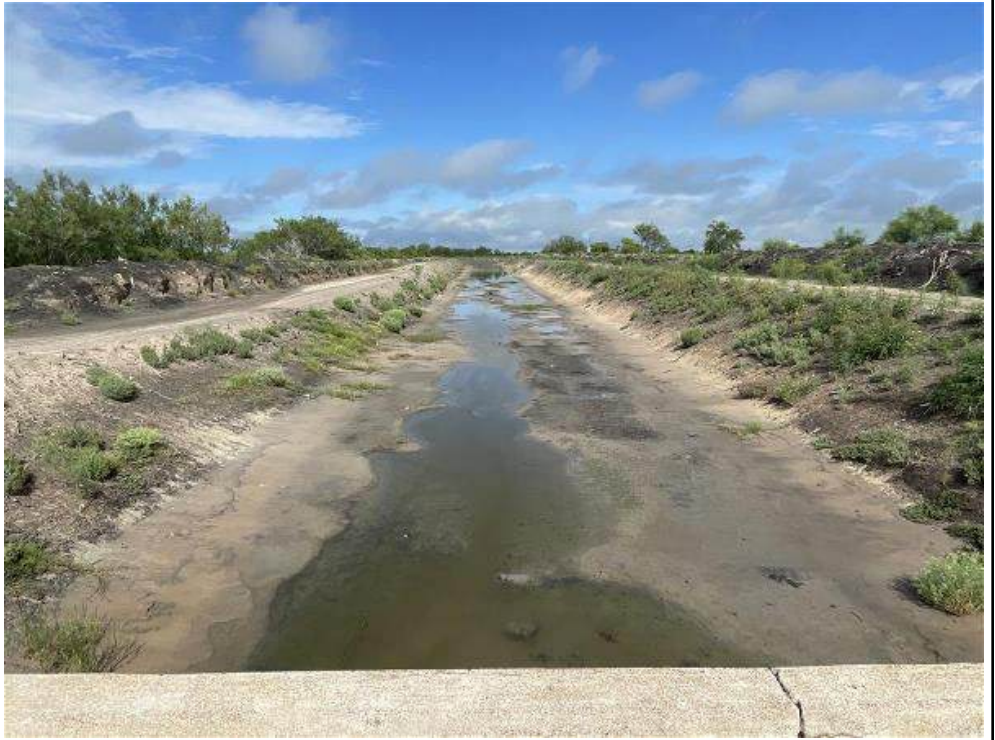
<b>Latitude/Longitude:</b> 26.48431, -98.014247			
<b>Photo Direction:</b> west			
<b>Description:</b> T002B (Perennial Drainage Ditch) looking upstream			
<b>Photograph ID:</b> 106

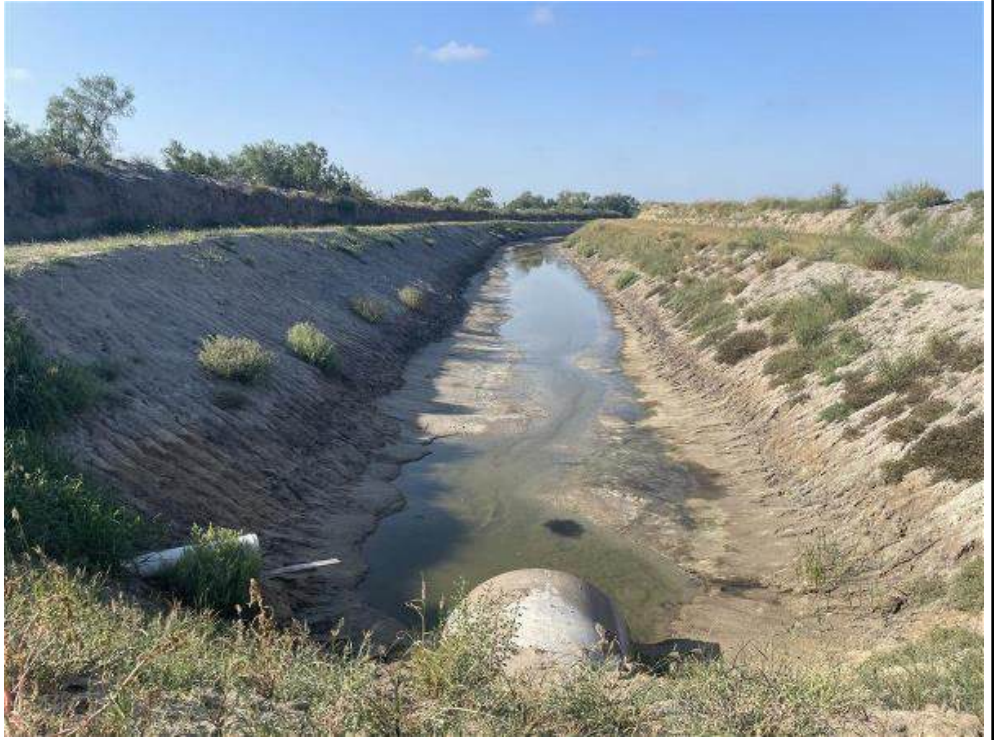
<b>Latitude/Longitude:</b> 26.474355, -98.027776			
<b>Photo Direction:</b> southwest			
<b>Description:</b> T002B (Perennial Drainage Ditch) looking upstream, at the beginning of perennial flow

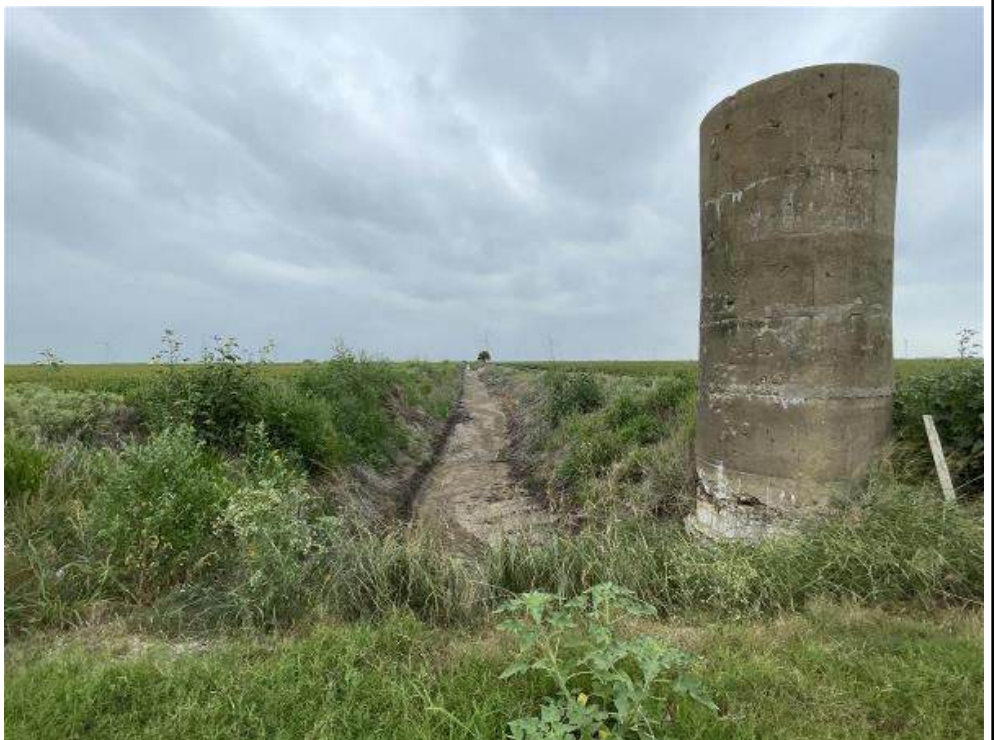
<b>Latitude/Longitude:</b> 26.50454723, -97.66379			
<b>Photo Direction:</b> south			
<b>Description:</b> T009 (Upland Drainage Ditch) up-gradient from nearby public road			
<b>Photograph ID:</b> 108

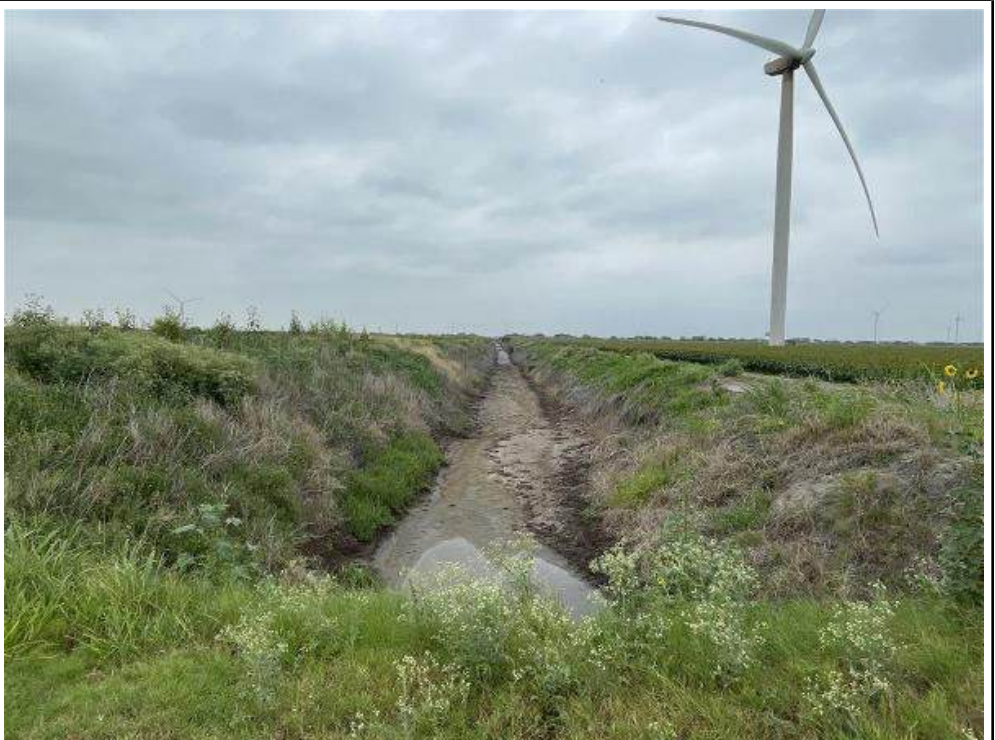
<b>Latitude/Longitude:</b> 26.50454735, -97.66379			
<b>Photo Direction:</b> north			
<b>Description:</b> T009 (Upland Drainage Ditch) down-gradient from nearby public road

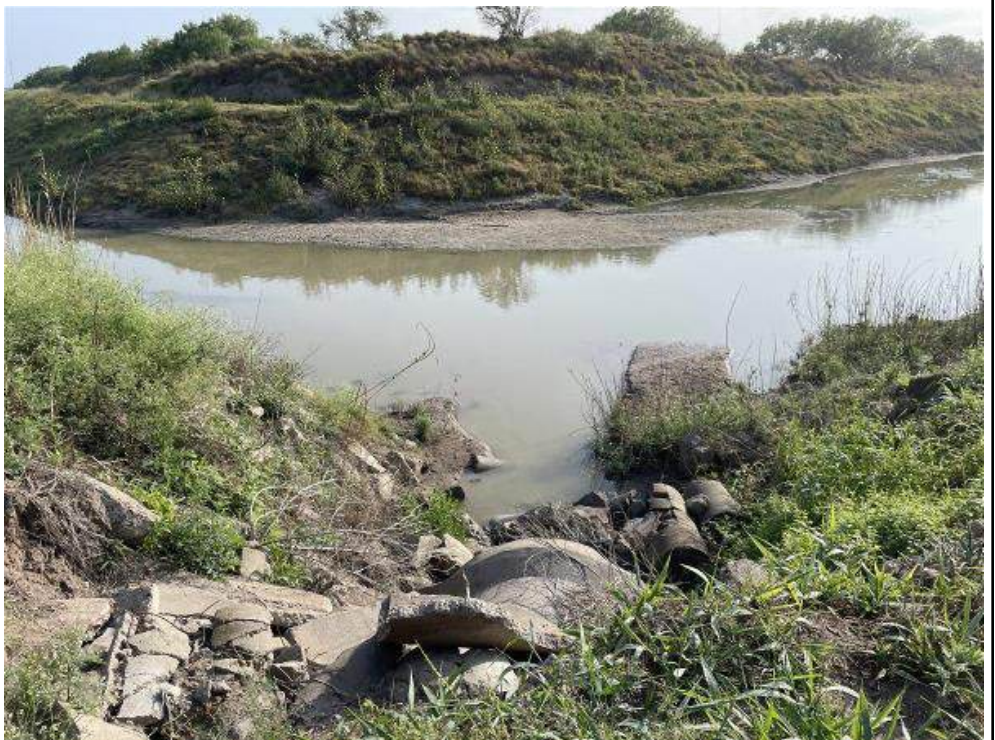
<b>Latitude/Longitude:</b> 26.51177408, -97.663991			
<b>Photo Direction:</b> northeast			
<b>Description:</b> T009 (Upland Drainage Ditch) facing downstream and facing confluence of T001B			
<b>Photograph ID:</b> 110

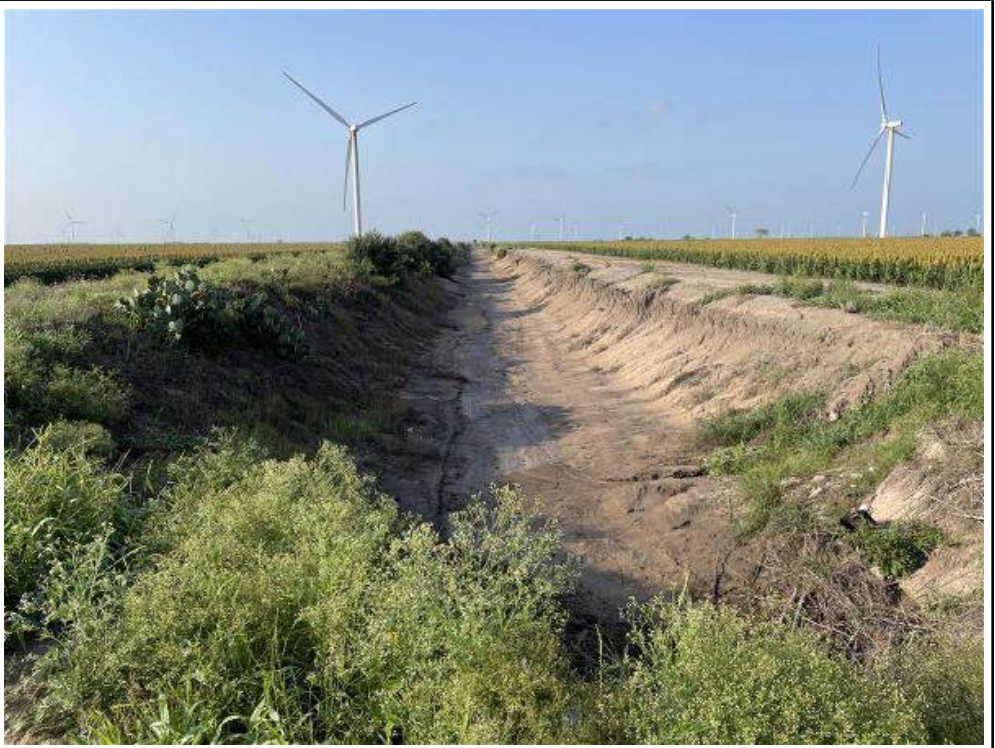
<b>Latitude/Longitude:</b> 26.51177242, -97.664005			
<b>Photo Direction:</b> south			
<b>Description:</b> T009 (Upland Drainage Ditch) facing upstream

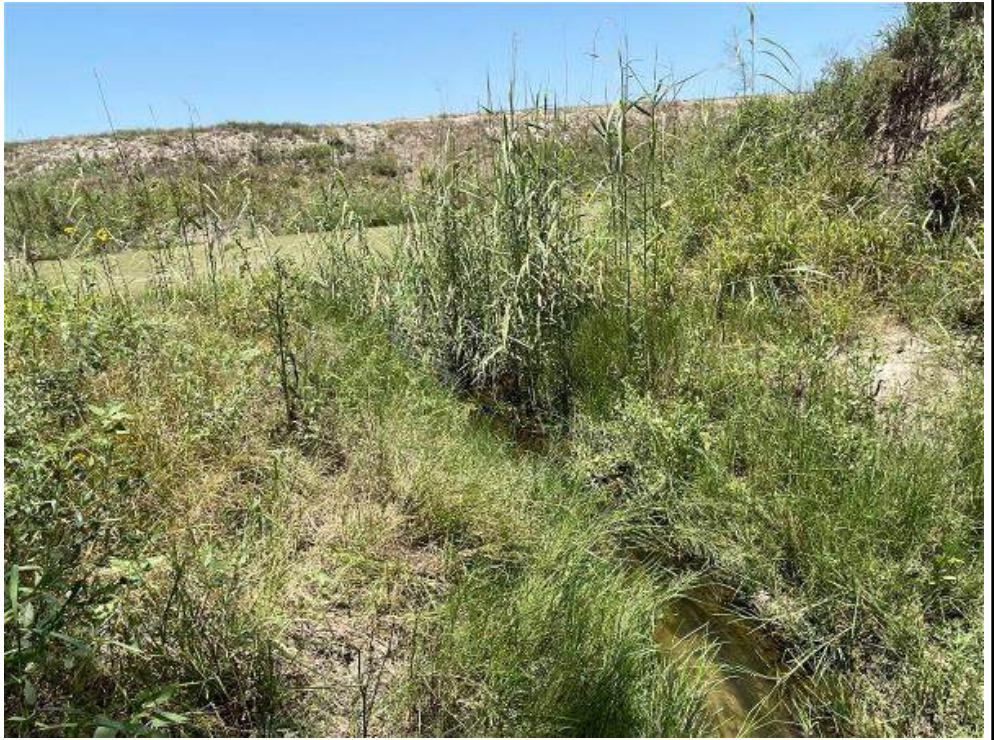
<b>Latitude/Longitude:</b> 26.51855943, -97.700374			
<b>Photo Direction:</b> north			
<b>Description:</b> T010 (Perennial Drainage Ditch) facing downstream			
<b>Photograph ID: 112</b>

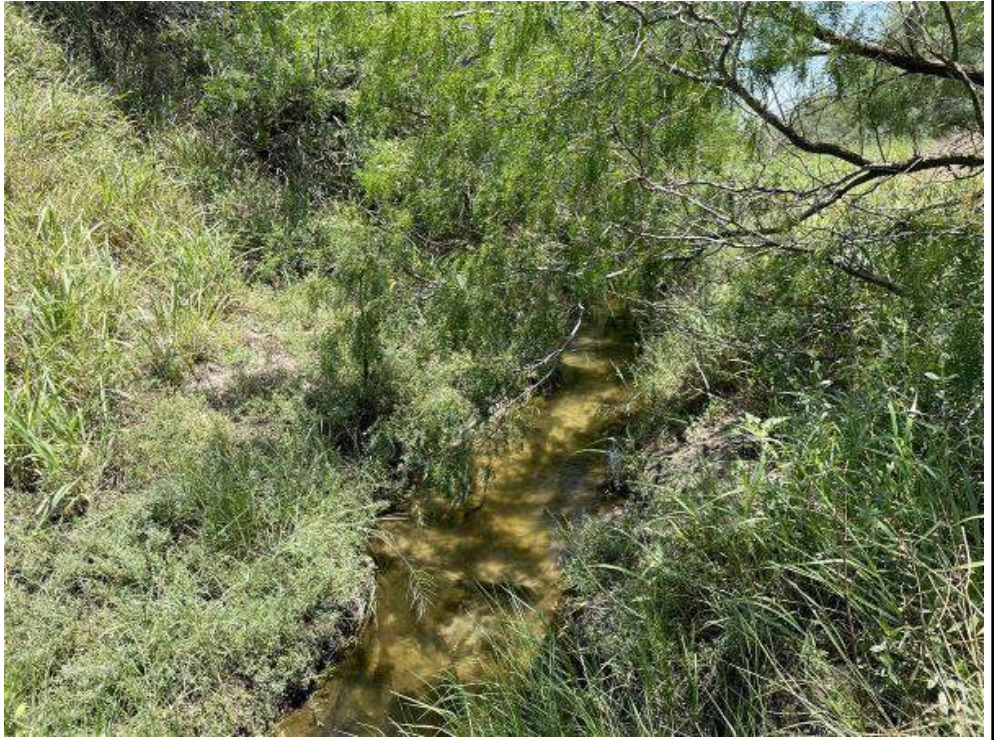
<b>Latitude/Longitude:</b> 26.51858306, -97.700371			
<b>Photo Direction:</b> south			
<b>Description:</b> T010 (Perennial Drainage Ditch) facing upstream

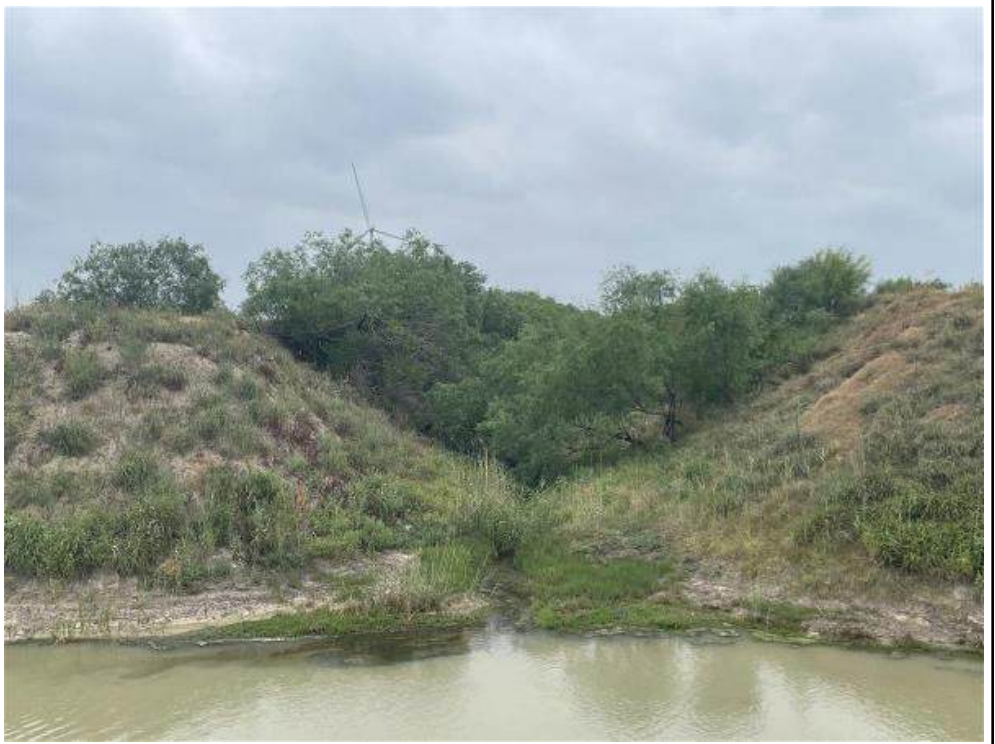
<b>Latitude/Longitude:</b> 26.51894739, -97.700436			
<b>Photo Direction:</b> south			
<b>Description:</b> T010 (Perennial Drainage Ditch) view up-gradient at confluence with RVD (No ROE)			
<b>Photograph ID:</b> 114

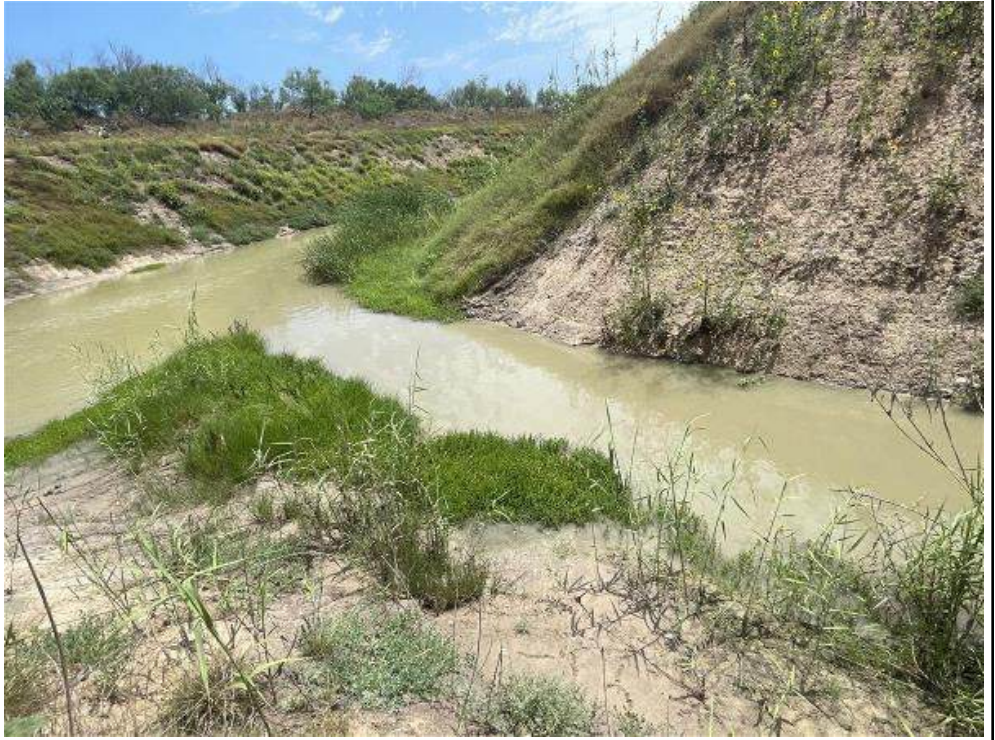
<b>Latitude/Longitude:</b> 26.51852154, -97.712528			
<b>Photo Direction:</b> north			
<b>Description:</b> T011 (Perennial Drainage Ditch) facing downstream

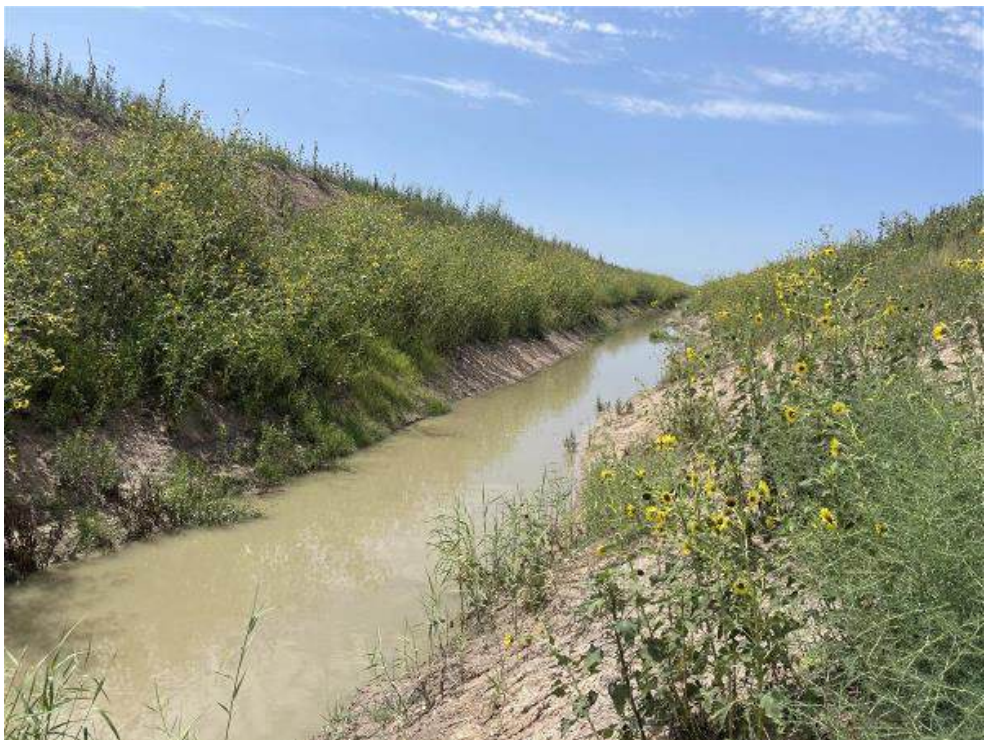
<b>Latitude/Longitude:</b> 26.518524, -97.712527			
<b>Photo Direction:</b> south			
<b>Description:</b> T011 (Perennial Drainage Ditch) facing upstream			
<b>Photograph ID:</b> 116

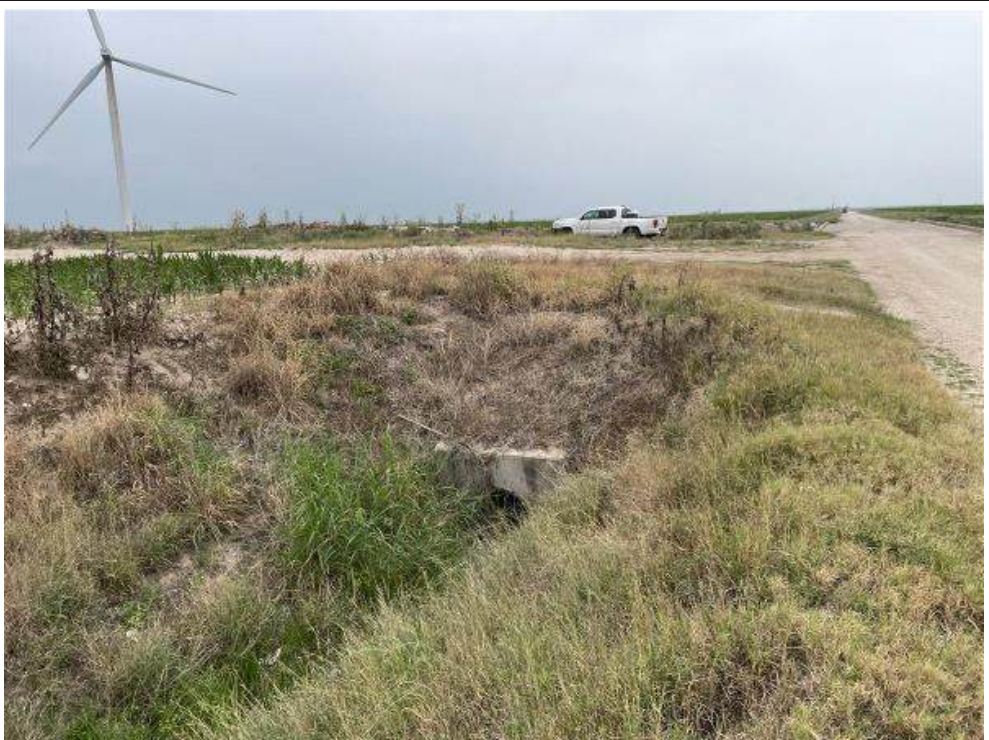
<b>Latitude/Longitude:</b> 26.51901756, -97.736703			
<b>Photo Direction:</b> south			
<b>Description:</b> T012 (Upland Drainage Ditch) facing downstream

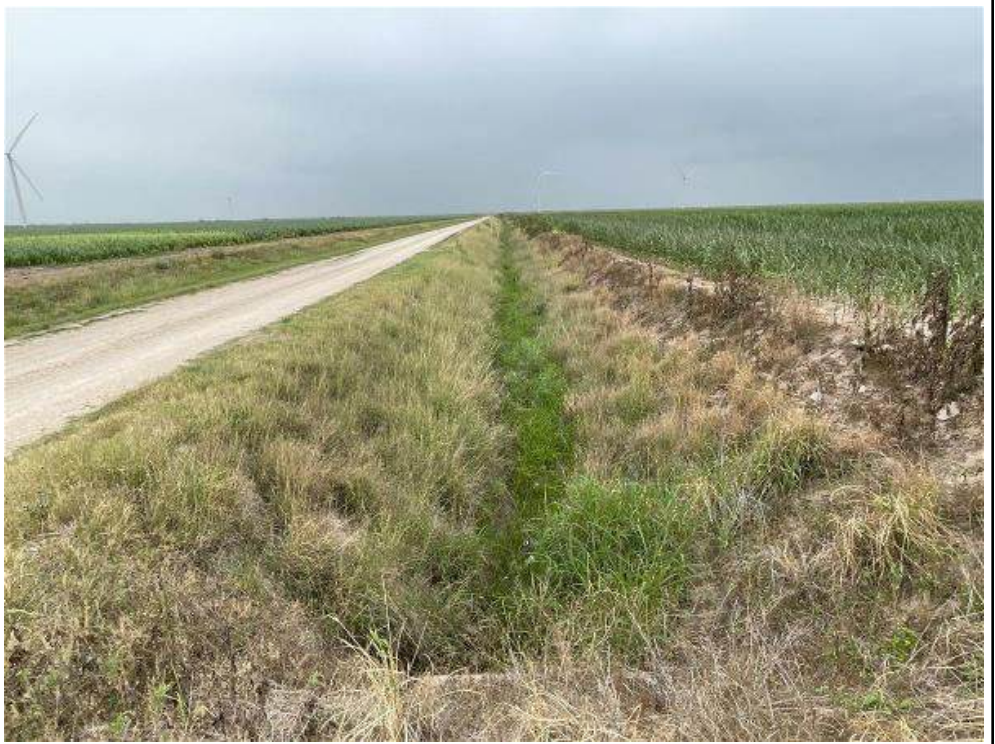
<b>Latitude/Longitude:</b> 26.51894245, -97.736659			
<b>Photo Direction:</b> north			
<b>Description:</b> T012 (Upland Drainage Ditch) facing upstream			
<b>Photograph ID: 118</b>

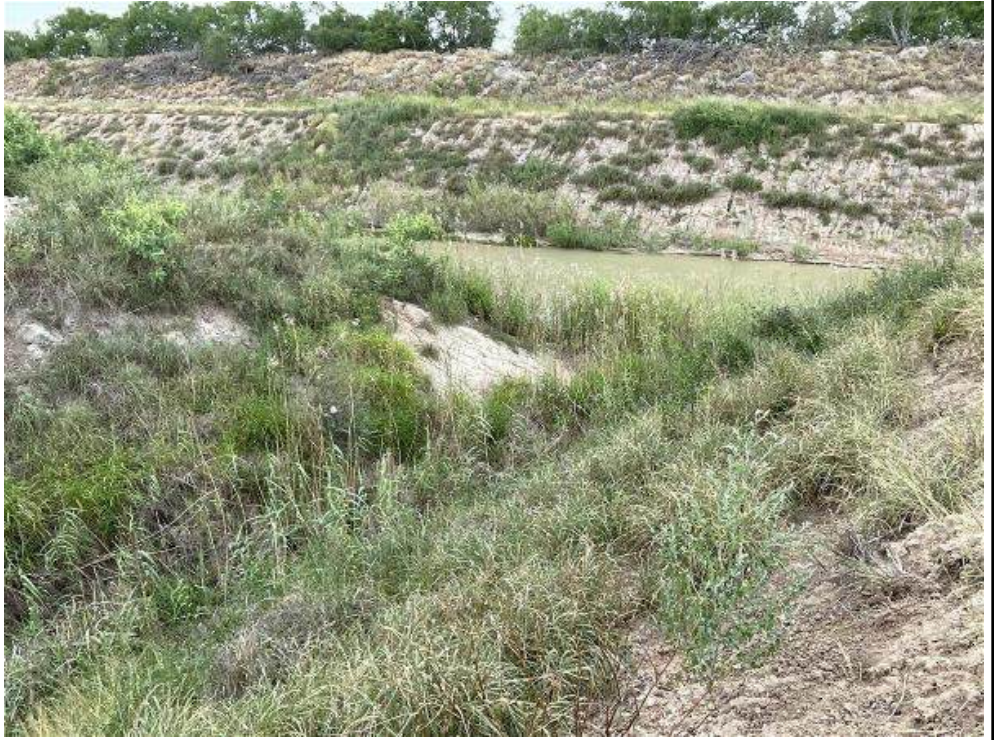
<b>Latitude/Longitude:</b> 26.51815317, -97.748599			
<b>Photo Direction:</b> north			
<b>Description:</b> T013 (Upland Drainage Ditch) facing downstream

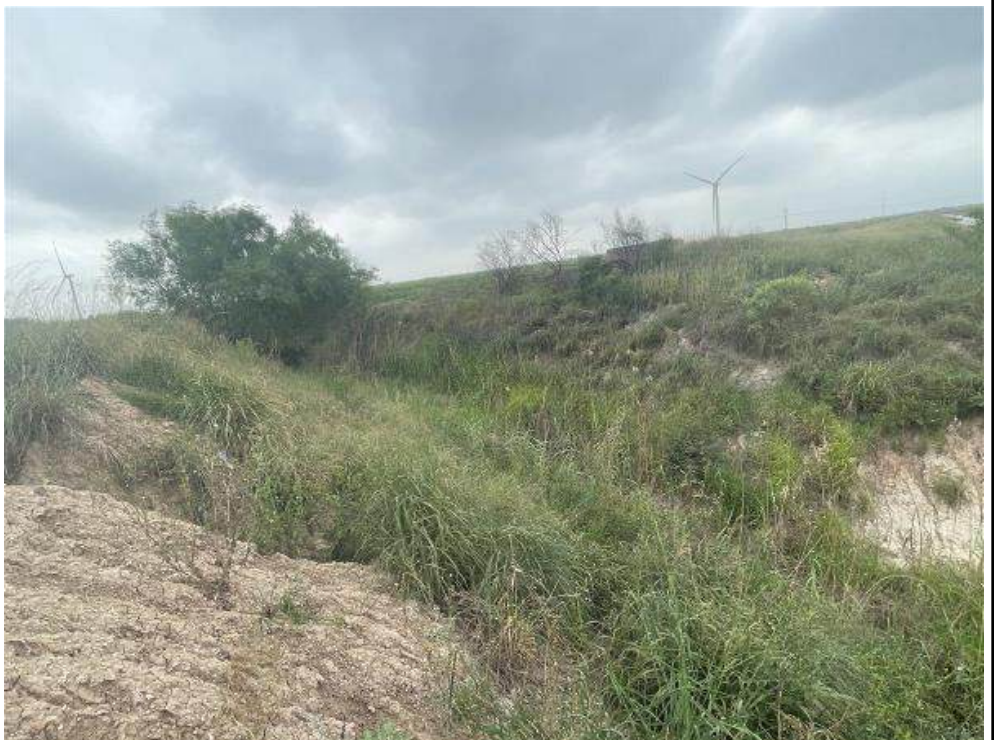
<b>Latitude/Longitude:</b> 26.51827923, -97.748551			
<b>Photo Direction:</b> south			
<b>Description:</b> T013 (Upland Drainage Ditch) facing upstream			
<b>Photograph ID:</b> 120

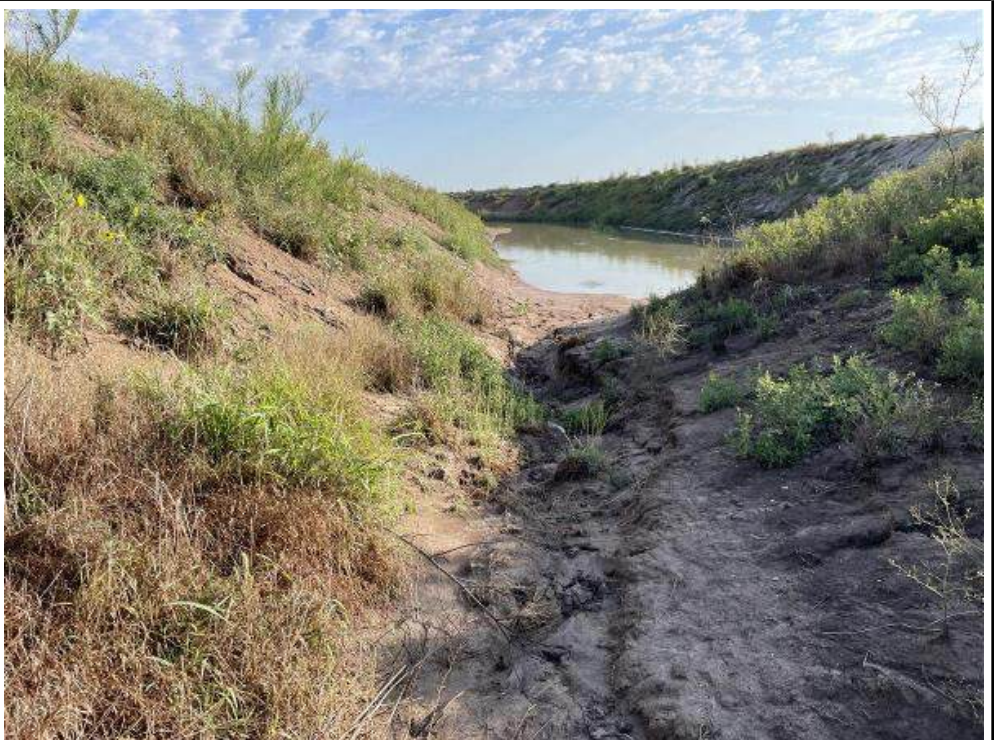
<b>Latitude/Longitude:</b> 26.51806243, -97.759408			
<b>Photo Direction:</b> north			
<b>Description:</b> T014 (Upland Drainage Ditch) facing downstream

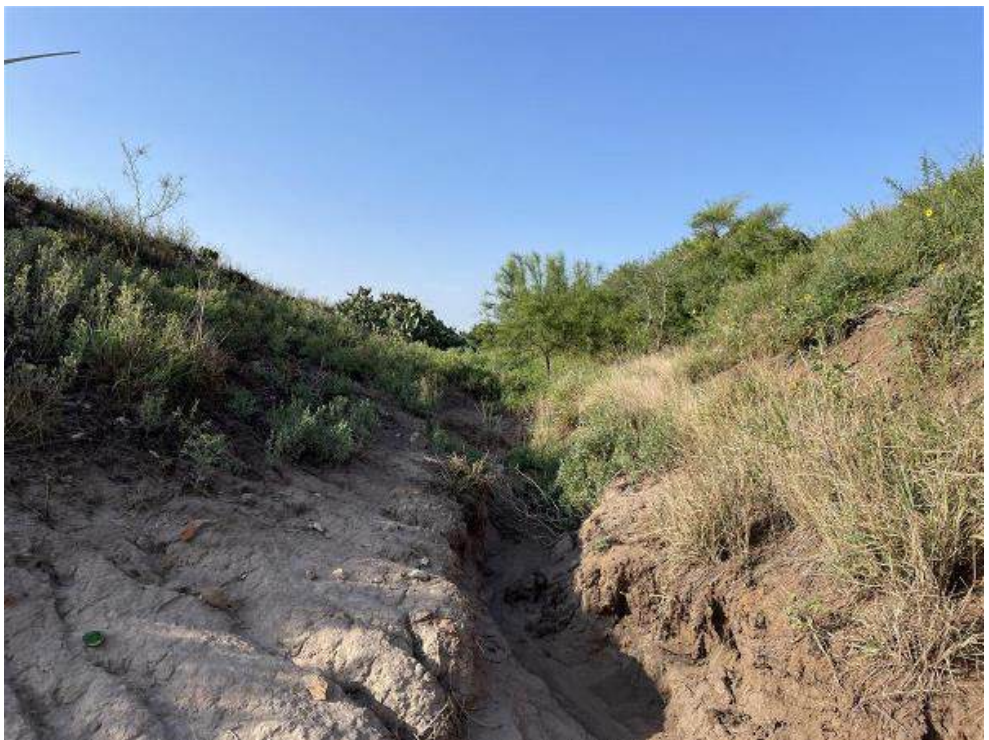
<b>Latitude/Longitude:</b> 26.5182129, -97.75939			
<b>Photo Direction:</b> south			
<b>Description:</b> T014 (Upland Drainage Ditch) facing upstream			
<b>Photograph ID:</b> 122

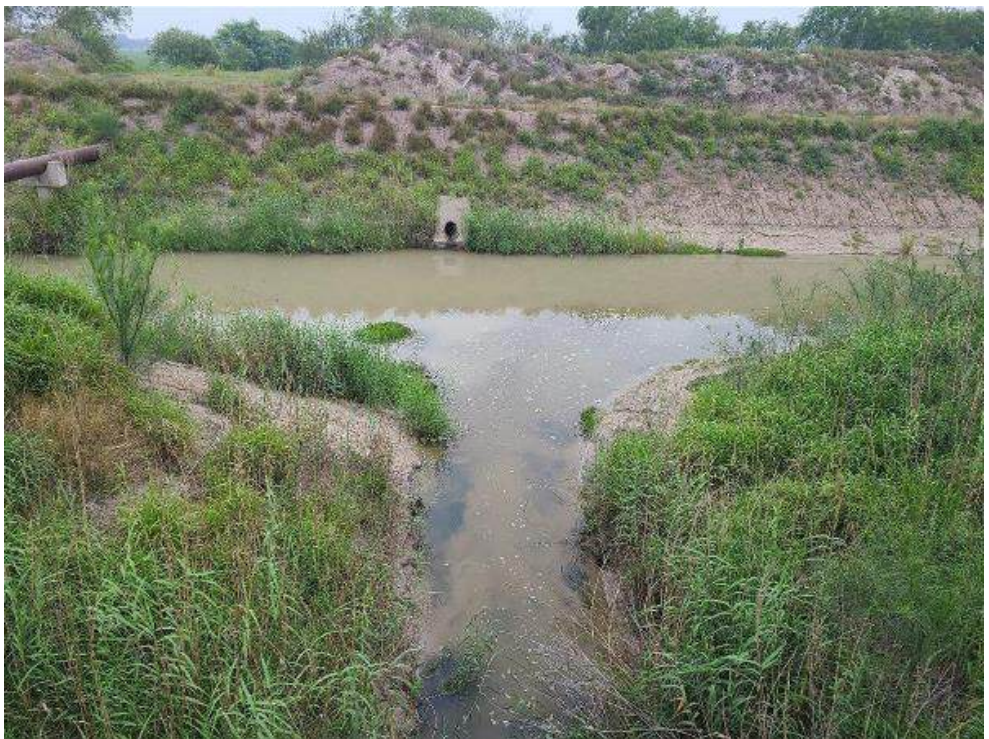
<b>Latitude/Longitude:</b> 26.51895938, -97.779286			
<b>Photo Direction:</b> north			
<b>Description:</b> T015 (Perennial Drainage Ditch) facing downstream

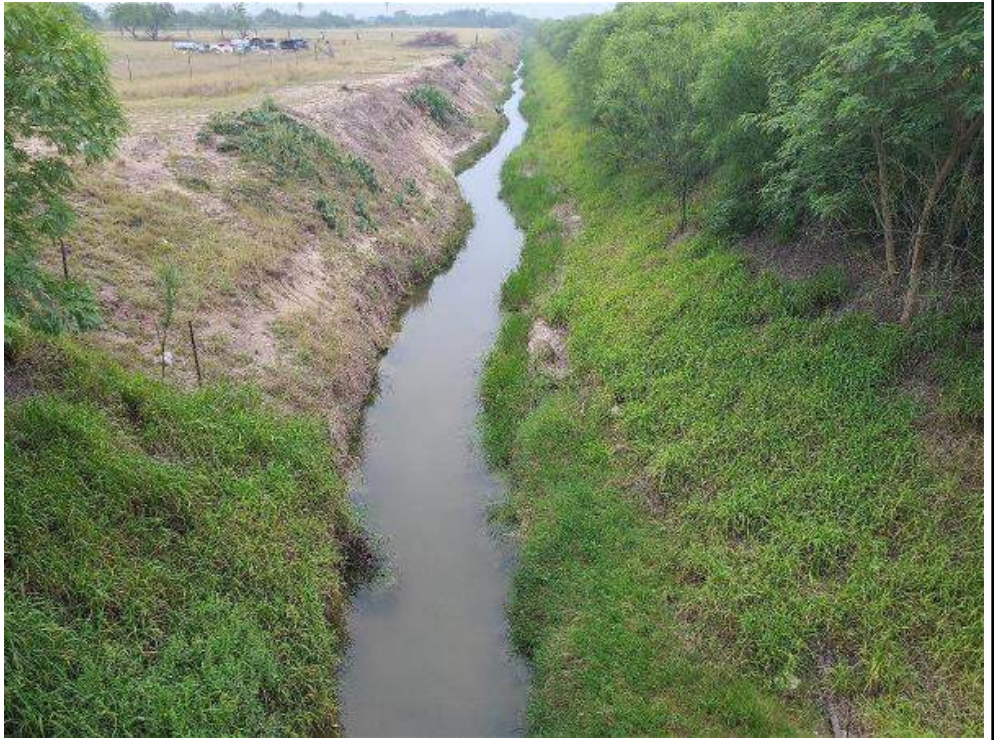
<b>Latitude/Longitude:</b> 26.5188534, -97.779267			
<b>Photo Direction:</b> north			
<b>Description:</b> T015 (Perennial Drainage Ditch) facing upstream			
<b>Photograph ID:</b> 124

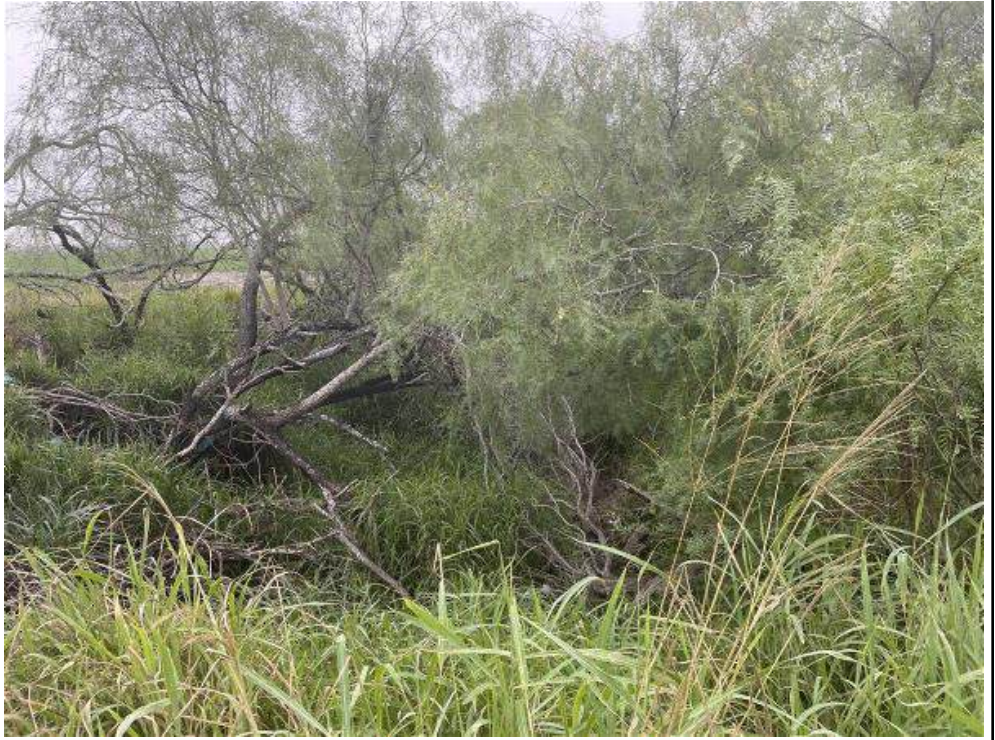
<b>Latitude/Longitude:</b> 26.52716393, -97.819067			
<b>Photo Direction:</b> south			
<b>Description:</b> T016 (Upland Drainage Ditch) facing upstream

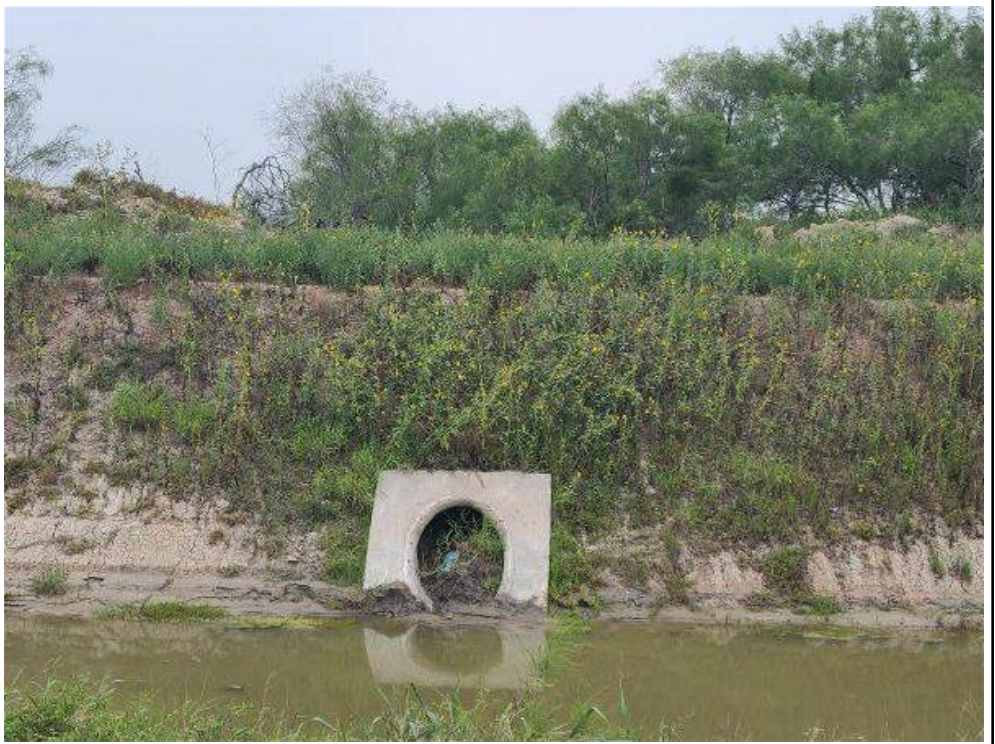
<b>Latitude/Longitude:</b> 26.52751515, -97.819099			
<b>Photo Direction:</b> south			
<b>Description:</b> T016 (Upland Drainage Ditch) facing upstream at culvert confluence with T001A			
<b>Photograph ID:</b> 126
