## **Delineation Report**

Raymondville Drain Project  
Hidalgo and Willacy Counties, Texas

December 11, 2024

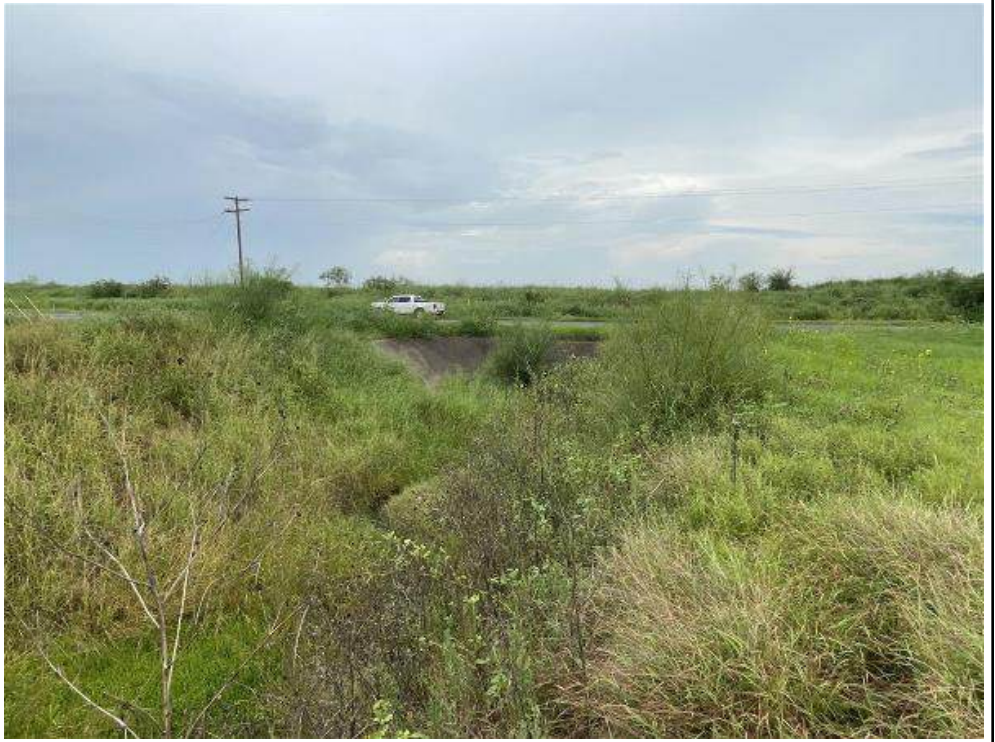
<b>Latitude/Longitude:</b> 26.51794815, -97.834042			
<b>Photo Direction:</b> north			
<b>Description:</b> T017 (Upland Drainage Ditch) facing downstream

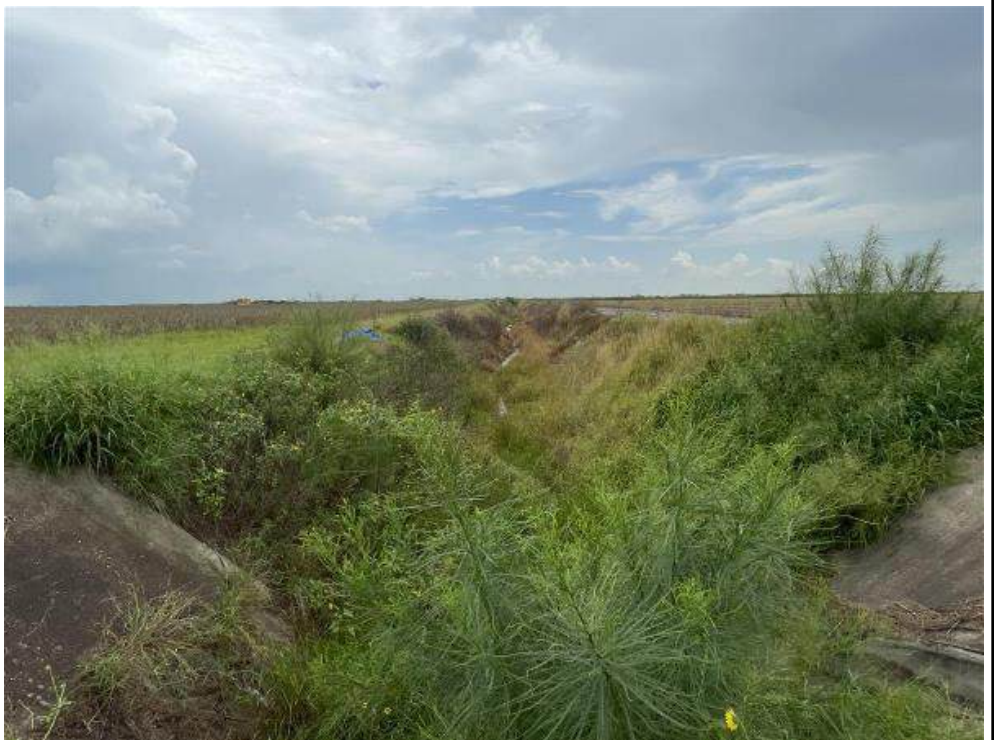
<b>Latitude/Longitude:</b> 26.51815635, -97.834093			
<b>Photo Direction:</b> south			
<b>Description:</b> T017 (Upland Drainage Ditch) facing upstream			
<b>Photograph ID:</b> 128

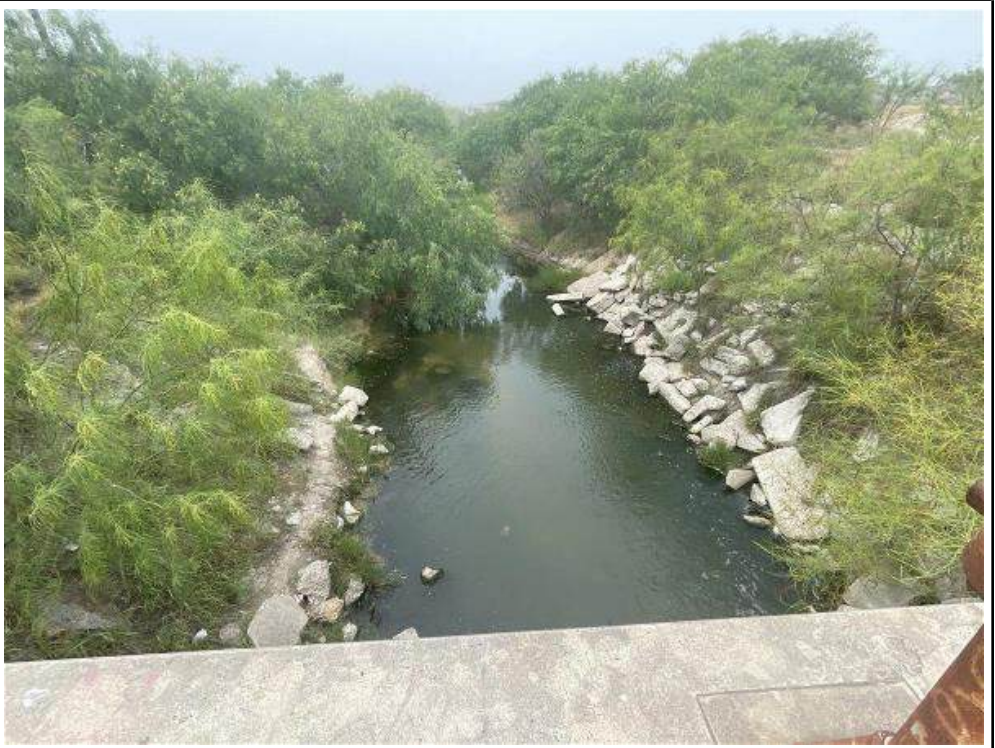
<b>Latitude/Longitude:</b> 26.4960625, -97.862041			
<b>Photo Direction:</b> west			
<b>Description:</b> T018 (Perennial Drainage Ditch) facing downstream

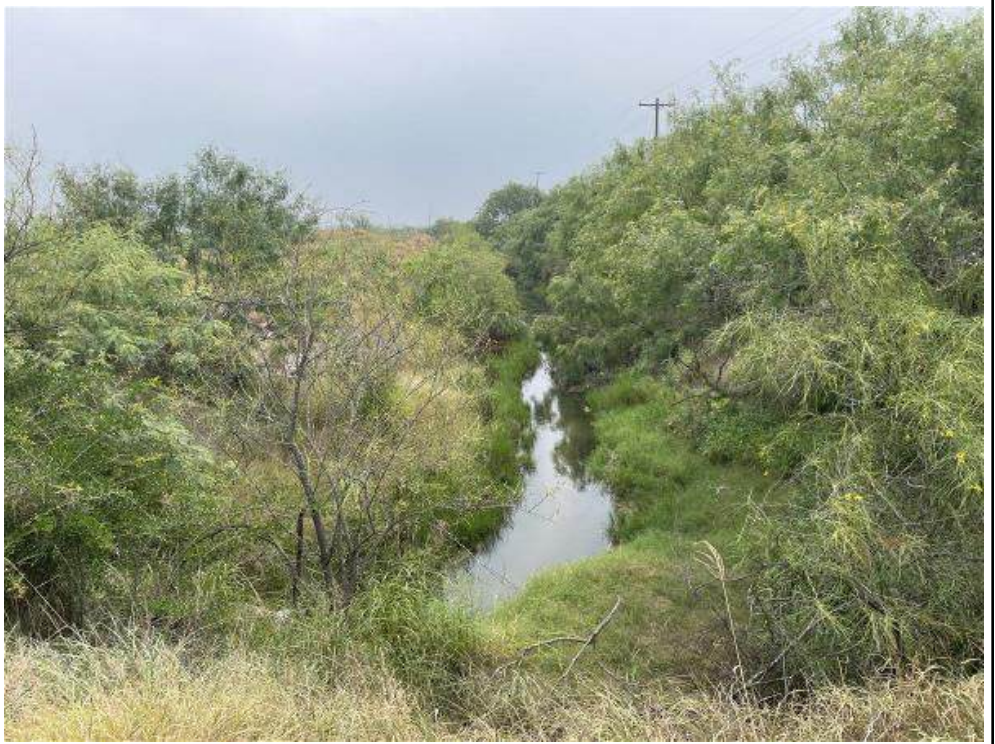
<b>Latitude/Longitude:</b> 26.49607348, -97.861989			
<b>Photo Direction:</b> east			
<b>Description:</b> T018 (Perennial Drainage Ditch) facing upstream			
<b>Photograph ID:</b> 130

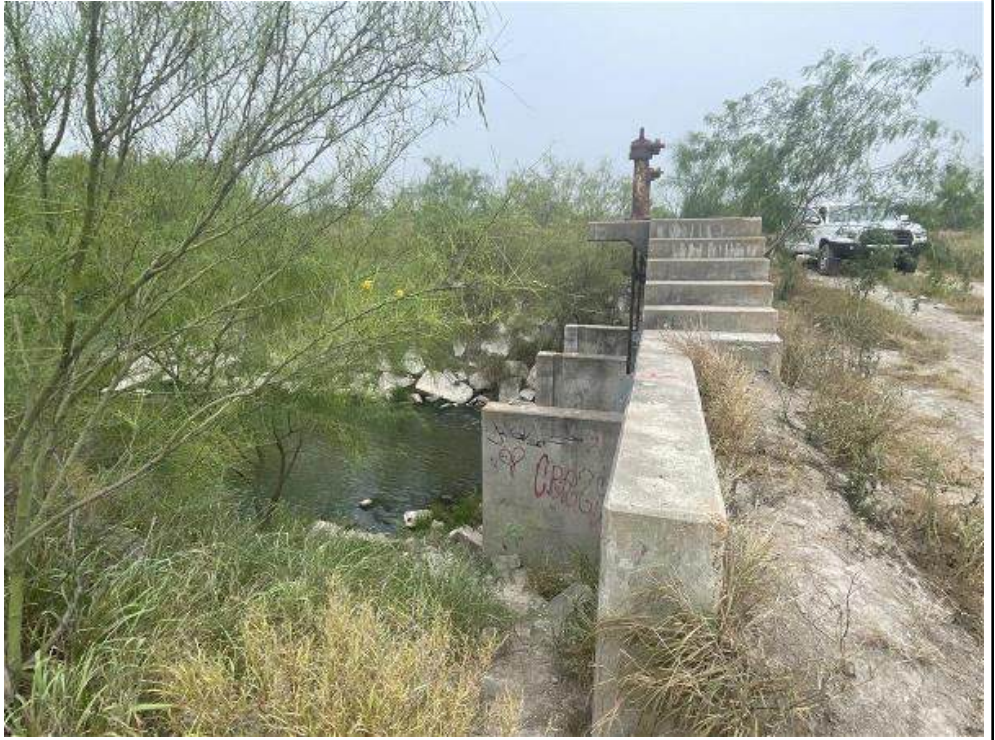
<b>Latitude/Longitude:</b> 26.49597238, -97.862047			
<b>Photo Direction:</b> west			
<b>Description:</b> T018 (Perennial Drainage Ditch) view of flow control structure

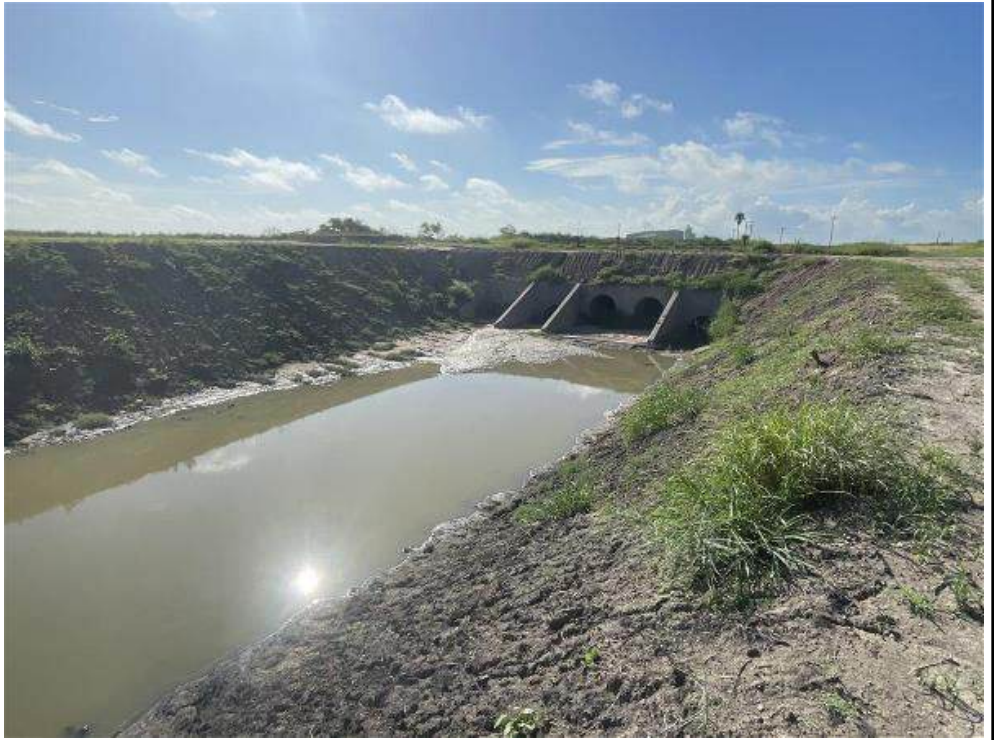
<b>Latitude/Longitude:</b> 26.47967649, -97.901117			
<b>Photo Direction:</b> southeast			
<b>Description:</b> T020 (Salt Lake Drain, Perennial Drainage Ditch) facing downstream. Flood control structure visible.			
<b>Photograph ID:</b> 132

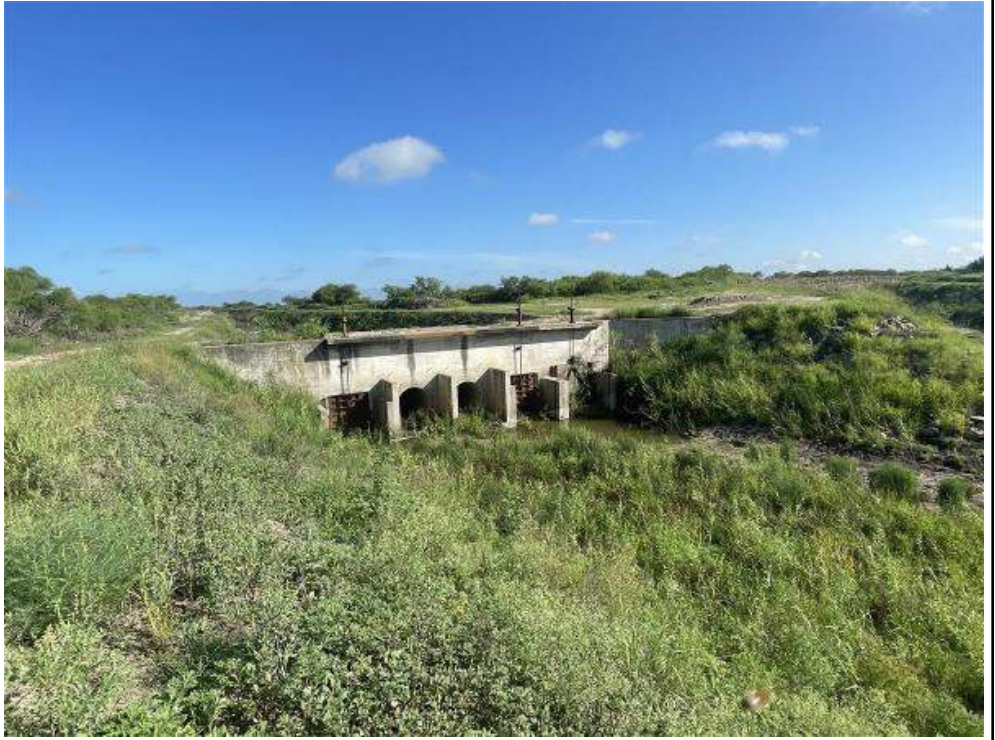
<b>Latitude/Longitude:</b> 26.47921516, -97.900622			
<b>Photo Direction:</b> northwest			
<b>Description:</b> T020 (Salt Lake Drain, Perennial Drainage Ditch) facing upstream. Flood control structure visible.

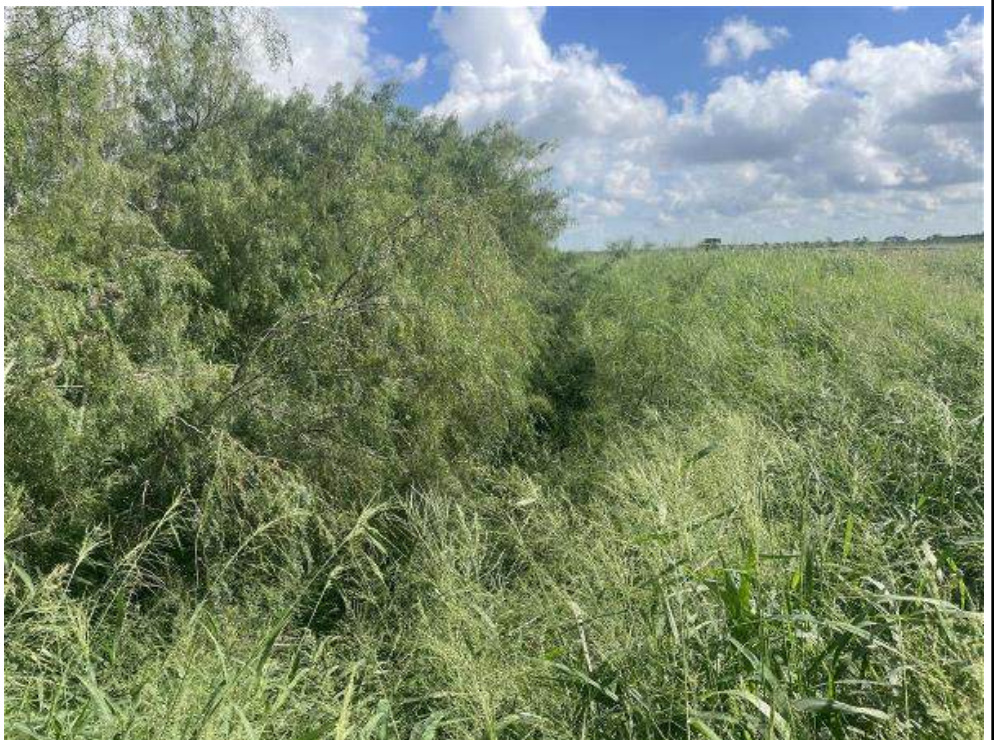
<b>Latitude/Longitude:</b> 26.47200724, -97.90998837			
<b>Photo Direction:</b> northeast			
<b>Description:</b> T021 (Upland Drainage Ditch) facing upstream			
<b>Photograph ID: 134</b>

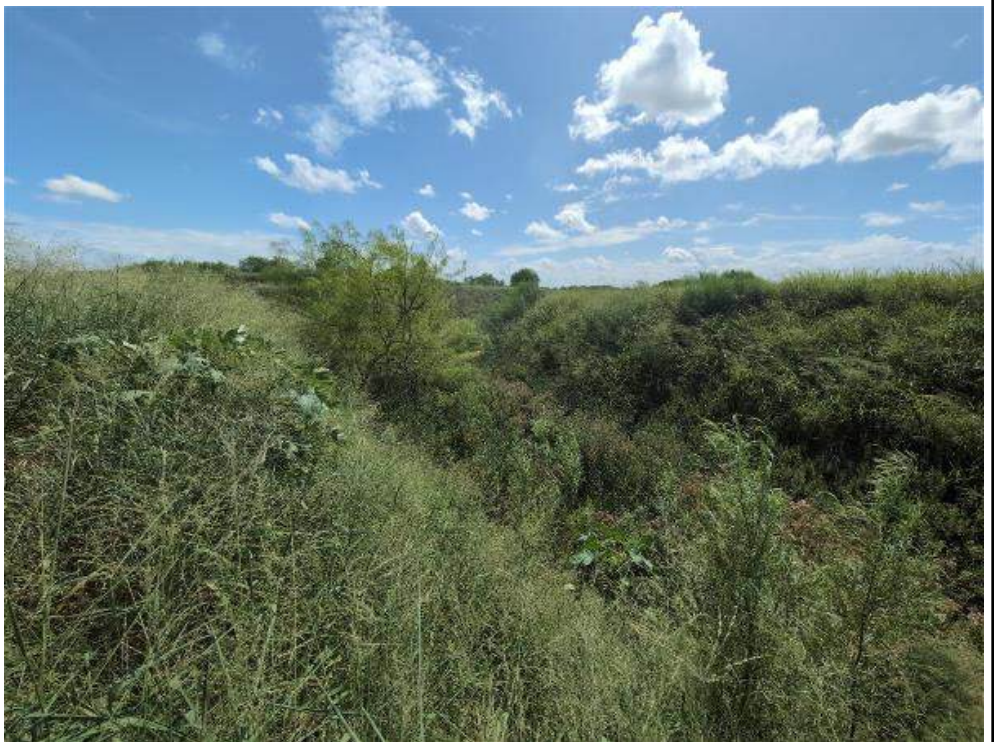
<b>Latitude/Longitude:</b> 26.47116424, -97.930801			
<b>Photo Direction:</b> northeast			
<b>Description:</b> T022 (Upland Drainage Ditch) facing downstream

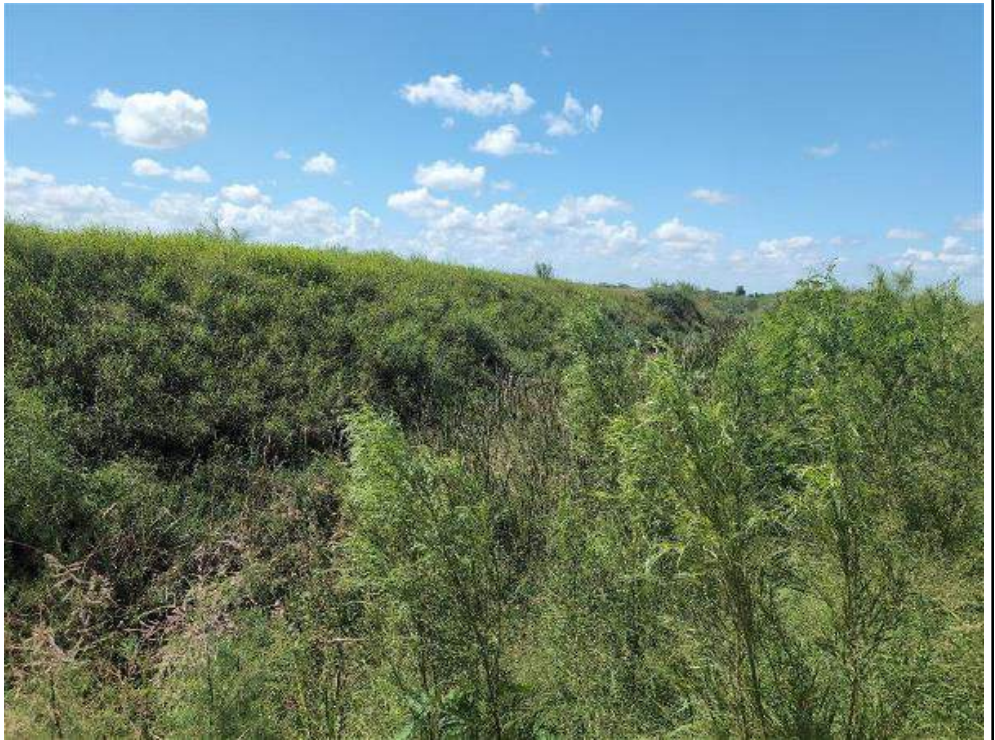
<b>Latitude/Longitude:</b> 26.47116469, -97.930801			
<b>Photo Direction:</b> southwest			
<b>Description:</b> T022 (Upland Drainage Ditch) facing upstream			
<b>Photograph ID:</b> 136

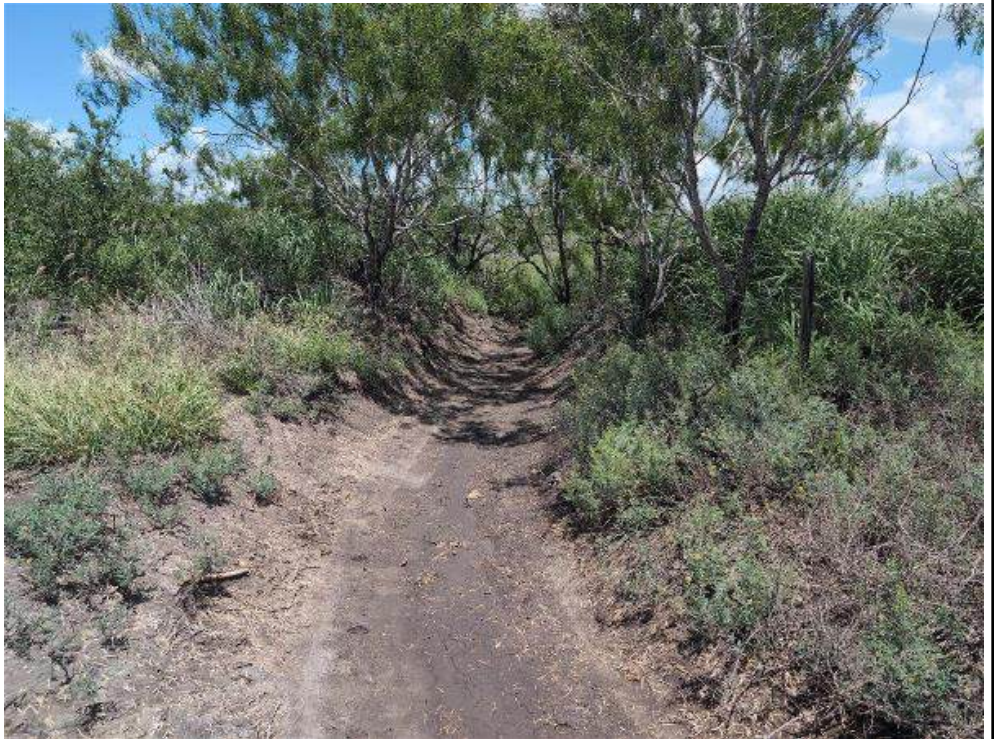
<b>Latitude/Longitude:</b> 26.48318121, -97.98748683			
<b>Photo Direction:</b> northwest			
<b>Description:</b> T024 (Upland Drainage Ditch) looking downstream

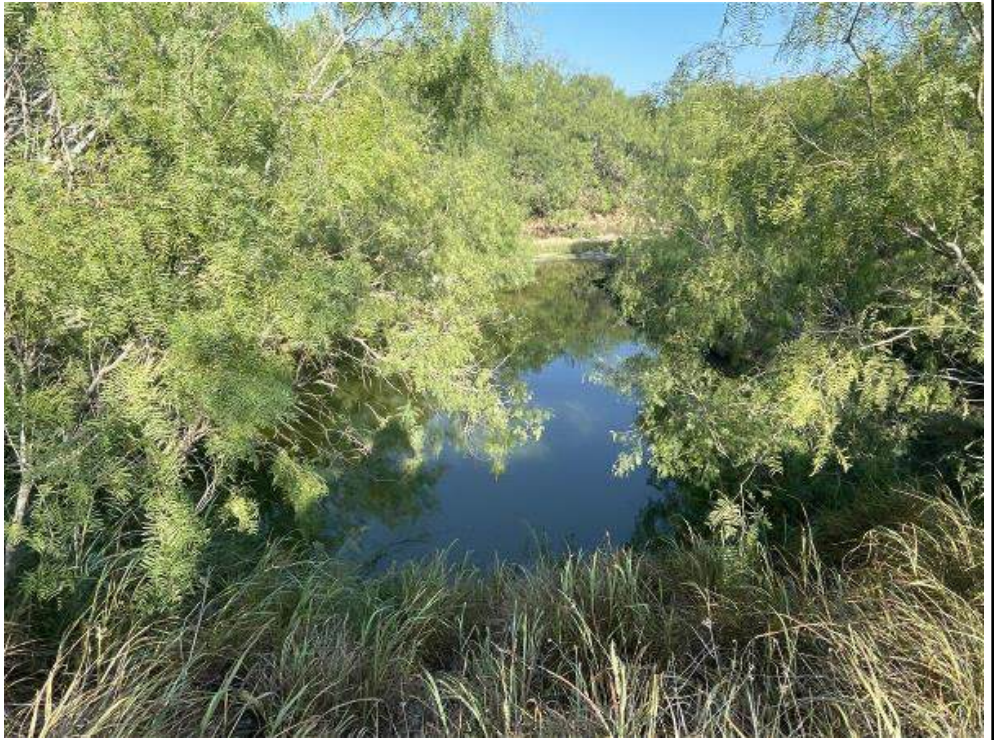
<b>Latitude/Longitude:</b> 26.47765519, -98.040002			
<b>Photo Direction:</b> west			
<b>Description:</b> T026 (Perennial Drainage Ditch) upgradient (outside project area at public access)			
<b>Photograph ID:</b> 138

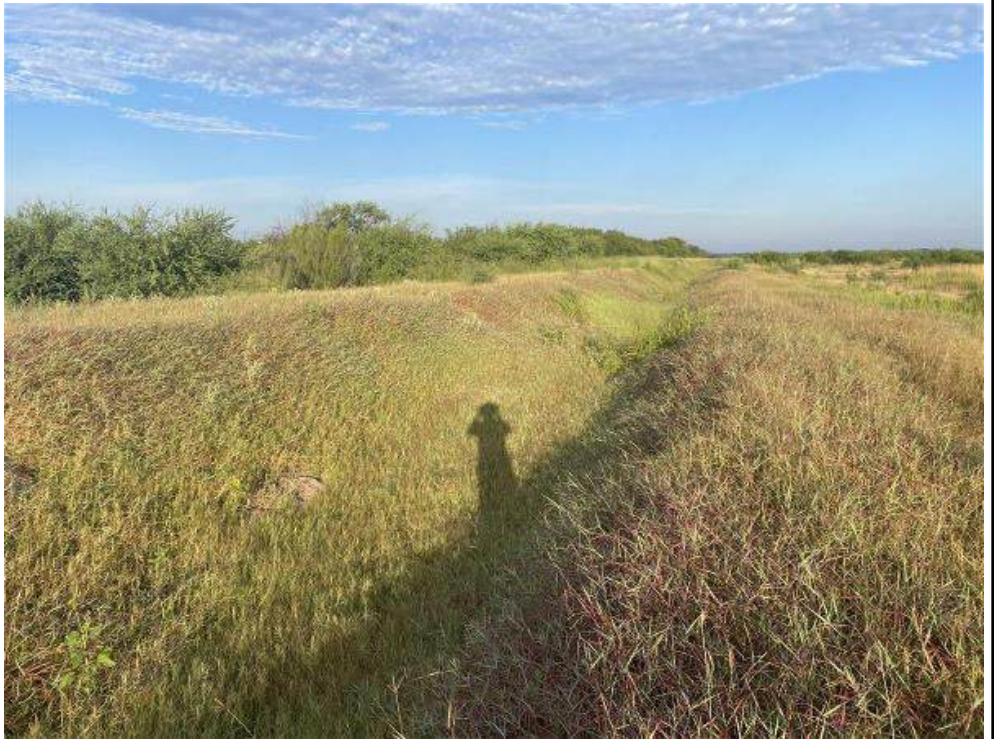
<b>Latitude/Longitude:</b> 26.40220418, -98.16104901			
<b>Photo Direction:</b> west			
<b>Description:</b> T028 (Upland Drainage Ditch) looking upstream

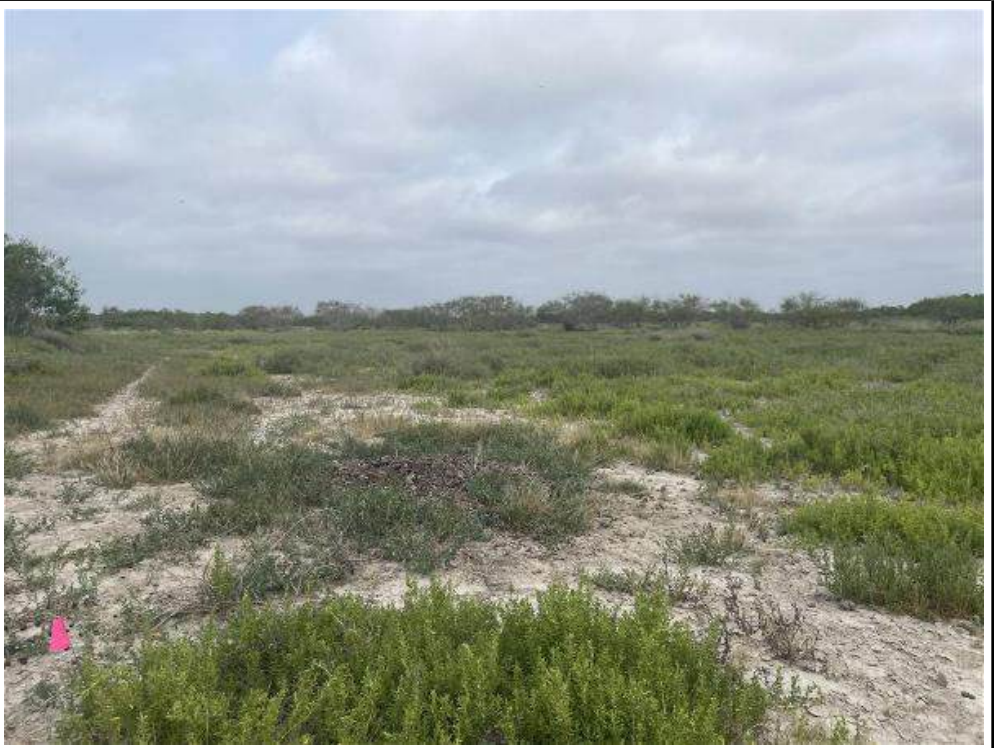
<b>Latitude/Longitude:</b> 26.52757293, -97.507745			
<b>Photo Direction:</b> northeast			
<b>Description:</b> W001 (Palustrine Emergent Wetland)

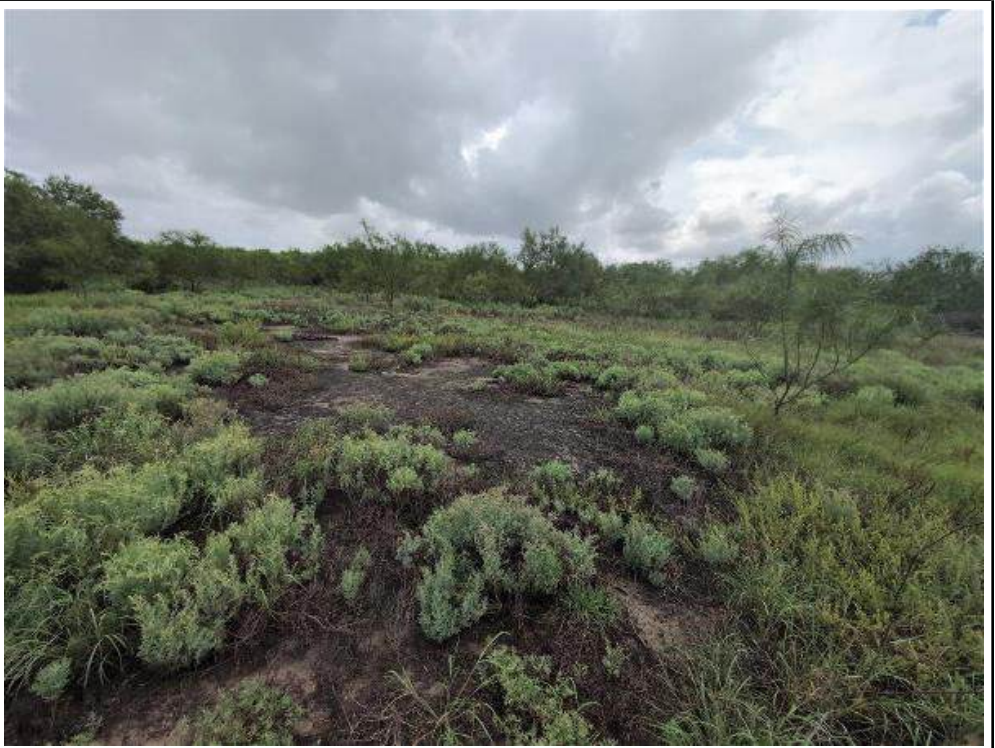
<b>Latitude/Longitude:</b> 26.45130749, -98.034726			
<b>Photo Direction:</b> east			
<b>Description:</b> W022 (Palustrine Emergent Wetland)

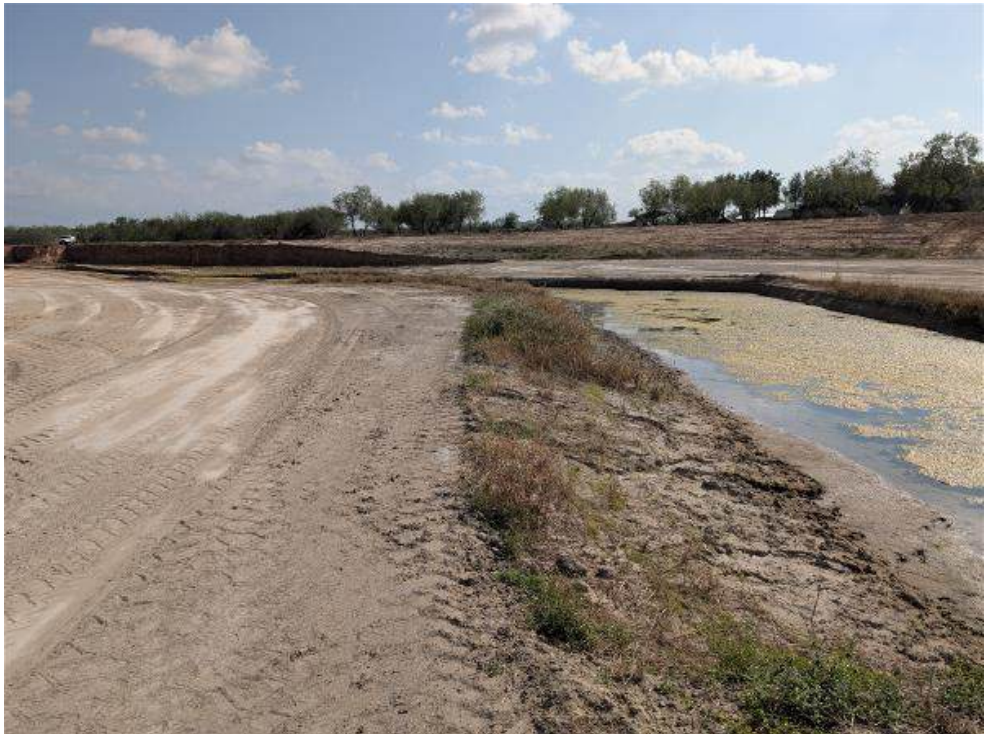
<b>Client:</b> <b>Report:</b>	<b>Hidalgo County Drainage District No. 1</b> <b>Wetland Delineation Report</b>	<b>Project:</b> <b>Site Location:</b>	<b>Raymondville Drain Project</b> <b>Hidalgo and Willacy County, Texas</b>
<b>Photograph ID:</b> 165  <b>Latitude/Longitude:</b> 26.25367299, -98.8488  <b>Photo Direction:</b> southeast  <b>Description:</b> Active construction and associated water filled depression incidental to construction located immediately east of I69C (characterized by DP 073)

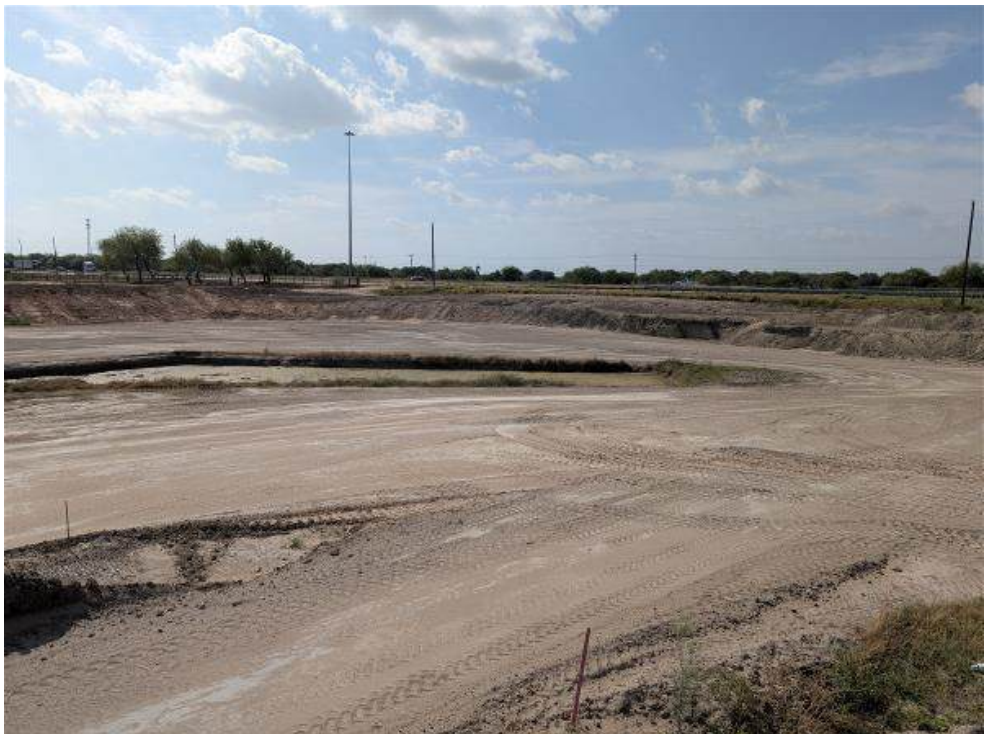
<b>Photograph ID:</b> 166  <b>Latitude/Longitude:</b> 26.25405899, -98.84809  <b>Photo Direction:</b> southwest  <b>Description:</b> Active construction and associated water filled depression incidental to construction located immediately east of I69C (characterized by DP 073)

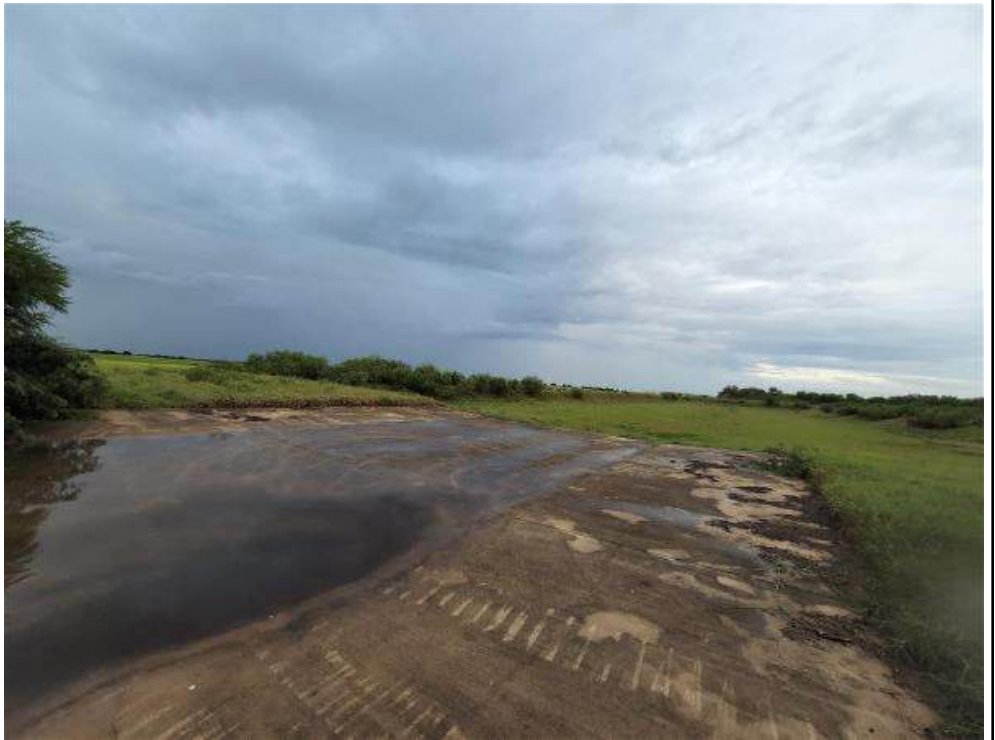
<b>Client:</b>	<b>Hidalgo County Drainage District No. 1</b>	<b>Project:</b>	<b>Raymondville Drain Project</b>
<b>Report:</b>	<b>Wetland Delineation Report</b>	<b>Site Location:</b>	<b>Hidalgo and Willacy County, Texas</b>
<b>Photograph ID:</b> 167

<b>Latitude/Longitude:</b> 26.42621994, -98.12417861			
<b>Photo Direction:</b> south			
<b>Description:</b> SWMS001 Overview, representative of stormwater management structures			
<b>Photograph ID:</b> 168

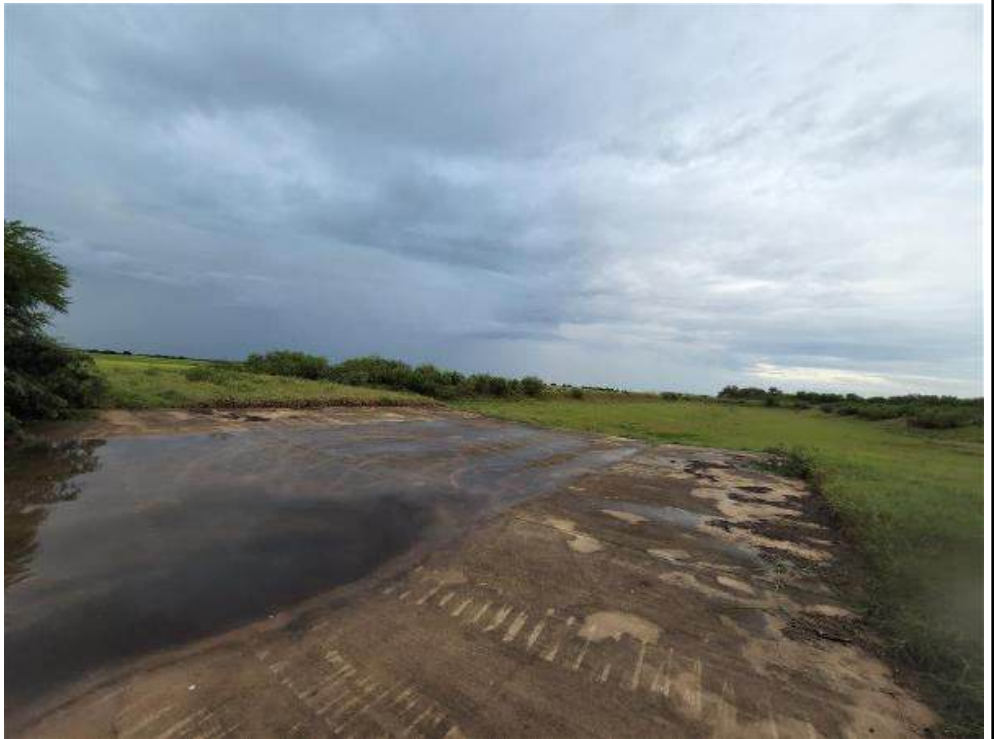
<b>Latitude/Longitude:</b> 26.42621994, -98.12417861			
<b>Photo Direction:</b> south			
<b>Description:</b> SWMS001, Representative photo of storm water detention pond

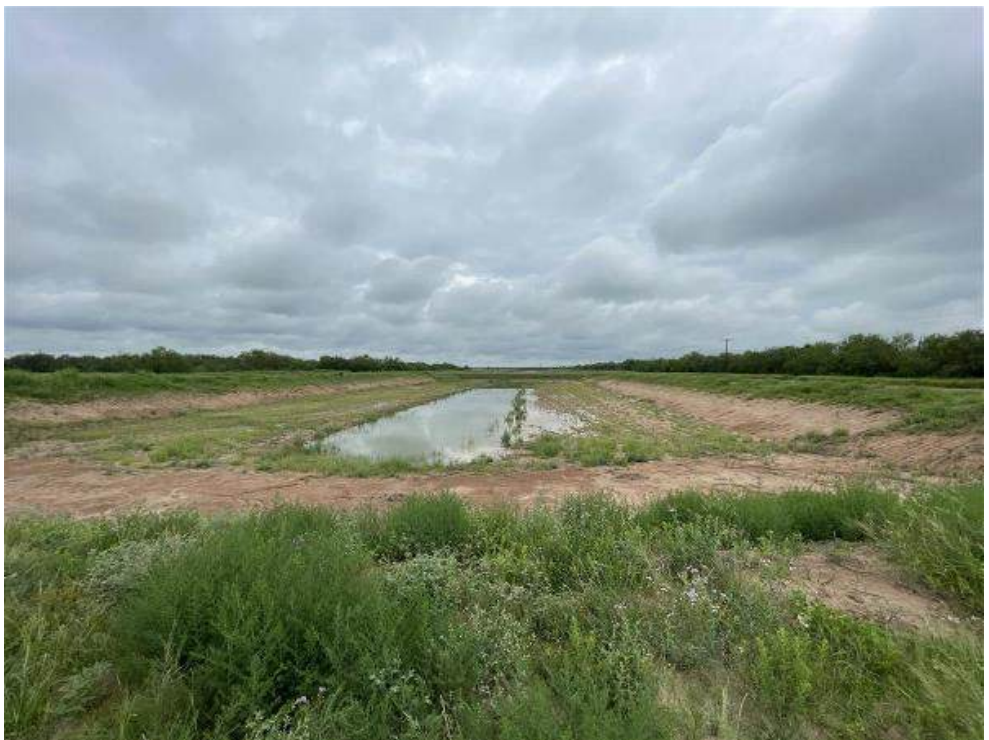
<b>Client:</b>	<b>Hidalgo County Drainage District No. 1</b>	<b>Project:</b>	<b>Raymondville Drain Project</b>
<b>Report:</b>	<b>Wetland Delineation Report</b>	<b>Site Location:</b>	<b>Hidalgo and Willacy County, Texas</b>
<b>Photograph ID:</b> 169

<b>Latitude/Longitude:</b> 26.39418681, -98.15483306			
<b>Photo Direction:</b> north			
<b>Description:</b> SWMS003 Overview, representative of stormwater management structures			
<b>Photograph ID:</b> 170

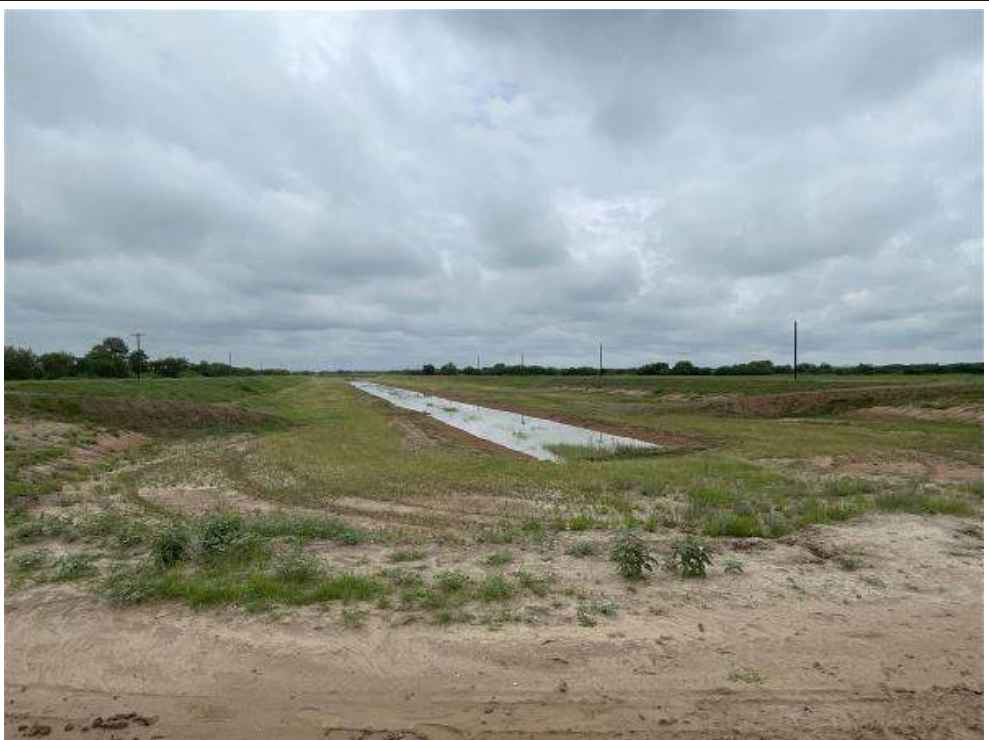
<b>Latitude/Longitude:</b> 26.39396652, -98.15485335			
<b>Photo Direction:</b> southwest			
<b>Description:</b> SWMS004 Overview, representative of stormwater management structures

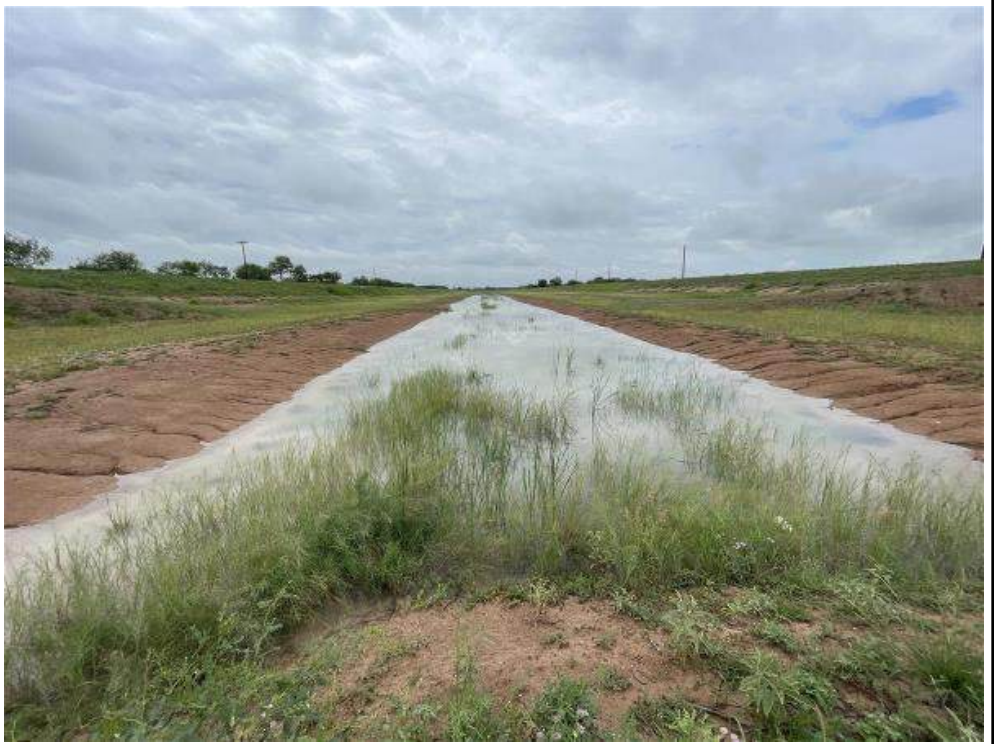
<b>Client:</b>	<b>Hidalgo County Drainage District No. 1</b>	<b>Project:</b>	<b>Raymondville Drain Project</b>
<b>Report:</b>	<b>Wetland Delineation Report</b>	<b>Site Location:</b>	<b>Hidalgo and Willacy County, Texas</b>
<b>Photograph ID:</b> 171

<b>Latitude/Longitude:</b> 26.3936138, -98.1550487			
<b>Photo Direction:</b> south			
<b>Description:</b> SWMS004 Overview, representative of stormwater management structures			
<b>Photograph ID:</b> 172

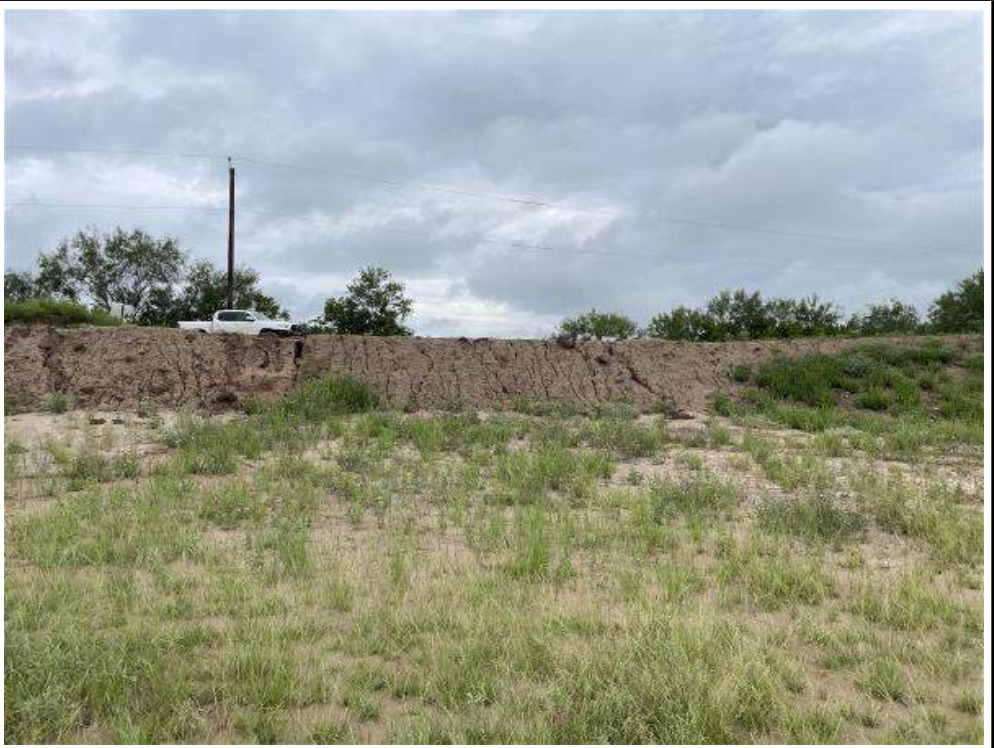
<b>Latitude/Longitude:</b> 26.39362505, -98.15503059			
<b>Photo Direction:</b> north			
<b>Description:</b> SWMS004, Representative photo of stormwater management structure, no culvert observed

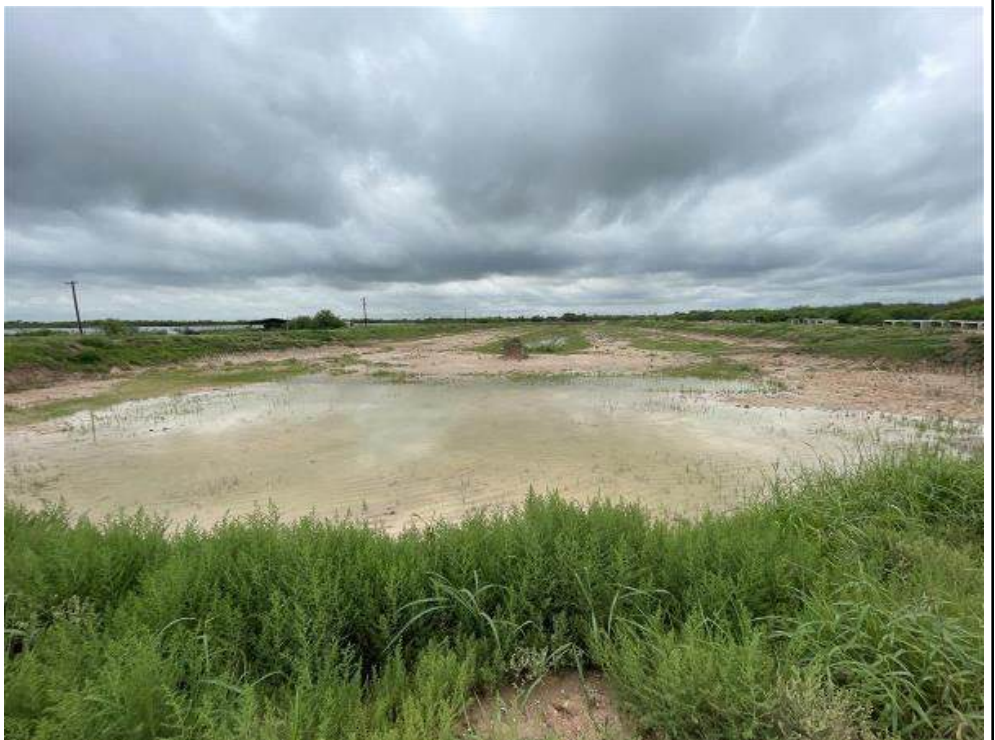
<b>Latitude/Longitude:</b> 26.38704102, -98.15627096			
<b>Photo Direction:</b> south			
<b>Description:</b> SWMS005 Overview, representative of stormwater management structures			
<b>Photograph ID: 174</b>

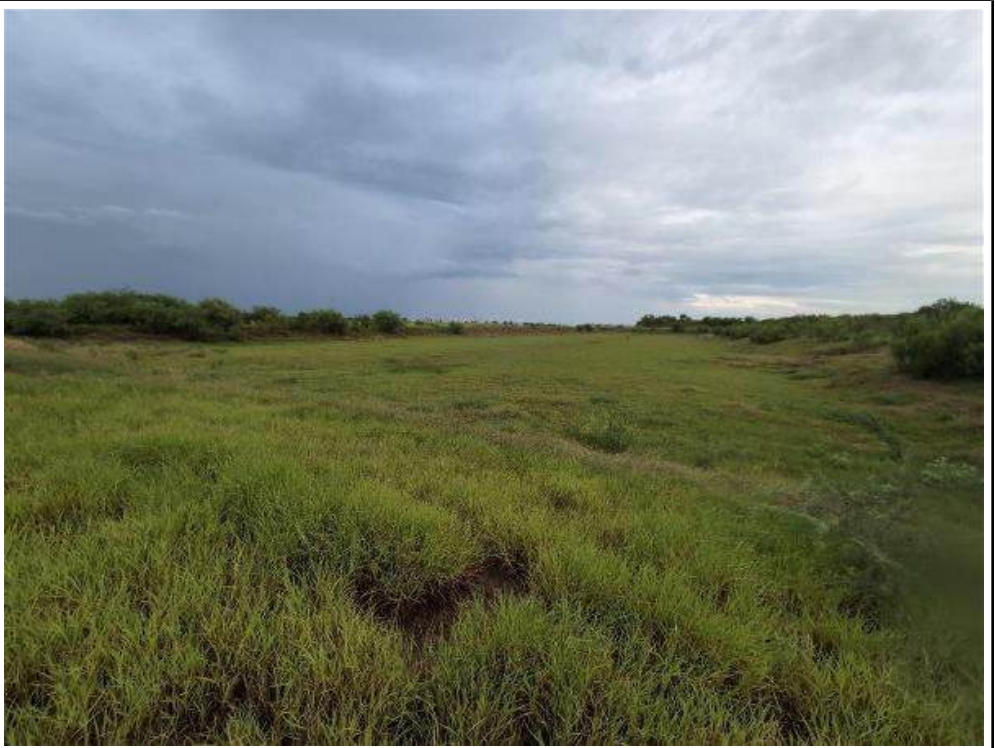
<b>Latitude/Longitude:</b> 26.42611099, -98.12431808			
<b>Photo Direction:</b> south			
<b>Description:</b> SWMS01, Representative photo of storm water detention pond

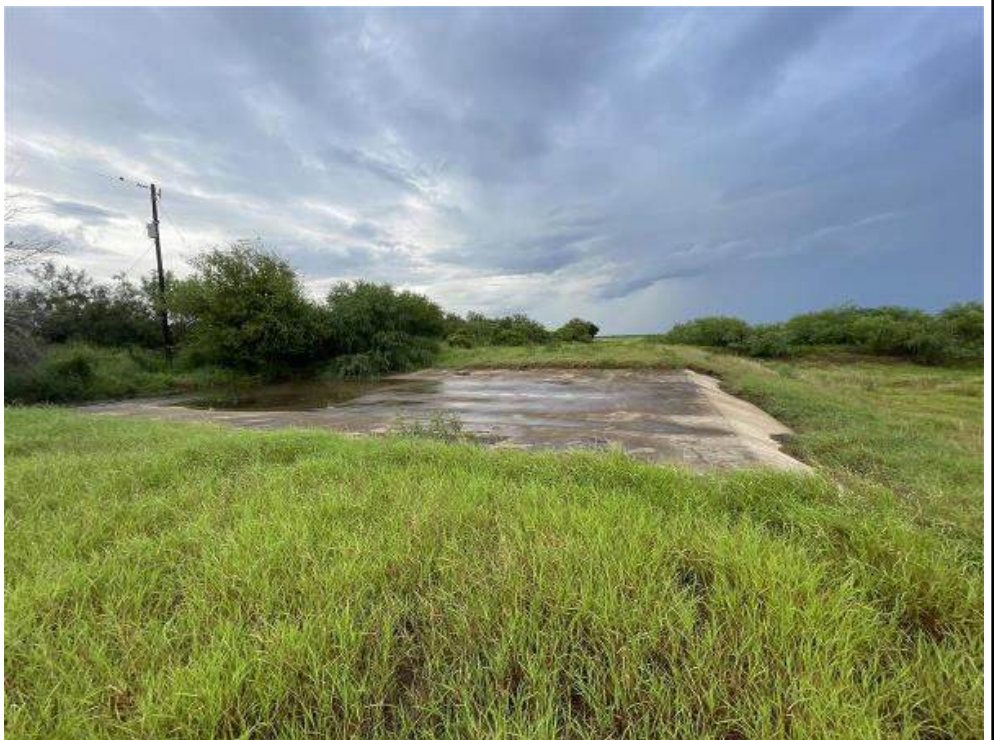
<b>Client:</b>	<b>Hidalgo County Drainage District No. 1</b>	<b>Project:</b>	<b>Raymondville Drain Project</b>
<b>Report:</b>	<b>Wetland Delineation Report</b>	<b>Site Location:</b>	<b>Hidalgo and Willacy County, Texas</b>
<b>Photograph ID: 175</b>

<b>Latitude/Longitude:</b> 26.42609719, -98.12425114			
<b>Photo Direction:</b> south			
<b>Description:</b> SWMS01, Representative photo of stormwater detention basin spillway			
<b>Photograph ID: 176</b>

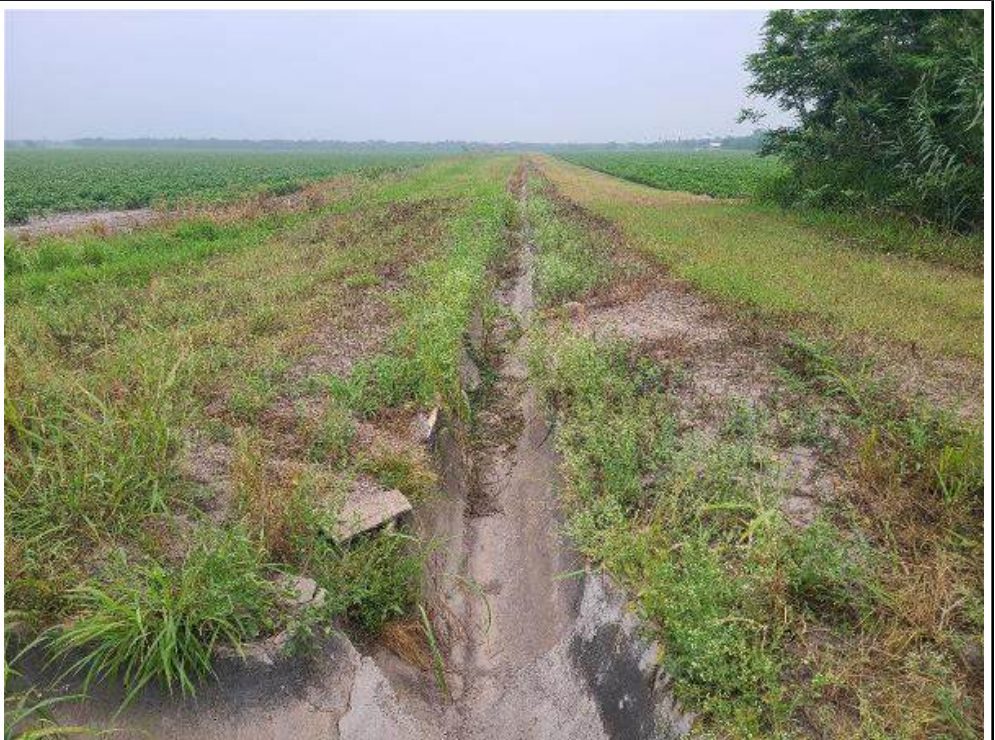
<b>Latitude/Longitude:</b> 26.52257671, -97.79246116			
<b>Photo Direction:</b> north			
<b>Description:</b> Representative photo of irrigation canal / artificial conduit

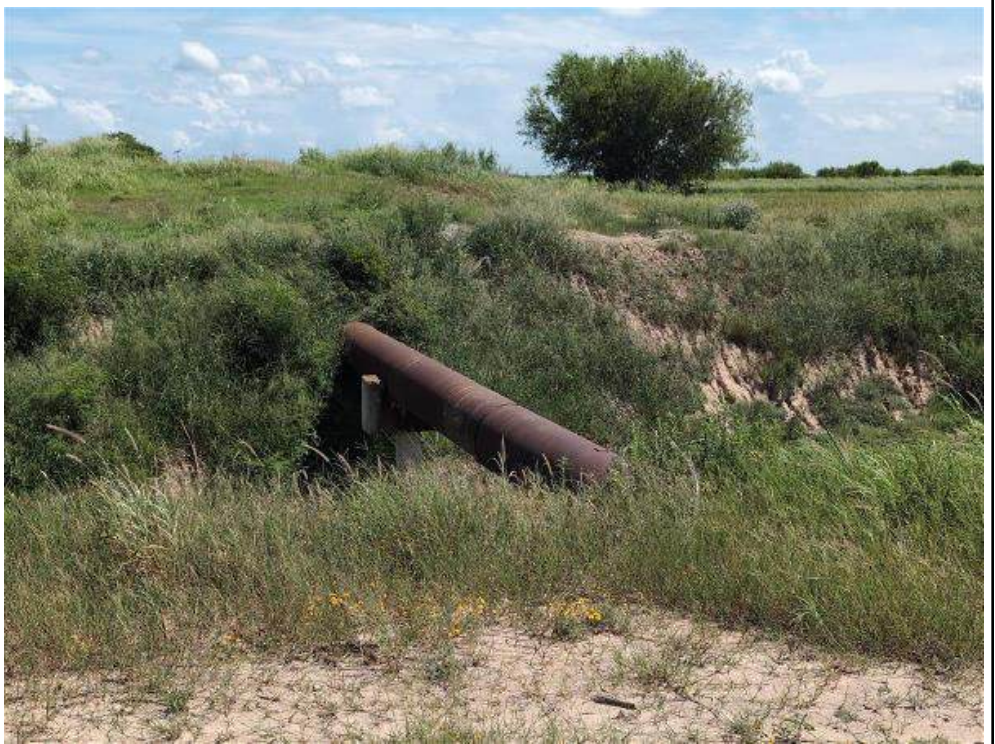
<b>Client:</b>	<b>Hidalgo County Drainage District No. 1</b>	<b>Project:</b>	<b>Raymondville Drain Project</b>
<b>Report:</b>	<b>Wetland Delineation Report</b>	<b>Site Location:</b>	<b>Hidalgo and Willacy County, Texas</b>
<b>Photograph ID: 177</b>

<b>Latitude/Longitude:</b> 26.47326366, -97.93039055			
<b>Photo Direction:</b> north			
<b>Description:</b> Representative photo of irrigation canal / artificial conduit			
<b>Photograph ID: 178</b>
