## **Delineation Report**

Raymondville Drain Project  
Hidalgo and Willacy Counties, Texas

December 11, 2024

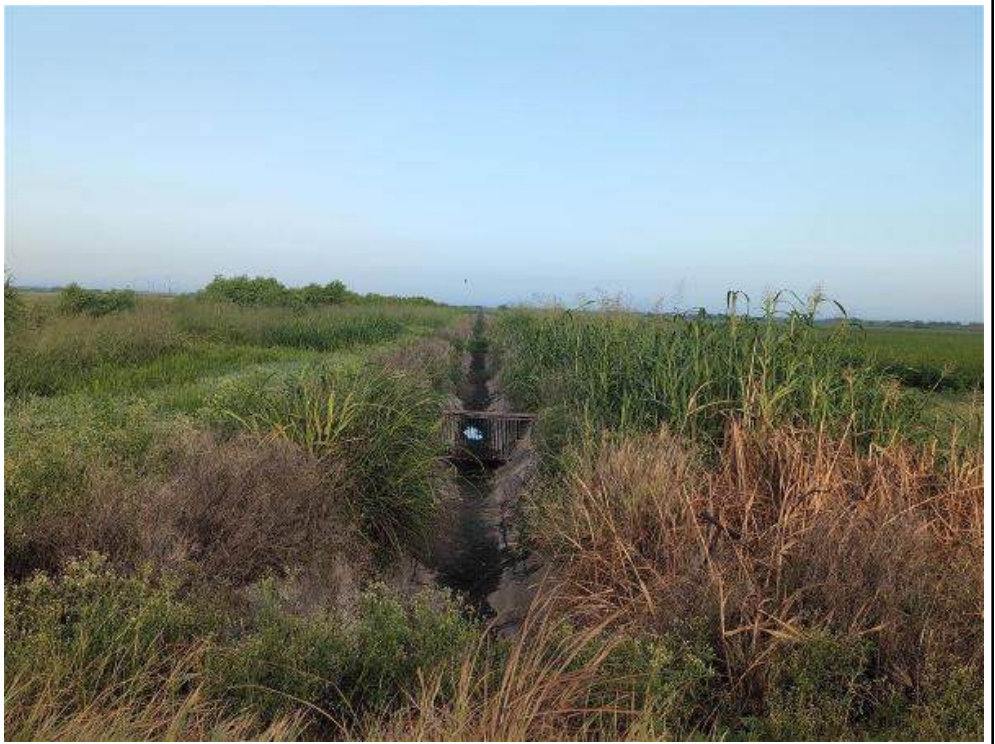
<b>Latitude/Longitude:</b> 26.49243726, -97.86078109			
<b>Photo Direction:</b> west			
<b>Description:</b> Representative photo of irrigation canal / artificial conduit

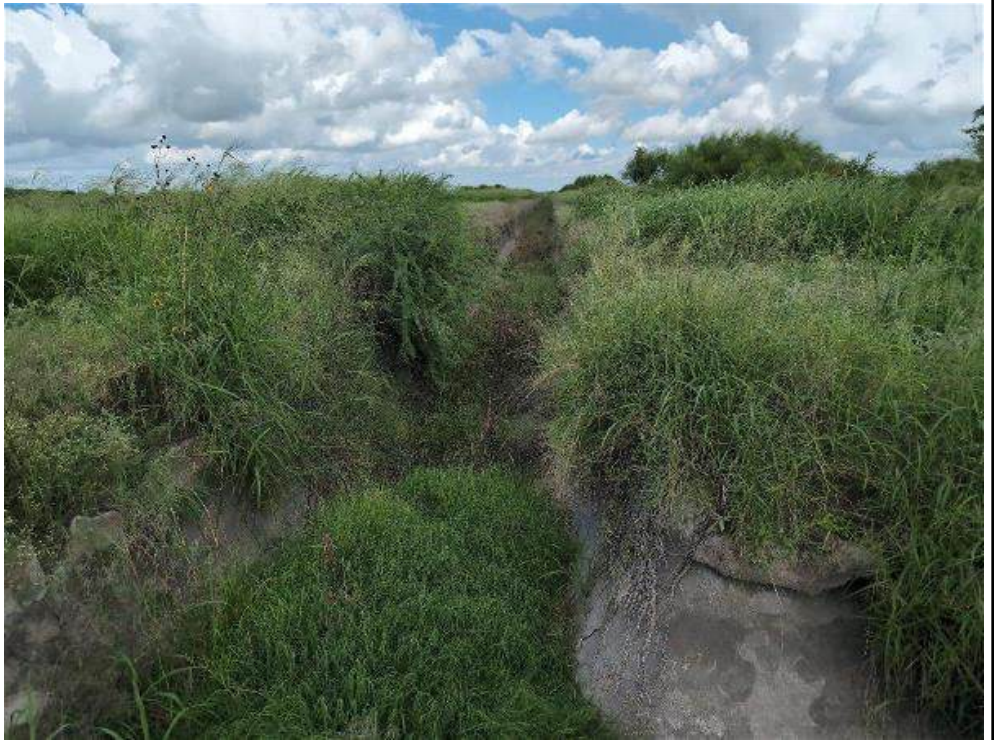
<b>Client:</b>	<b>Hidalgo County Drainage District No. 1</b>	<b>Project:</b>	<b>Raymondville Drain Project</b>
<b>Report:</b>	<b>Wetland Delineation Report</b>	<b>Site Location:</b>	<b>Hidalgo and Willacy County, Texas</b>
<b>Photograph ID:</b> 179

<b>Latitude/Longitude:</b> 26.47323749, -97.91836484			
<b>Photo Direction:</b> northeast			
<b>Description:</b> Representative photo of irrigation canal / artificial conduit			
<b>Photograph ID:</b> 180

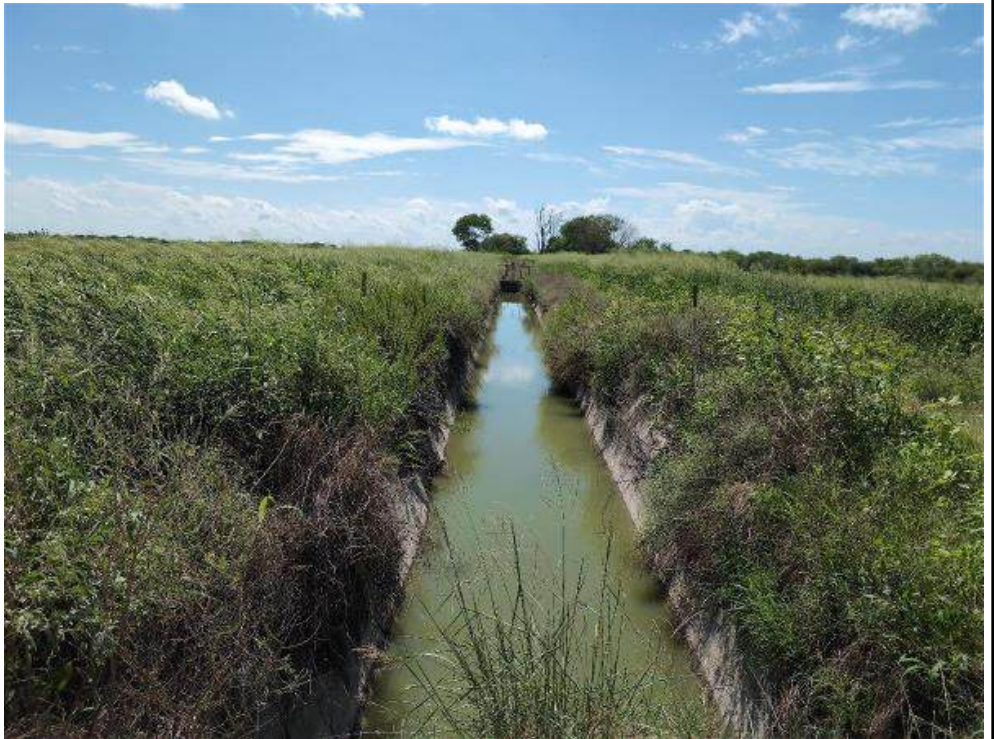
<b>Latitude/Longitude:</b> 26.47304156, -97.9427044			
<b>Photo Direction:</b> south			
<b>Description:</b> Representative photo of irrigation canal / artificial conduit

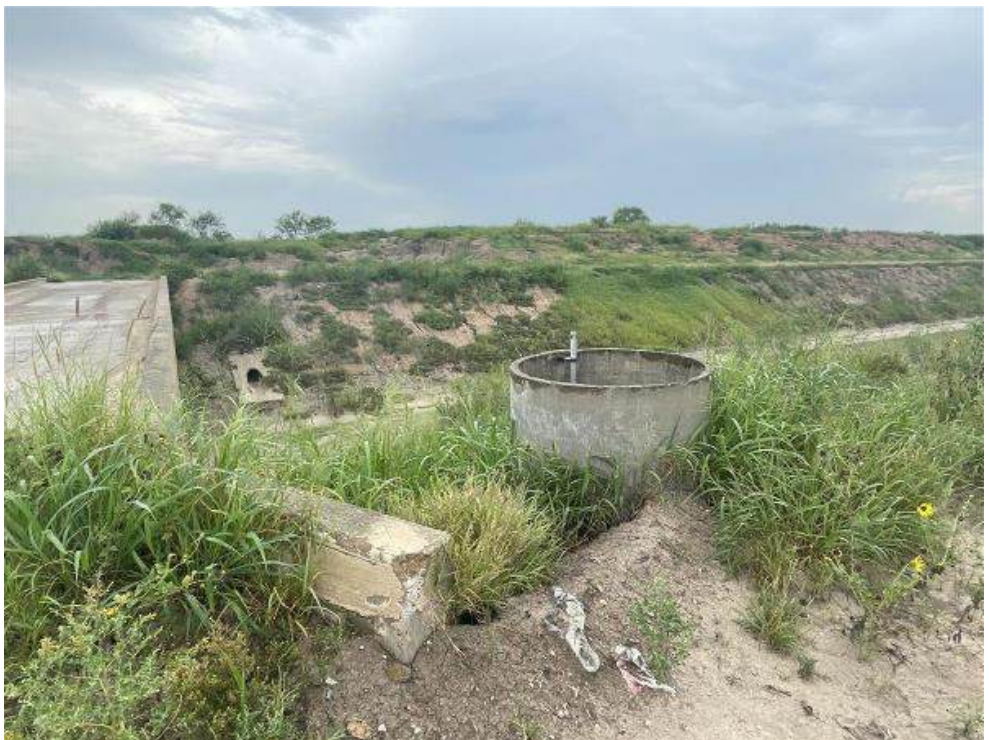
<b>Client:</b>	<b>Hidalgo County Drainage District No. 1</b>	<b>Project:</b>	<b>Raymondville Drain Project</b>
<b>Report:</b>	<b>Wetland Delineation Report</b>	<b>Site Location:</b>	<b>Hidalgo and Willacy County, Texas</b>
<b>Photograph ID:</b> 181

<b>Latitude/Longitude:</b> 26.51906413, -97.83014728			
<b>Photo Direction:</b> northwest			
<b>Description:</b> Representative photo of irrigation canal / artificial conduit control valve			
<b>Photograph ID:</b> 182

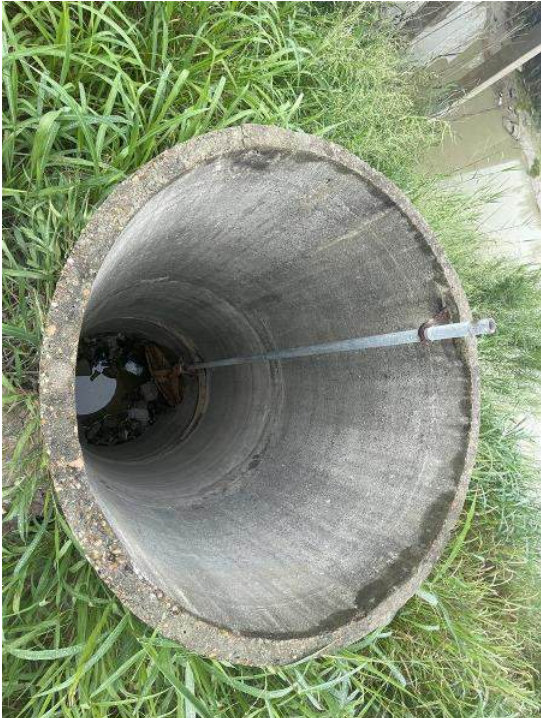
<b>Latitude/Longitude:</b> 26.51907728, -97.83015461			
<b>Photo Direction:</b> west			
<b>Description:</b> Representative photo of irrigation canal / artificial conduit control valve

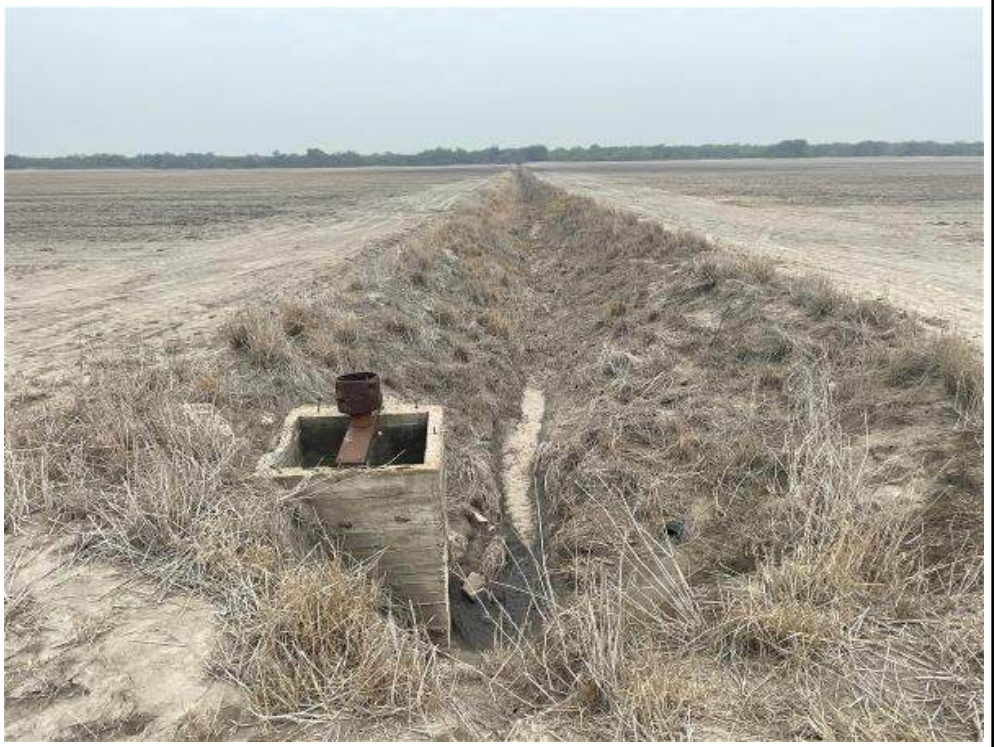
<b>Client:</b>	<b>Hidalgo County Drainage District No. 1</b>	<b>Project:</b>	<b>Raymondville Drain Project</b>
<b>Report:</b>	<b>Wetland Delineation Report</b>	<b>Site Location:</b>	<b>Hidalgo and Willacy County, Texas</b>
<b>Photograph ID:</b> 183

<b>Latitude/Longitude:</b> 26.52813424, -97.80774006			
<b>Photo Direction:</b> north			
<b>Description:</b> Representative photo of irrigation canal / artificial conduit with control valve
